LICENSEE EVENT REPORT (LER)

FACILITY NAME (1) Haddam Neck										DOCKET NUMBER (2) 0 5 0 0 0 2 1 3 1										PAGE (3) 1 OF 10																		
TITLE (4) Post-LOCA Release Paths Outside Containment																																						
EVENT DATE (5)						LER NUMBER (6)						REPORT DATE (7)						OTHER FACILITIES INVOLVED (8)																				
MONTH			DAY			YEAR			YEAR			SEQUENTIAL NUMBER			REVISION NUMBER			MONTH			DAY			YEAR			FACILITY NAMES Non-Applicable						DOCKET NUMBER(S) 0 5 0 0 0					
0 8			0 2			8 5			8 5			1 7			0 1			1 1			0 8			8 5									0 5 0 0 0					
OPERATING MODE (9) 1						THIS REPORT IS SUBMITTED PURSUANT TO THE REQUIREMENTS OF 10 CFR § (Check one or more of the following) (11)																																
POWER LEVEL (10) 1 0 0						20.402(b)						20.405(c)						50.73(a)(2)(iv)						73.71(b)

II. Identification of New Release Pathway Resulting From PDCR 380

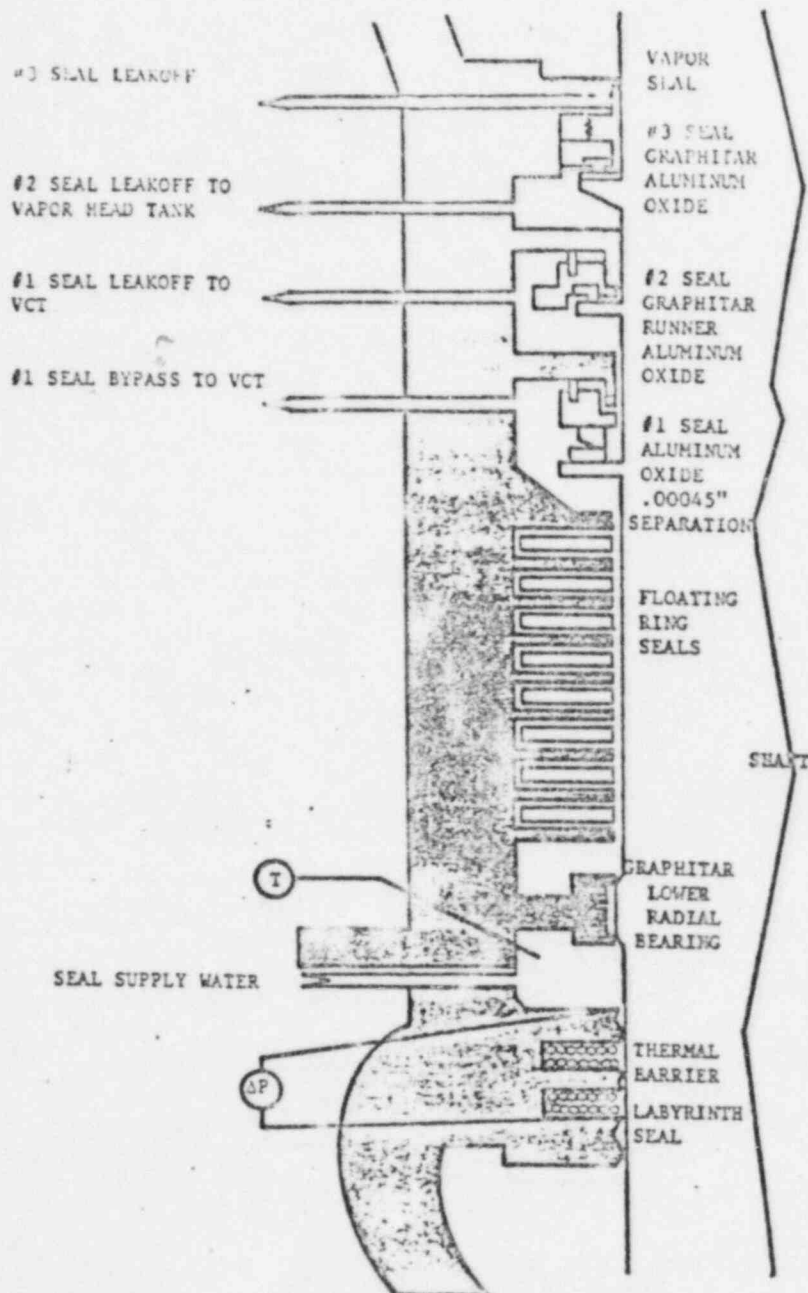
FIGURE A
RCP SEAL PACKAGE

When the charging system is running and aligned to provide seal injection flow to the Reactor Coolant Pump (RCP) seals, borated water is injected into the seal area at a pressure higher than Reactor Coolant System (RCS) pressure and this water flows through the thermal barrier into the primary system (Figure A). Some of the seal injection water flows through the #1 seal and returns through a filter to the charging pump suction via the seal water return header (Figure B). In the post-LOCA situation, the system operates essentially the same with the exception that the injection water is drawn from the Refueling Water Storage Tank (RWST) rather than the Volume Control Tank (VCT) and the charging pumps will automatically start only if normal power is available. As long as seal injection continues, the flow of fluid through the thermal barrier is into the RCS, thus no release path of potentially highly contaminated water would exist. If seal injection were to cease however, then RCS fluid would leak out through the RCP #1 seal and enter the seal water return header.

Prior to the 1980 refueling outage, the isolation valves on the seal water return lines (CH-MOV-311, 312, 313, 314) would automatically close on a safety injection actuation signal and prevent seal return flow from leaving the containment. Since the closure of these valves would prevent sustained operation of the RCP, these valves were removed from the automatic actuation scheme via the implementation of PDCR 380. As a result, a pathway for reactor coolant to bypass containment isolation was created. This potential source of radioactivity was not considered in the accident analysis.
