DOCKET 50-312
RANCHO SECO NUCLEAR GENERATING STATION
UNIT NO. 1
SUMMARY AND SUPPLEMENTAL INFORMATION FROM TRANSIENT OF OCTOBER 2, 1985

HPI "A" FLOW ANOMALY

RANCHO SECO NONCONFORMING REPORT

Page 1 of 8 No. S 5150 Rev. 2

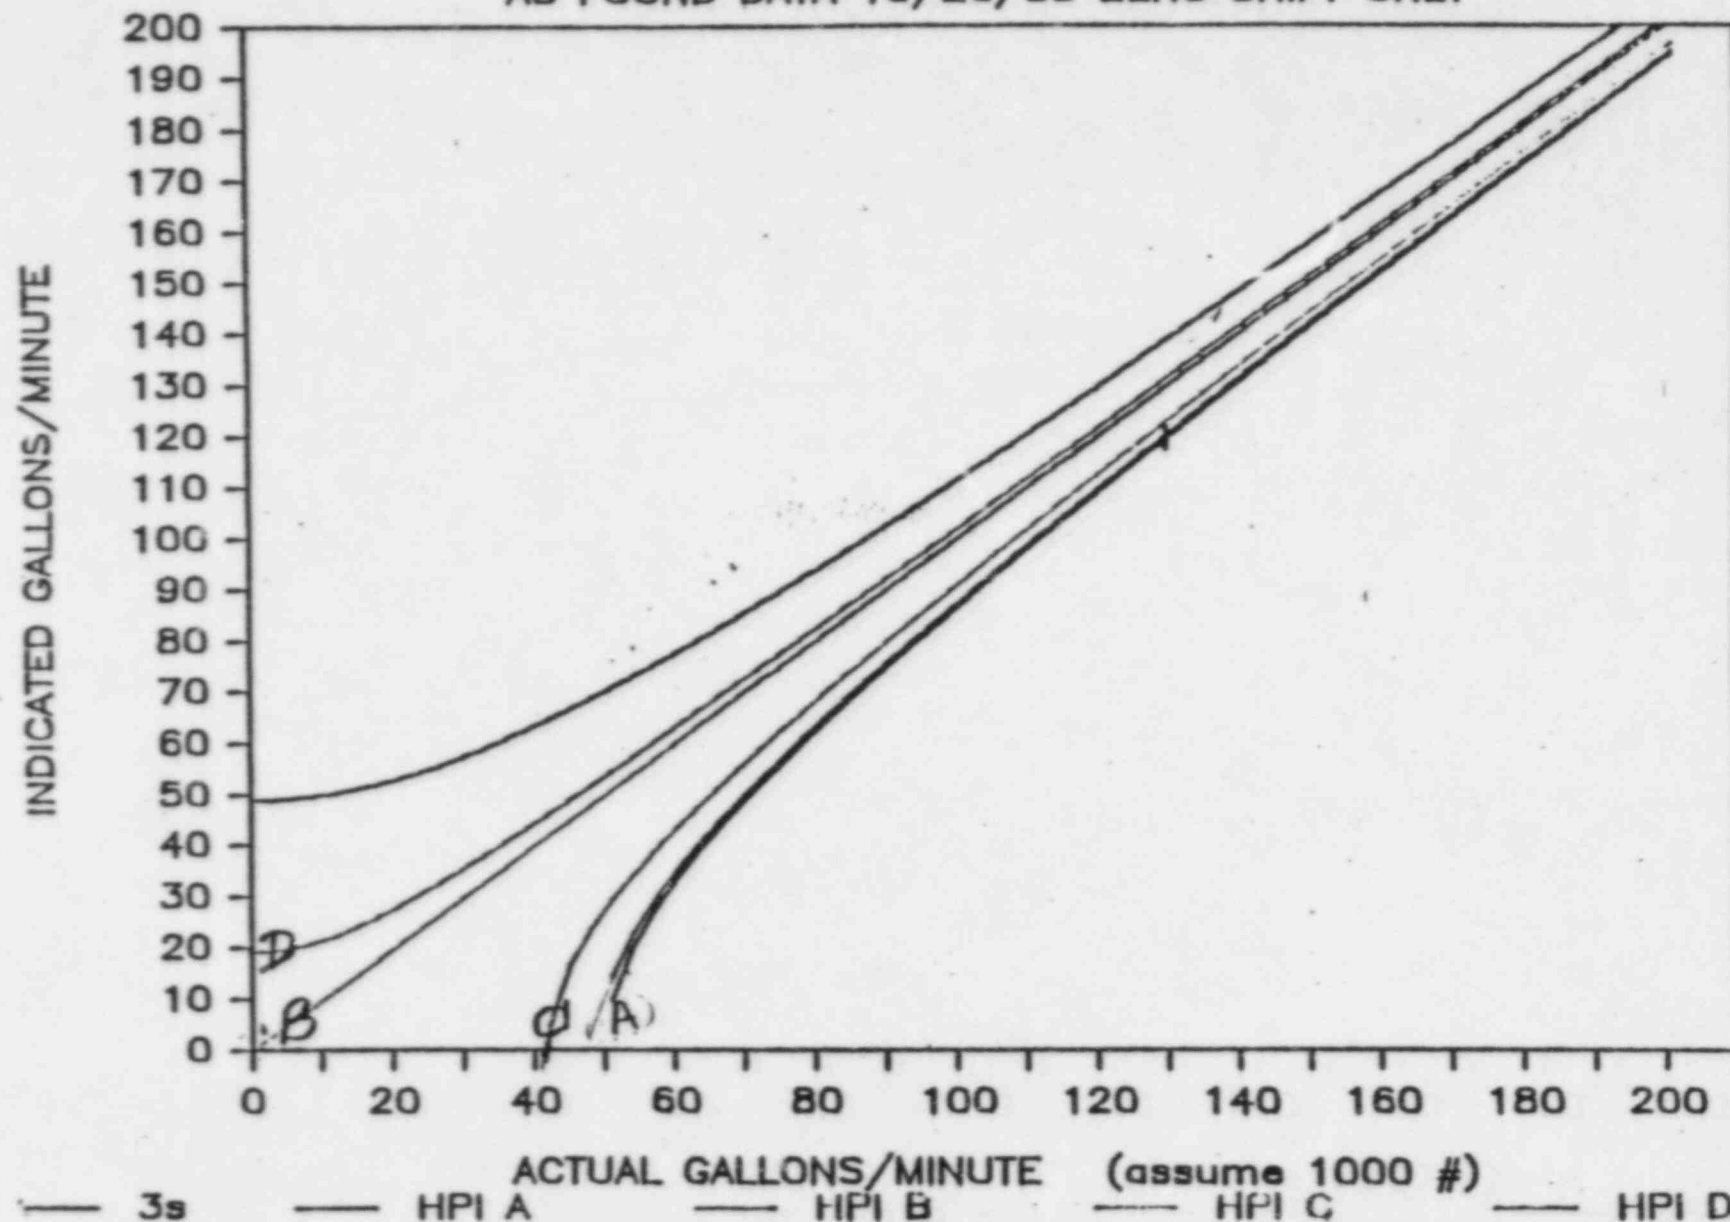
NCR S-5150 Figure 1

HPI DP FLOW ERROR

AS FOUND DATA 10/26/85 ZERO SHIFT ONLY

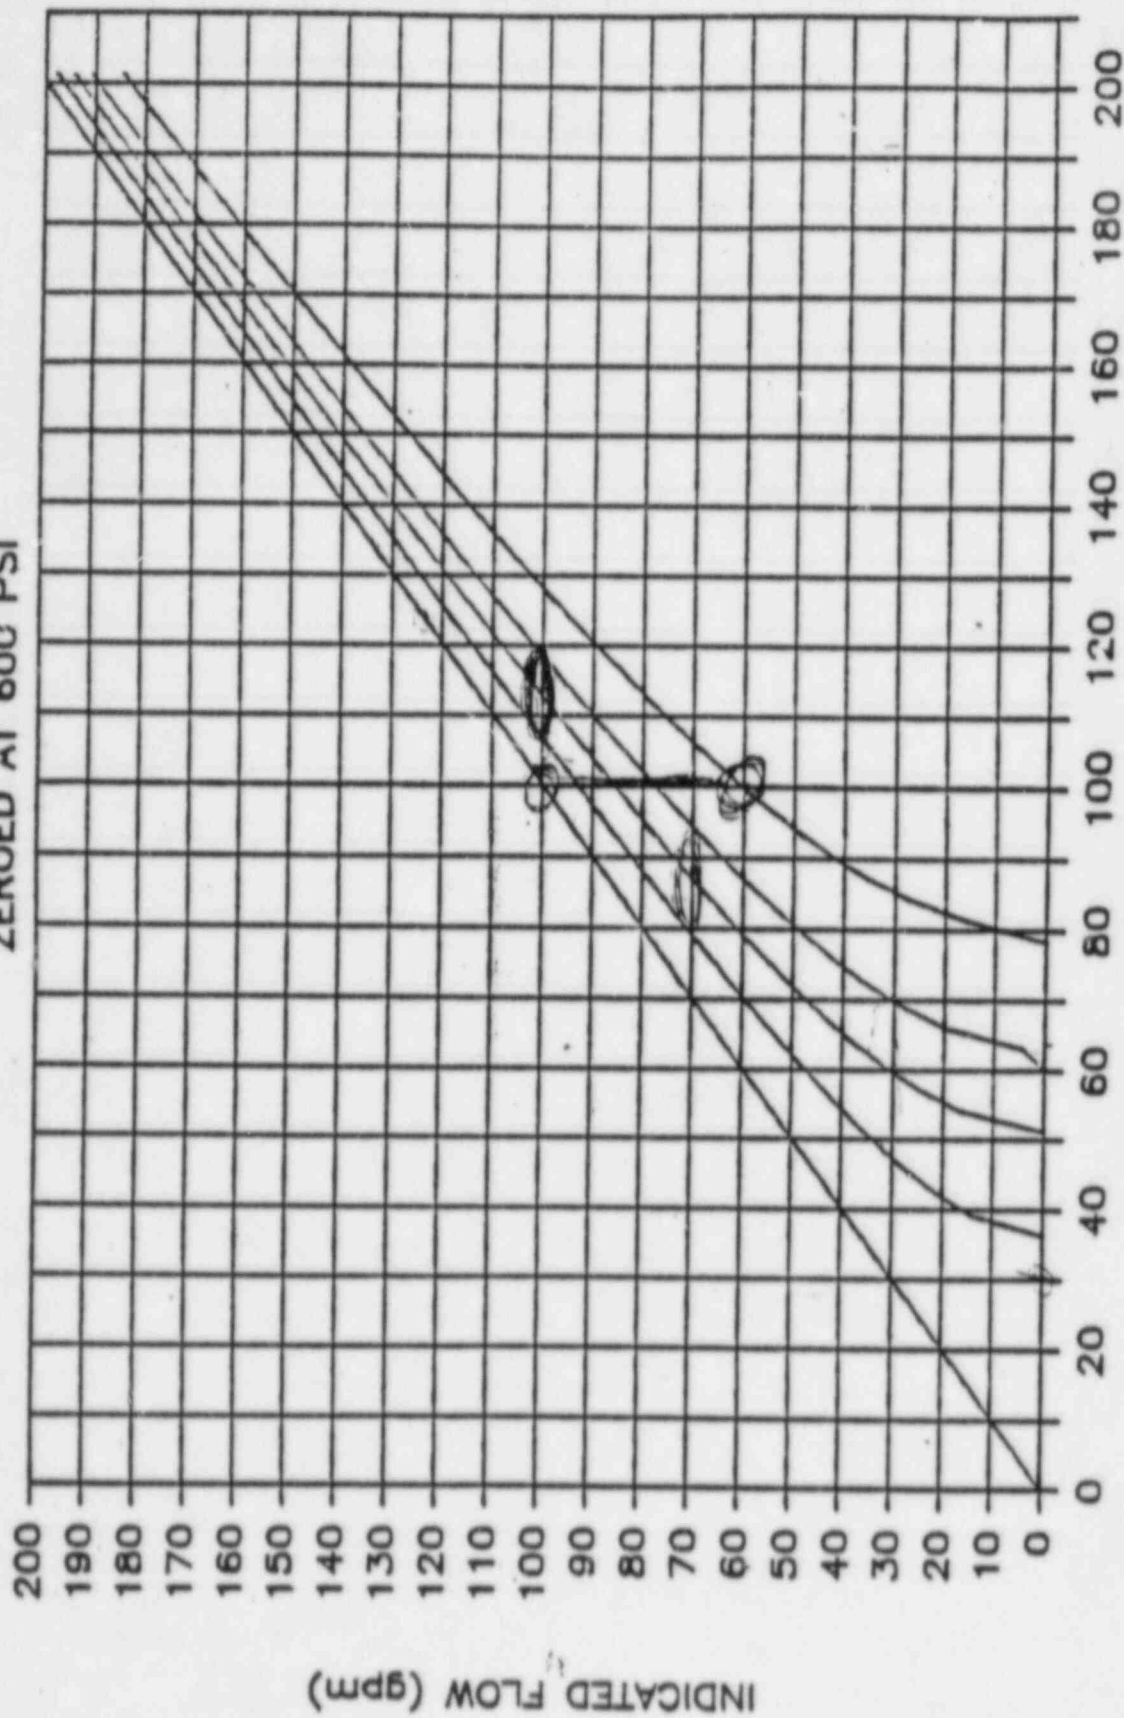
HPI A FLOW

The effect of system pressure on the zero shift was calculated for all four (4) transmitters at various pressures, resulting in the curves shown in Figure Nos. 2, 3, 4, and 5. These curves indicate that, with proper selection of the calibration pressure, the zero error can be caused to always be in a minus direction (indicated flow less than actual). For example, on the A loop (worst case), indicated flow could vary from 60 gpm, at 3000 psig header pressure, to 100 gpm at 600 psig, for an actual flow of 100 gpm (Calculation No. Z-SIM-10099, Attachment 3, substantiates these curves).

ZEROED AT 600 PSI

1. Nuclear Operations to recalibrate HPI transmitters to assure that indicate flow is below actual flow as noted in Figures 2, 3, 4 and 5.
2. Nuclear Engineering to develop human engineered method to alert operators that lower portion of indicators are not accurate.
3. Nuclear Operations to notify operators of HPI flow accuracy limitations.
4. Nuclear Engineering to evaluate short/long term upgrade of HPI flow, submit Pre-Mods as appropriate.
5. Nuclear Operations to determine zero shift characteristics of other Rosemount dp transmitter applications, specifically for Pressurizer level, RCP seal injection flow, AFW flow, and DH flow.

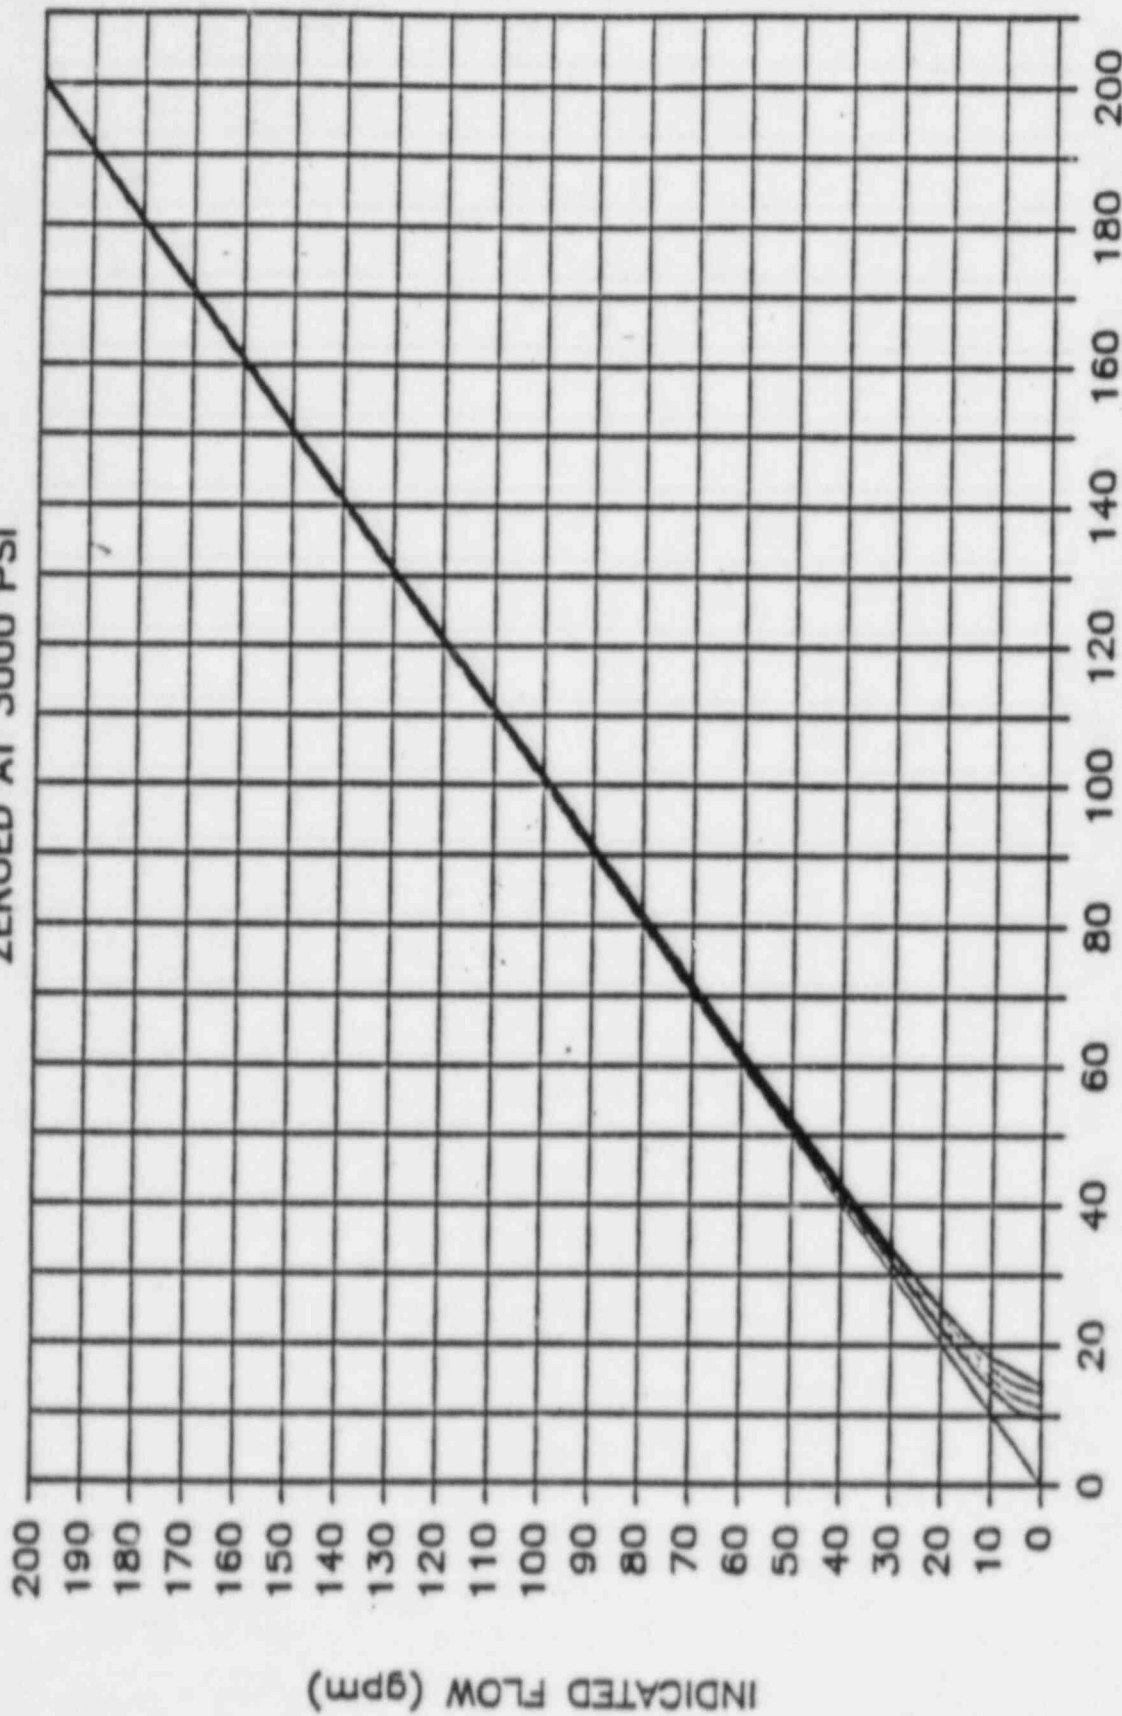
HPI B FLOW

ZEROED AT 3000 PSI

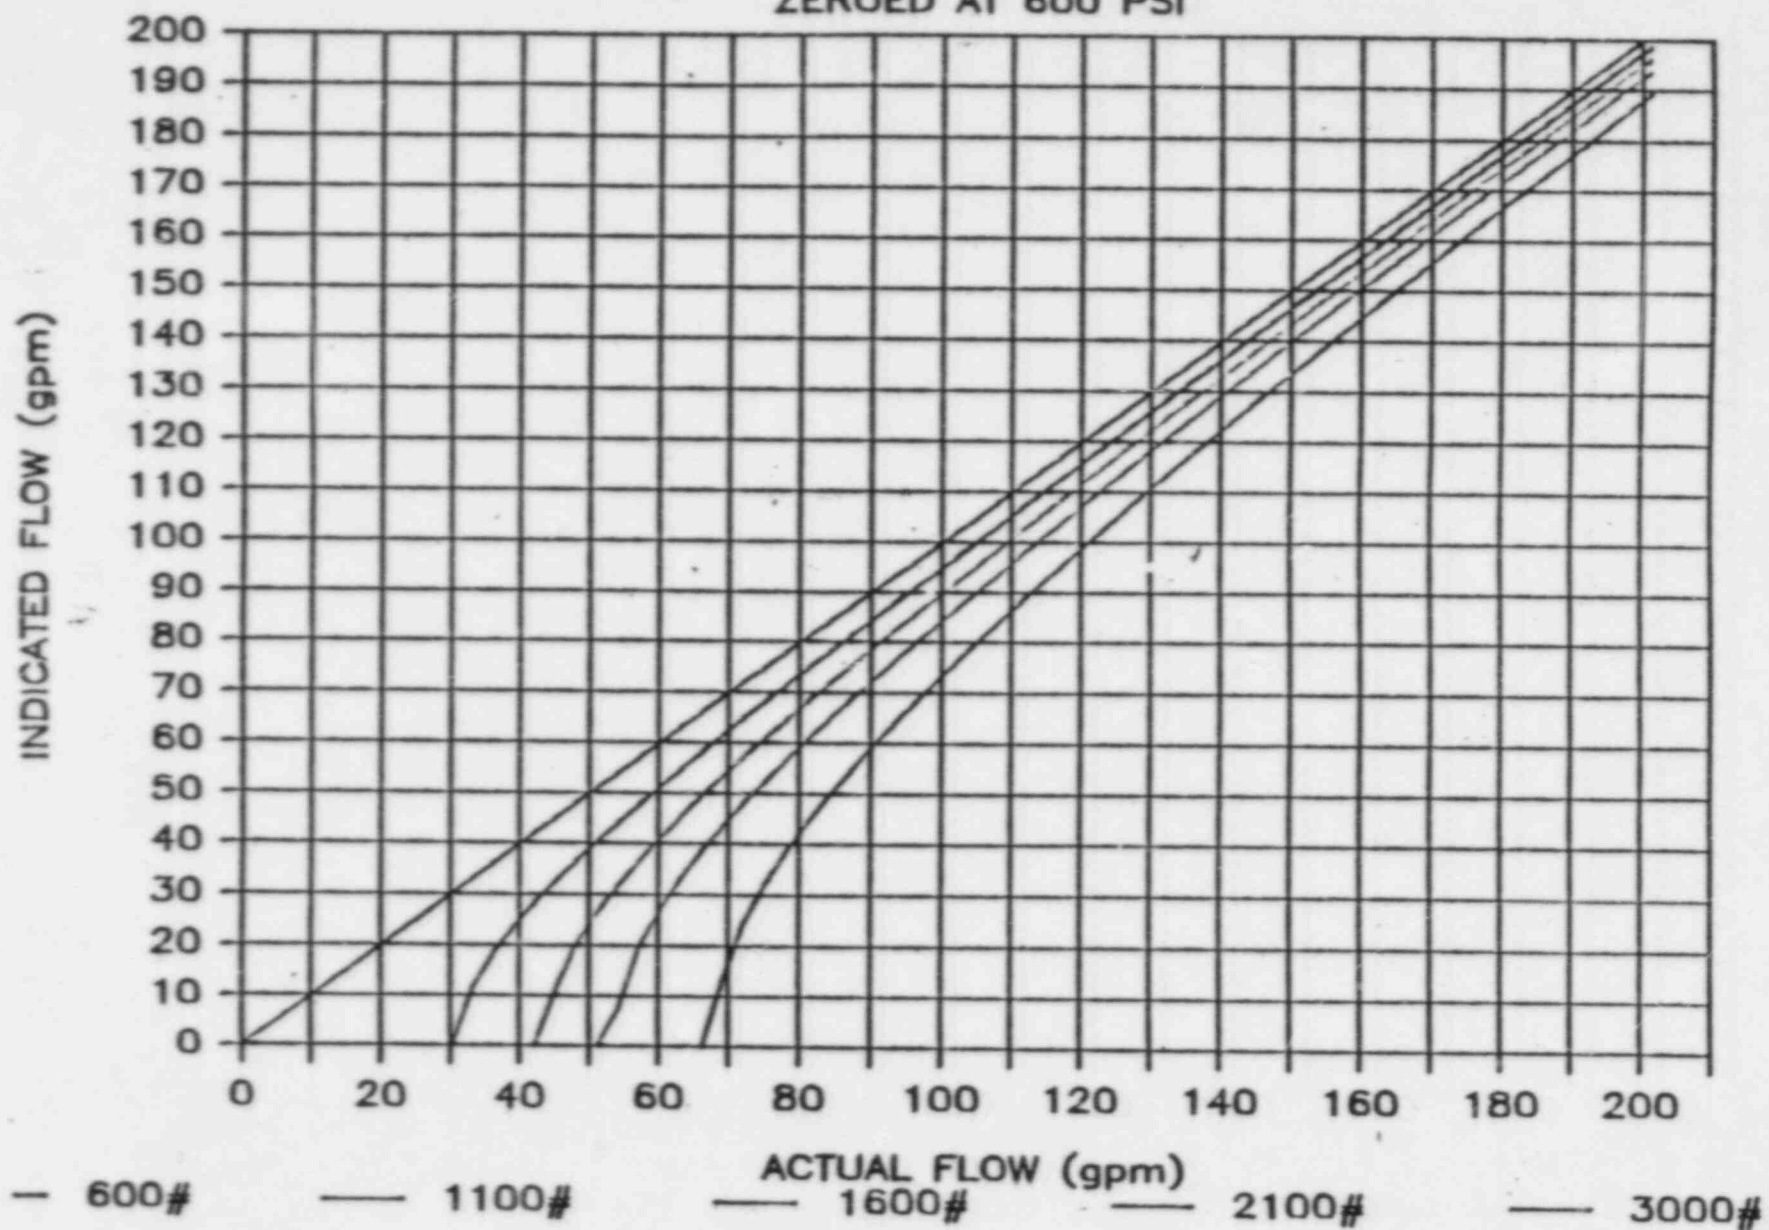
NCR S-5150 Figure 4

HPI C FLOW

ZEROED AT 600 PSI

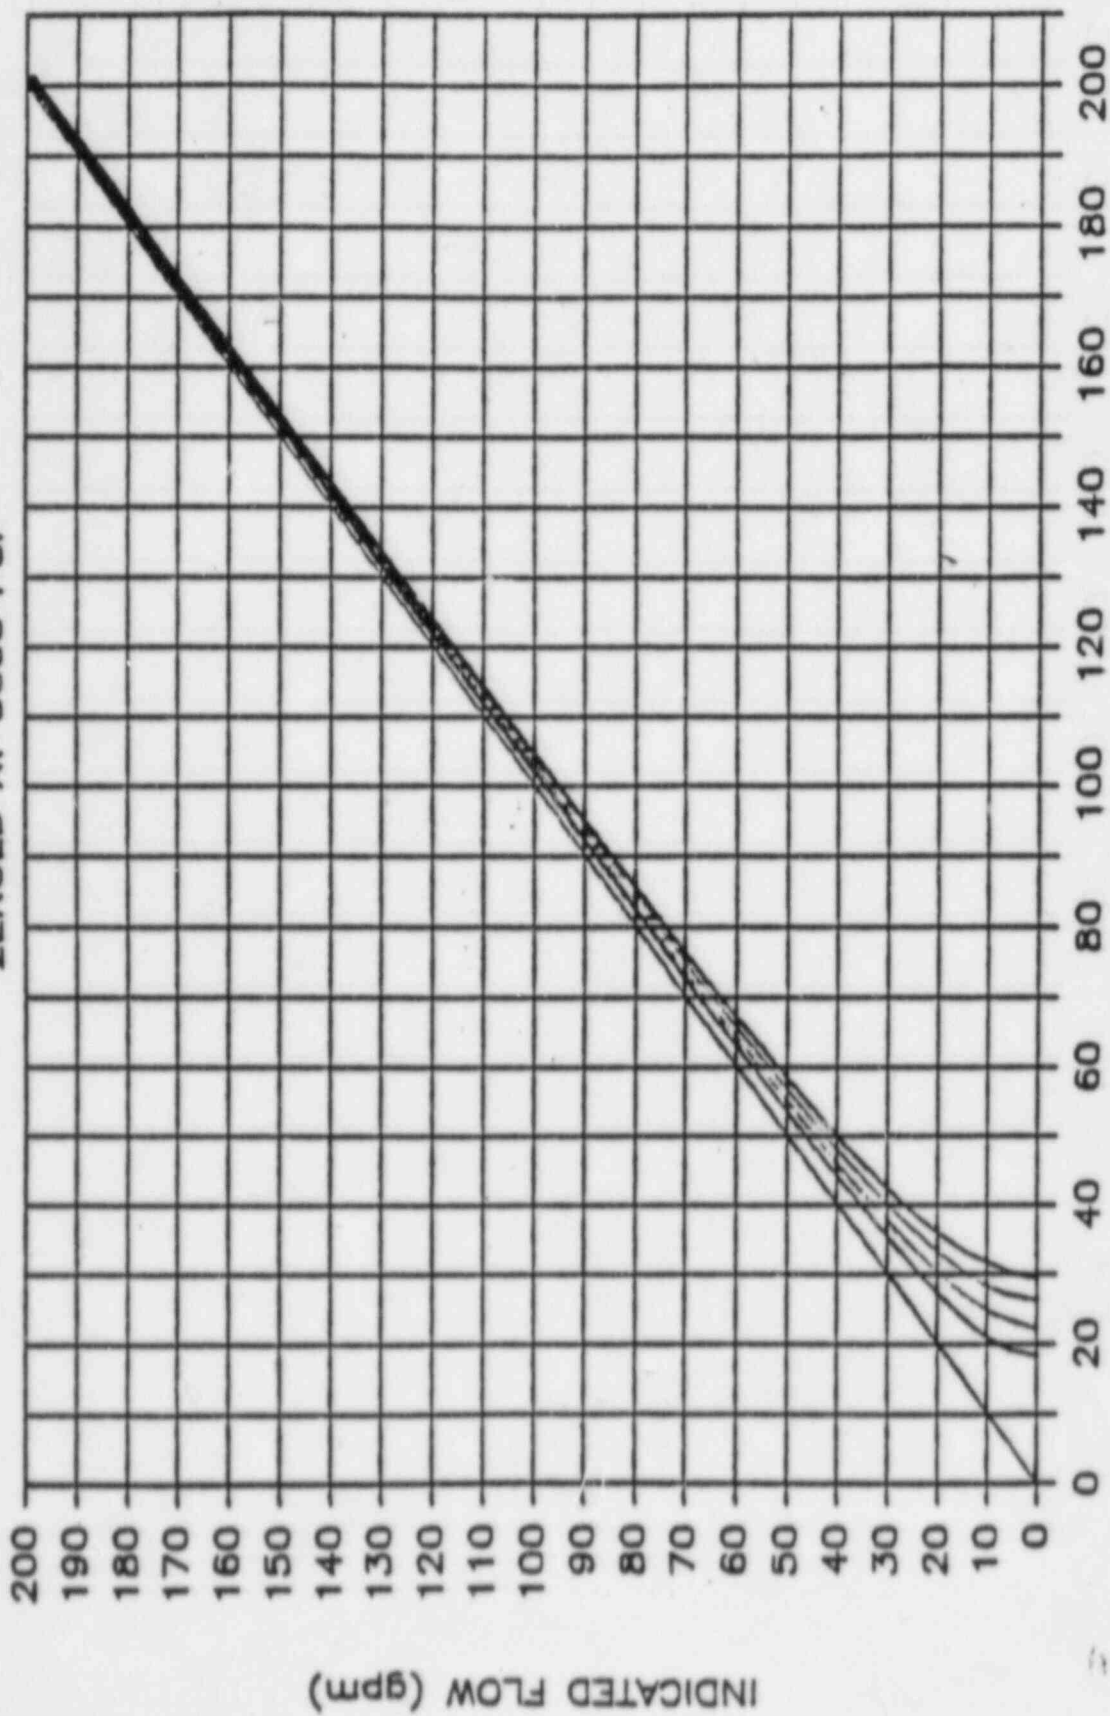
NCR S-5150 Figure 5

HPI D FLOW

ZEROED AT 3000 PSI

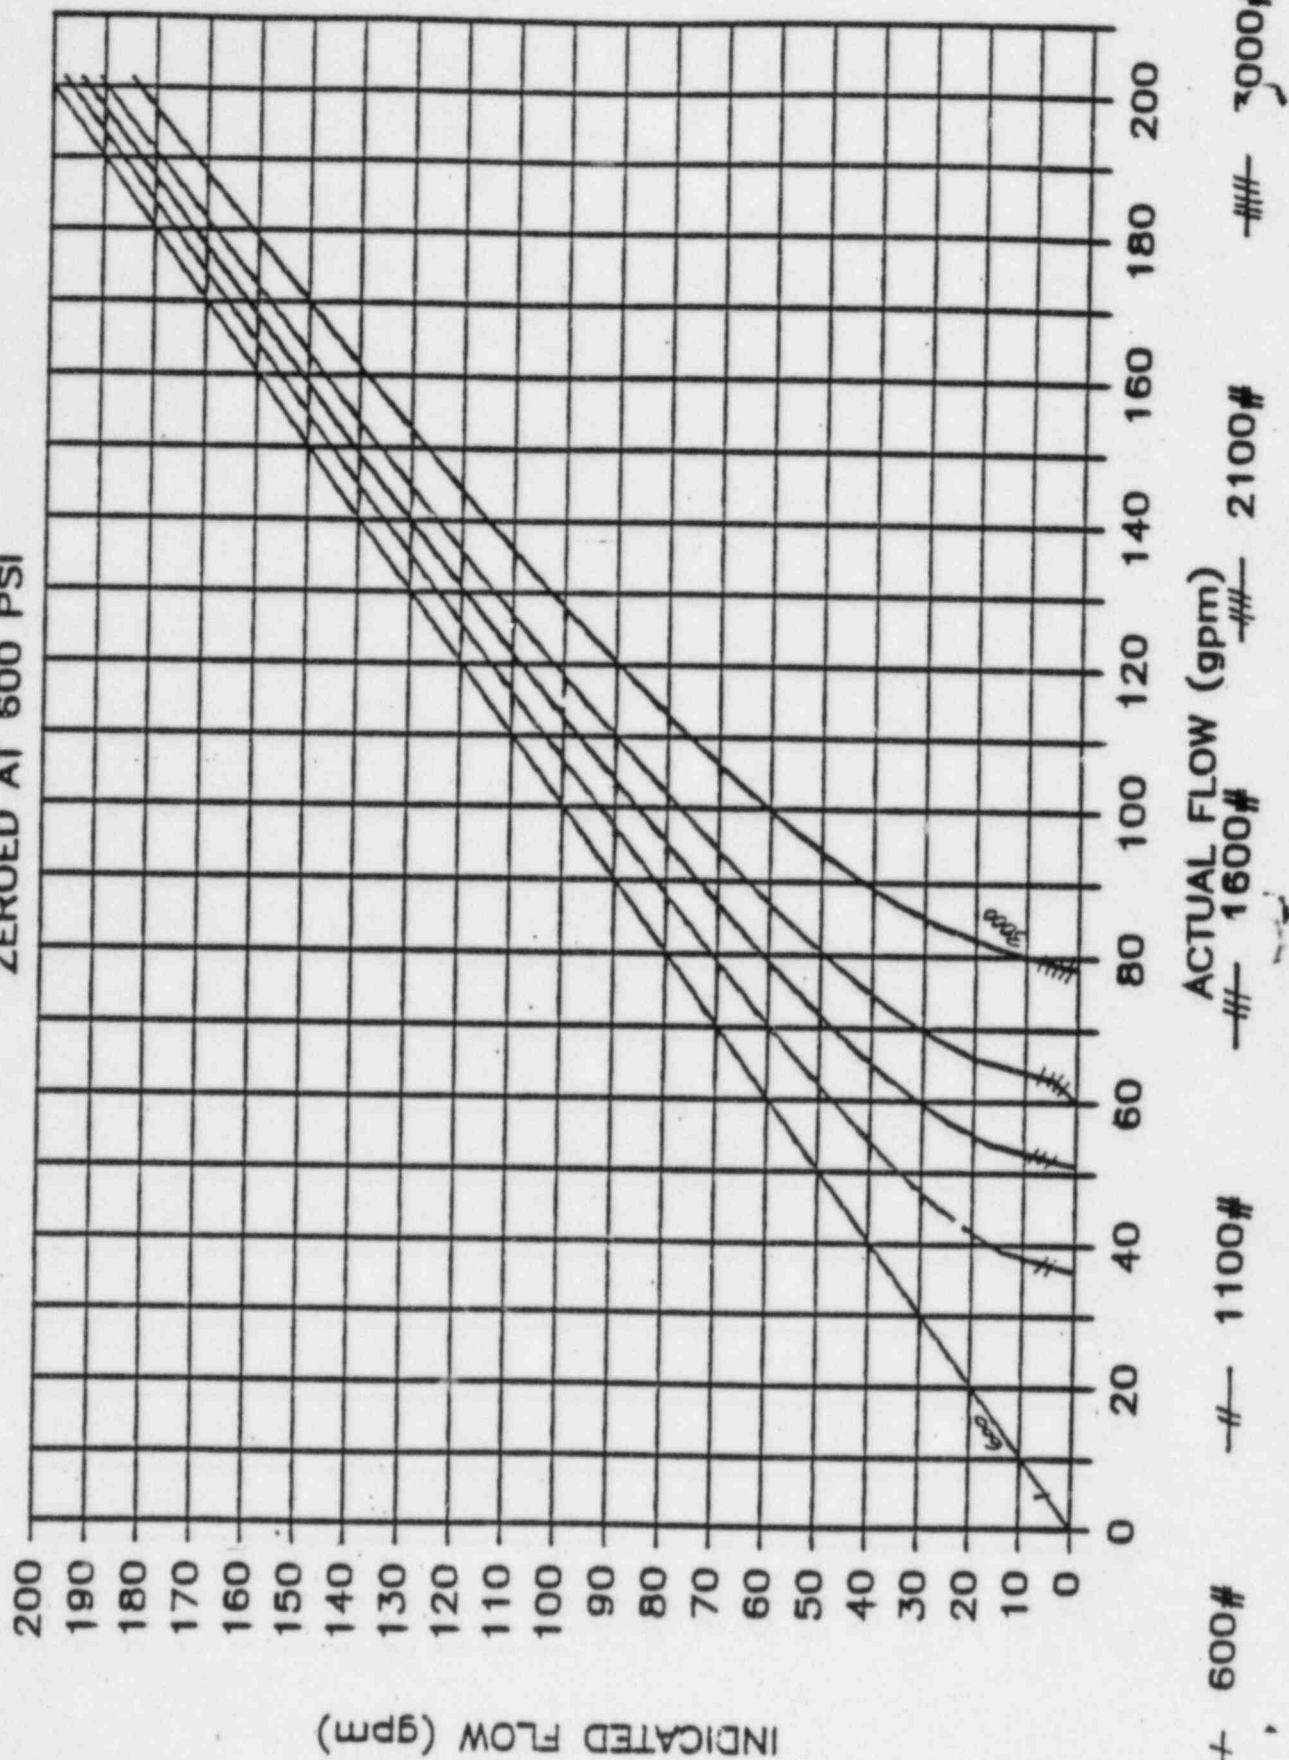
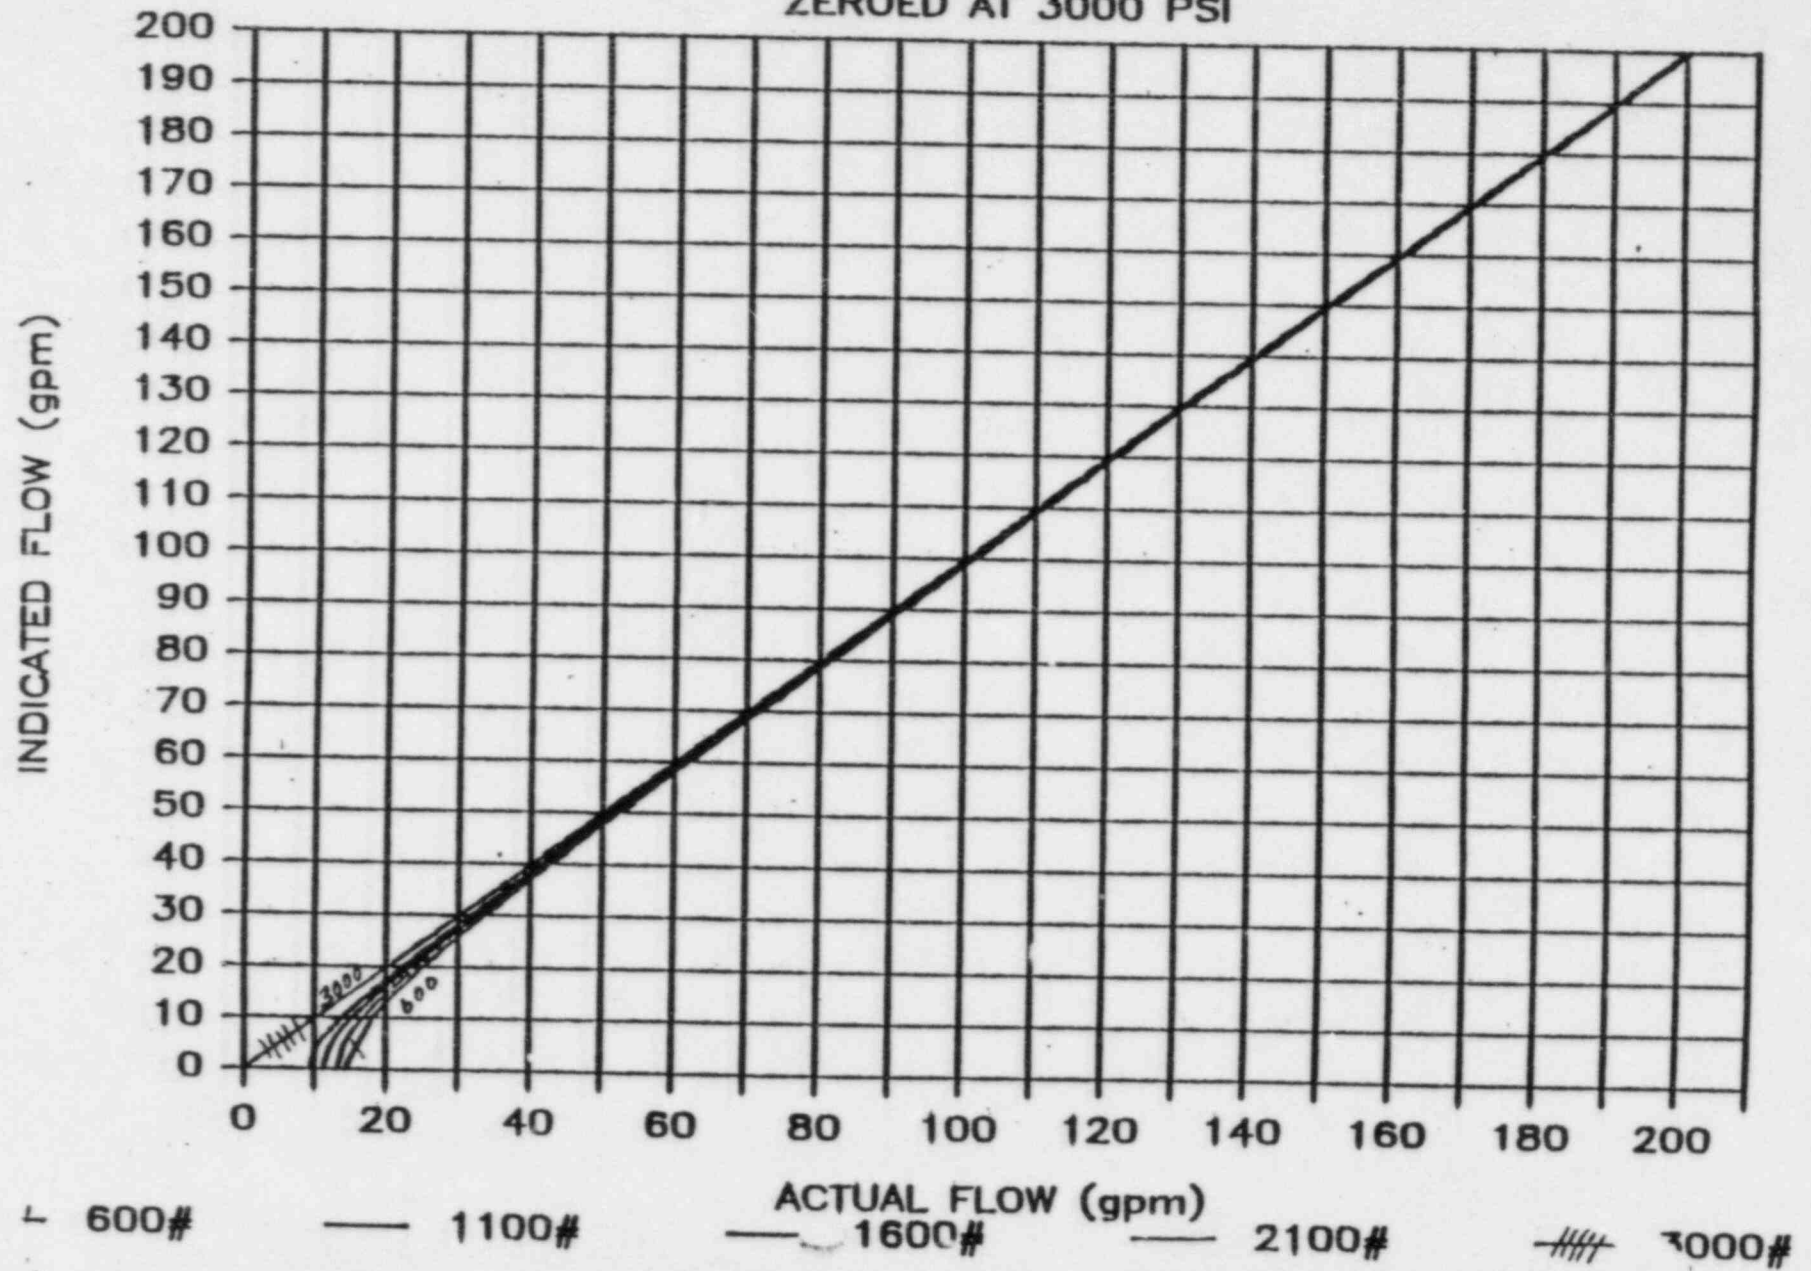
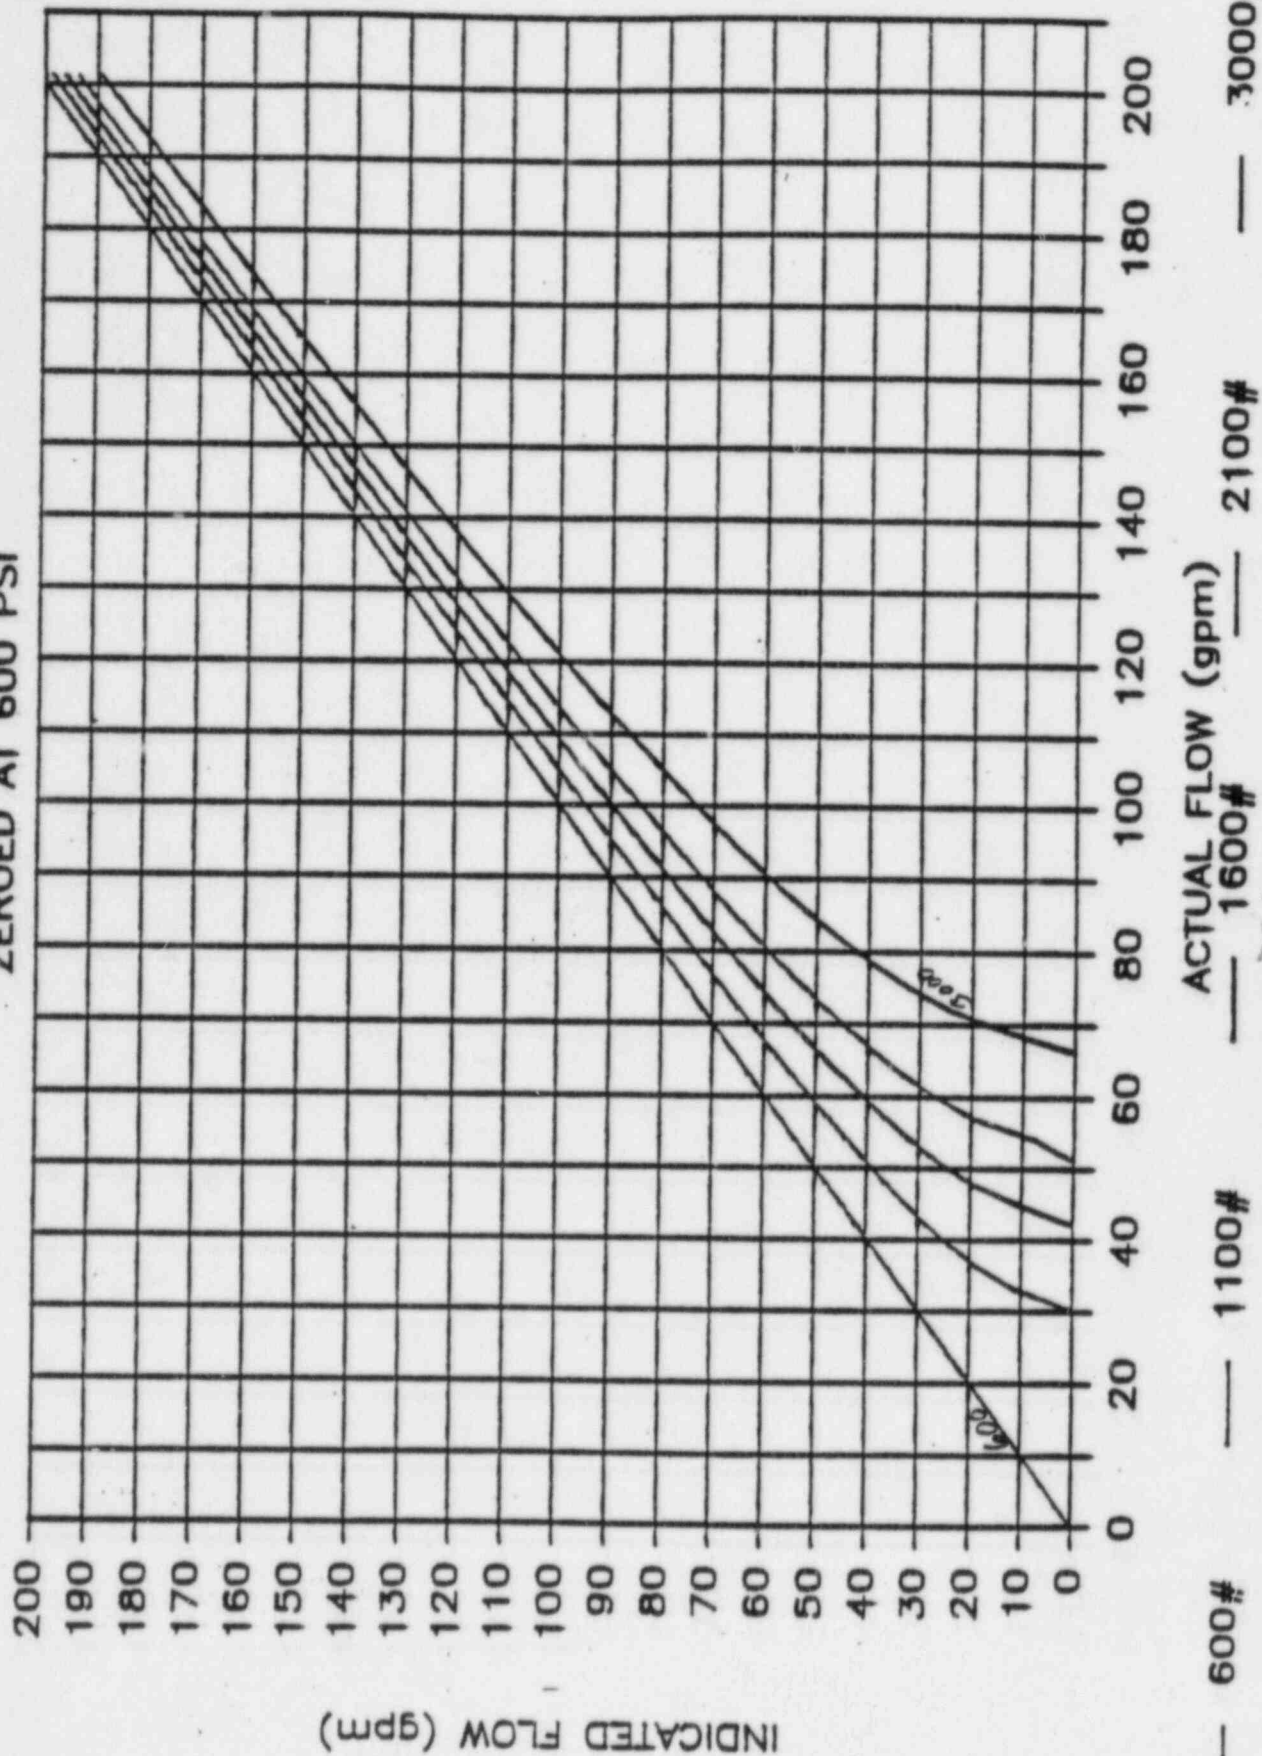
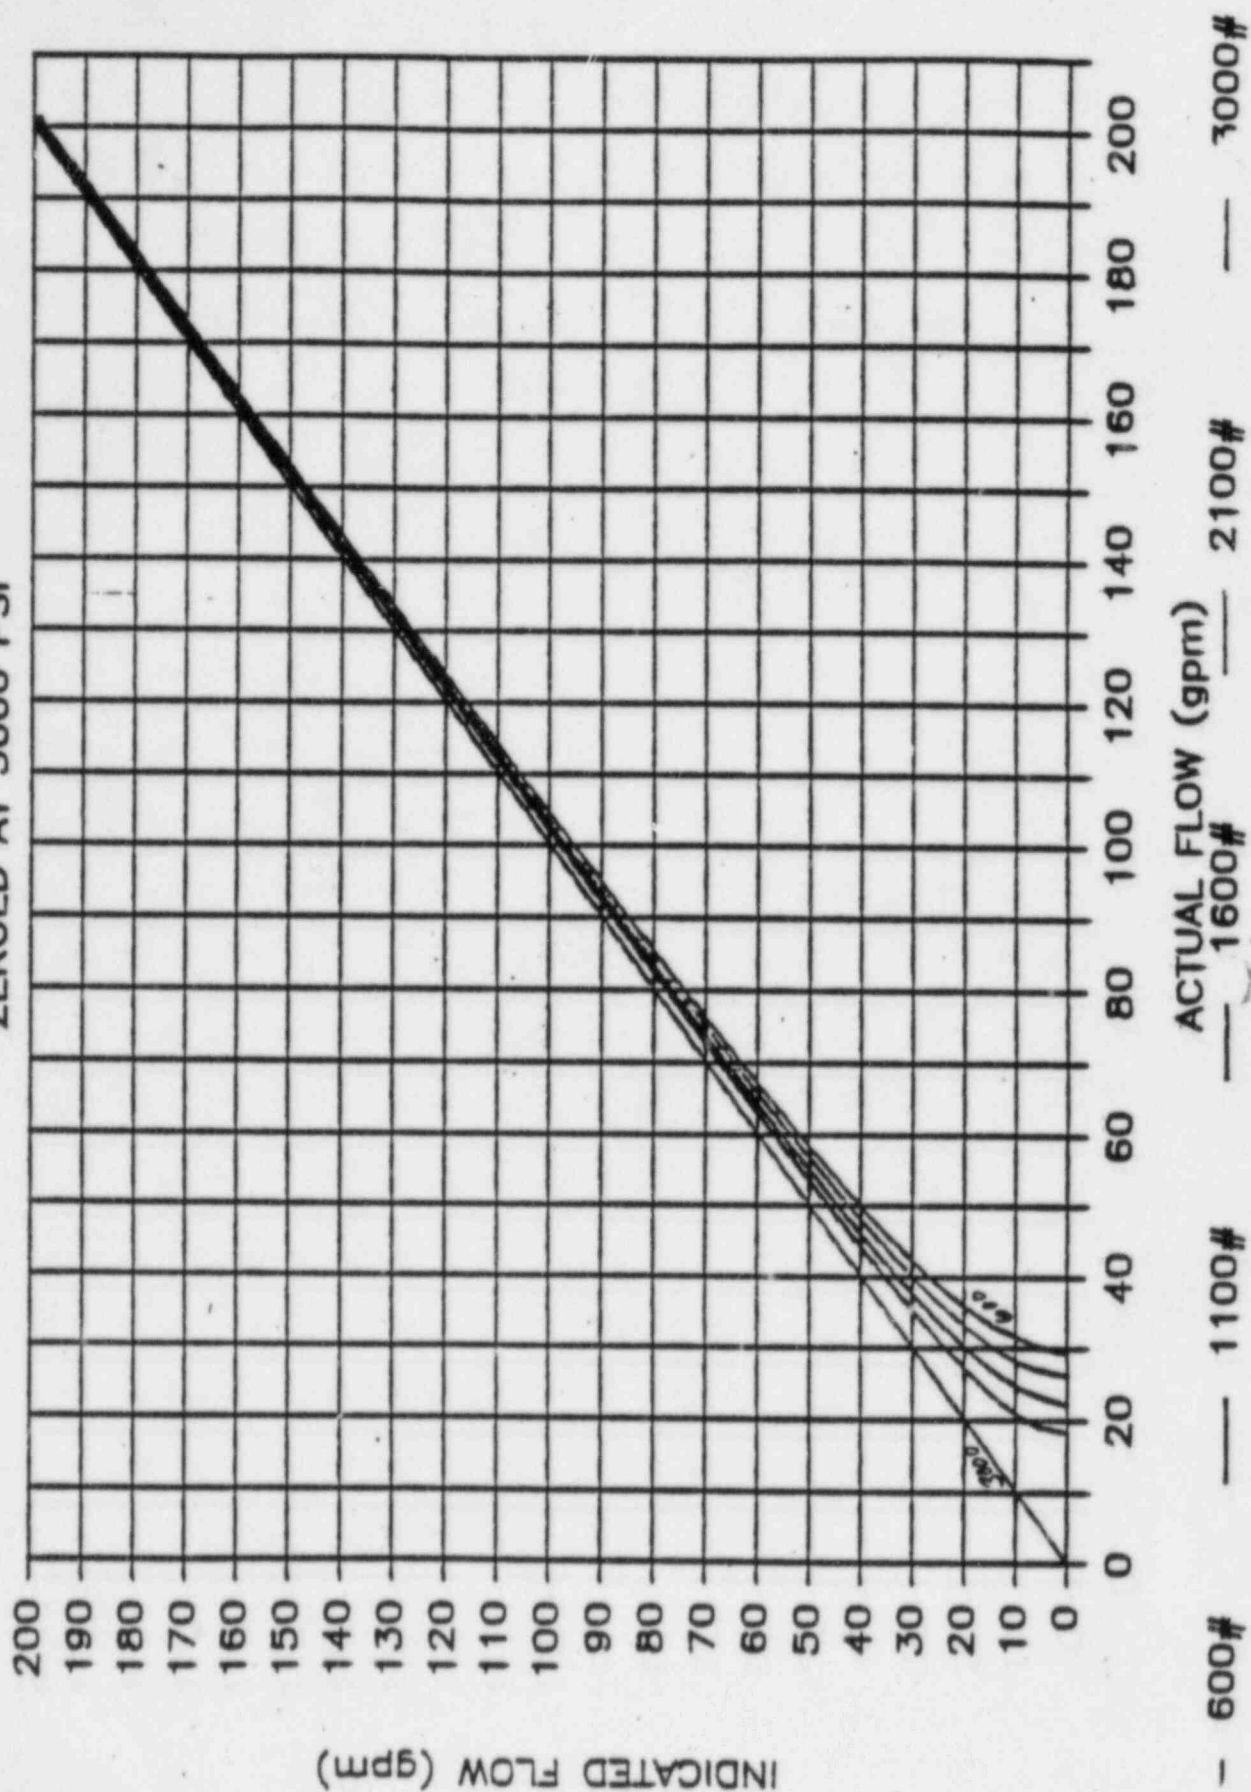
Indicated vs actual flows are shown on attachment 2-5 for a range of system pressures. These curves demonstrate that the indicated flows are indeed always less than actual flows and that at the flows of normal interest, namely greater than 90 gallons per minute, the flow errors are acceptably small. At 1600 lbs. when the flows are automatically balanced all four flows read within 30 GPM of the 125 actual.

The criteria has been established that at no time will actual flow be less than the indicated flow. In order to meet this criteria several considerations must be met. Transmitter A and transmitter C must be zeroed at a pressure at the bottom of the operating pressure range. Transmitter B and D have to be zeroed at a pressure at the top of their operating range. This assures that the errors in indicated flow are always negative. At high operating pressures such as those which we normally encounter for HPI injection under normal, non-accident conditions, there is no serious concern of pump run out. Pump run out can only occur at low system pressures.

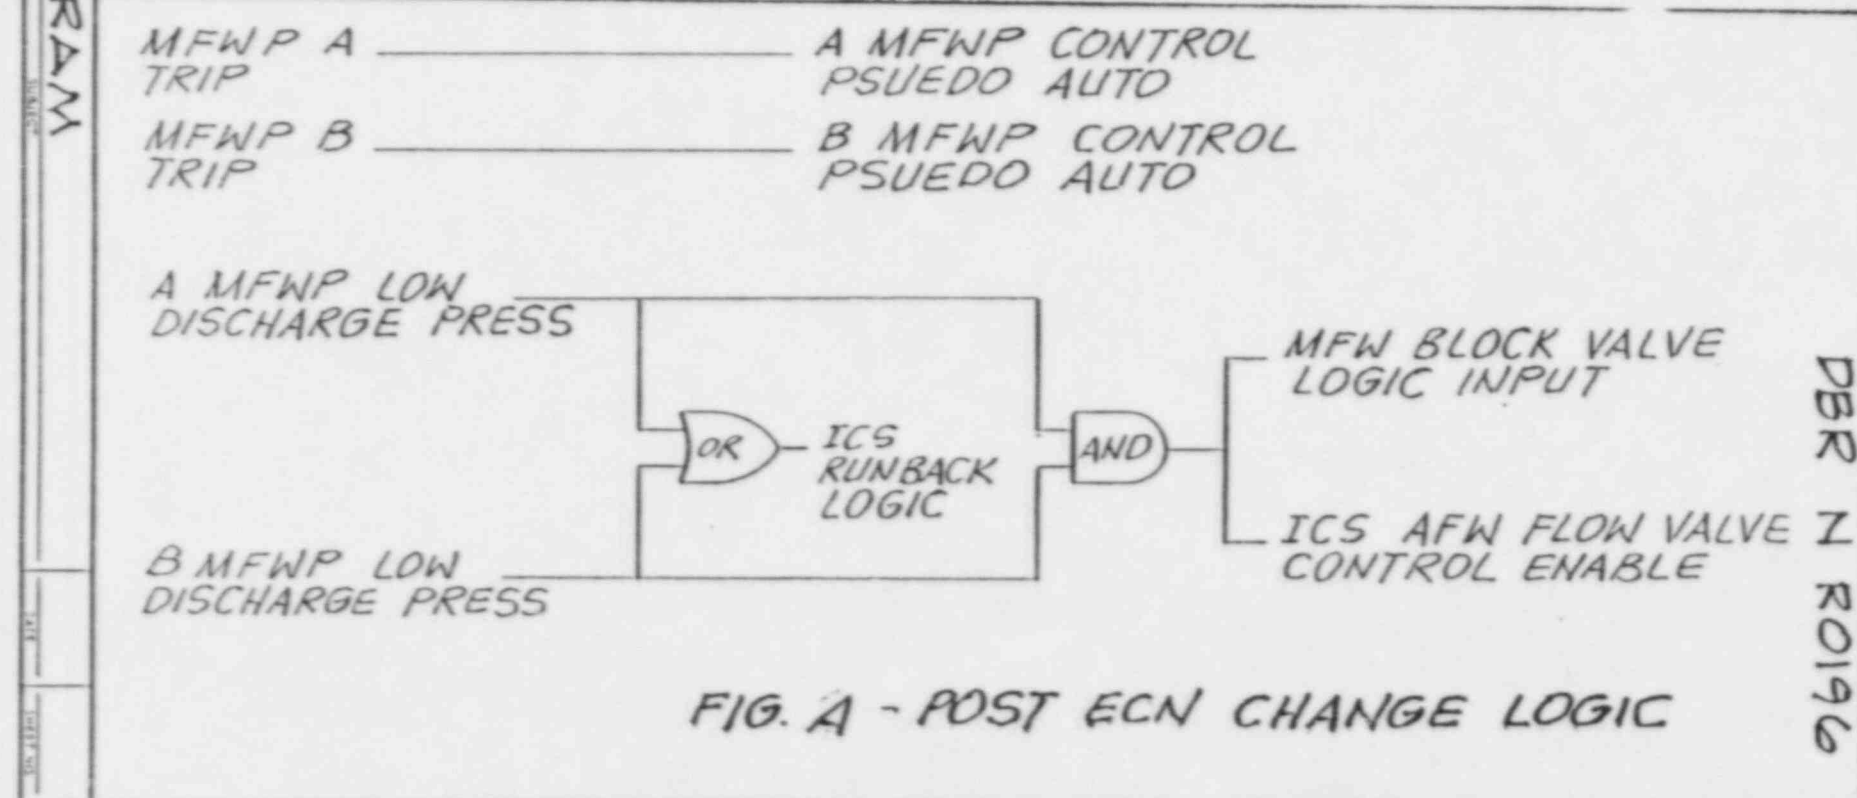
FIG. A - POST ECN CHANGE LOGIC

MFW Block Valves - The "A&B MFW pumps tripped" signal will be replaced with the "MFW pumps discharge pressure low" signal. The remainder of the logic will remain the same (4RCP's tripped to close the block valve).

AFW Valve Control - The "A&B MFW pumps tripped" signal will be replaced with the "MFW pumps discharge pressure low" signal. This signal will allow the ICS to control the AFW valves on low OTSG level.
