U.S. NUCLEAR REGULATORY COMMISSION

Report No. 50-454/85042(DRP)

Facility Name: Byron Station, Unit 1

Inspection Conducted: August 12 through October 18, 1985

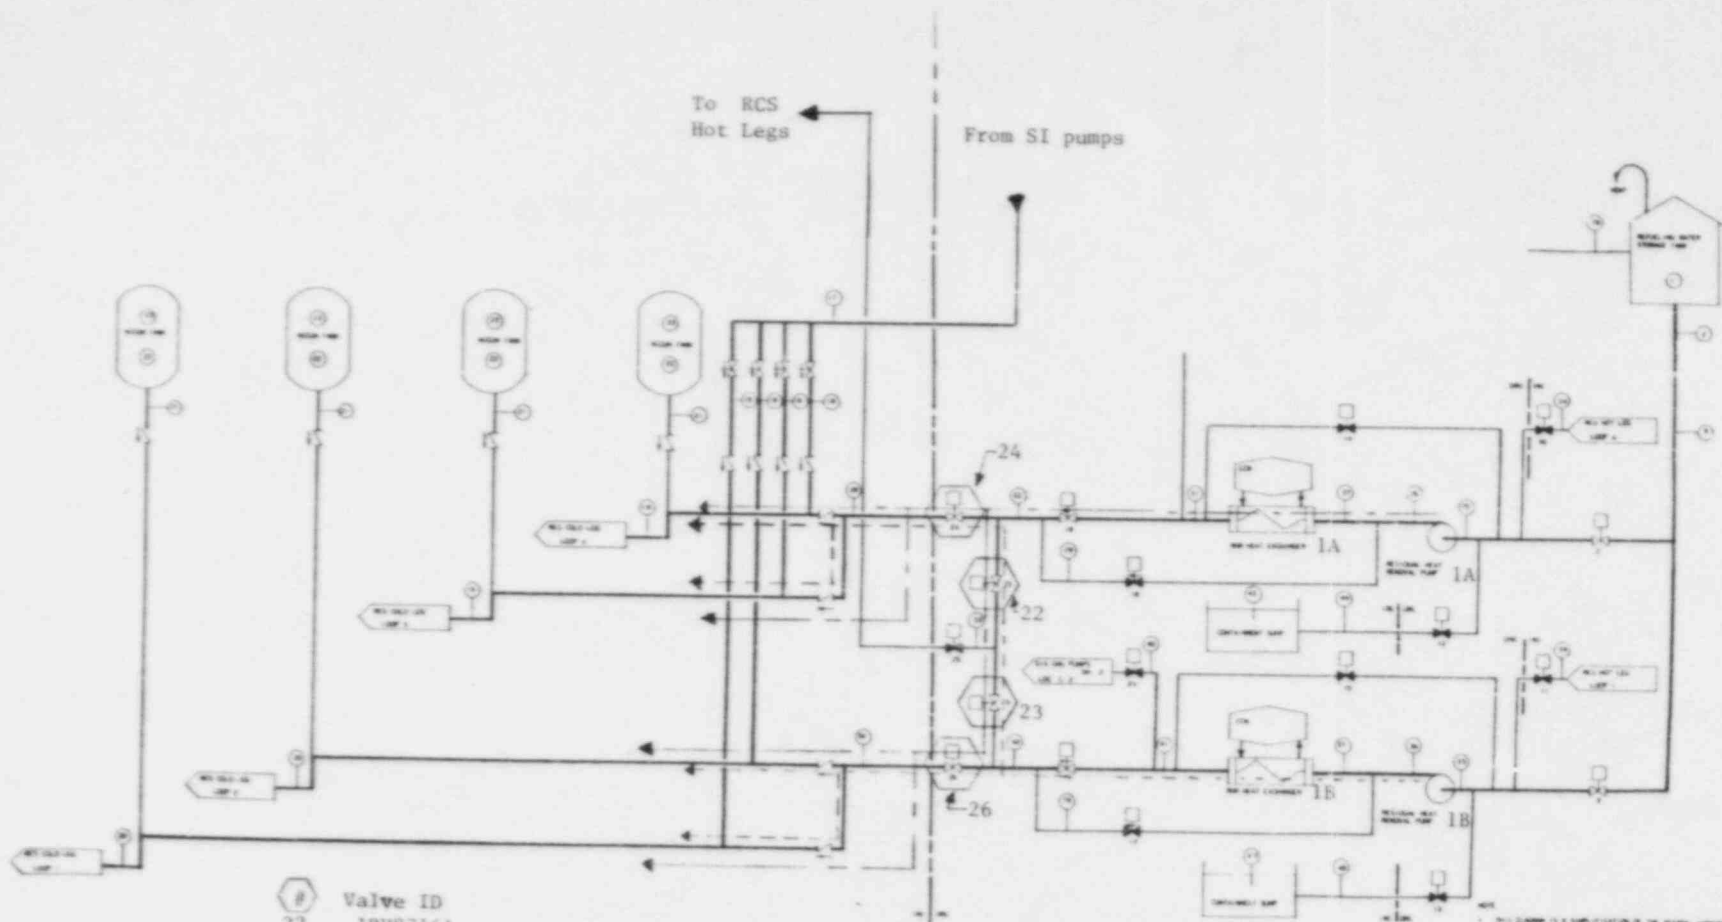
FIGURE 6.3-2

The low pressure injection portion of the ECCS consists of two Residual Heat Removal (RHR) pumps, two RHR Heat Exchangers, and suction and discharge flowpaths (see Attachment 1). Technical Specification 3.5.2 states, in part: "Two independent . . . ECCS subsystems shall be OPERABLE. . .," when in Modes 1, 2, or 3. The Safety Analysis, contained in the Byron FSAR, for a Large Break - Loss of Coolant Accident (LB-LOCA) assumes that each RHR pump is capable of injecting cold borated water into all four Reactor Coolant System (RC) cold legs during the "Injection Phase" of ECCS operation.

Both subsystems of the ECCS were rendered inoperable during the performance of Byron Technical Staff Surveillances 1BVS 5.2.f.3-1, "ASME Surveillance Requirements for Residual Heat Removal Pump 1RH01PA" [A Subsystem] and 1BVS 5.2.f.3-2, "ASME Surveillance Requirements for Residual Heat Removal Pump 1RH01PB" [B Subsystem] when valves 1RH8716A and 1SI8809A (see Attachment 1) were shut during the performance of the RHR pump 1A surveillance and also when valves 1RH8716B and 1SI8809B were shut during the performance of the RHR pump 1B surveillance.

Byron FSAR, Figure 6.3-2 (see Attachment 1) and its notes define the position of valves 1RH8716A, 1RH8716B, 1SI8809A and 1SI8809B as open during the injection phase of the ECCS operation. With valves 1RH8716A or 1SI8809A shut and RHR pump 1A isolated, the B subsystem would have only been capable of injecting water into a maximum of two RC cold legs (1 and 2). Conversely, with valves 1RH8716B or 1SI8809B shut and RHR pump 1B isolated, the A subsystem would have only been capable of injecting water into a maximum of two RC cold legs (3 and 4). Consequently, with this valve configuration both ECCS subsystems should have been considered inoperable.

The inspector identified to the licensee that the valve identification numbers and valve positions described in the notes attached to Byron FSAR, Figure 6.3-2, Sheet 3 were not correct for the valves labeled as numbers "22," "23," "24," "25," and "26." The licensee has committed to issuing an amendment to the FSAR to correct this problem and accomplishment of this action will be followed as an Open Item (454/85042-03(DRP)).
