DEPARTMENT OF THE ARMY  
FITZSIMONS ARMY MEDICAL CENTER  
AURORA, COLORADO 80045

SUBJECT: Additional Information Requested Regarding Teletherapy Facility Survey

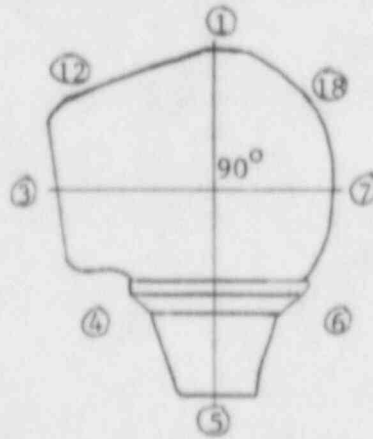
View A - Vertical from left side

View A	1	3.0
	2	2.2
	3	1.1
	4	2.8
	5	3.2
	6	0.2
	7	4.0
	8	0.1

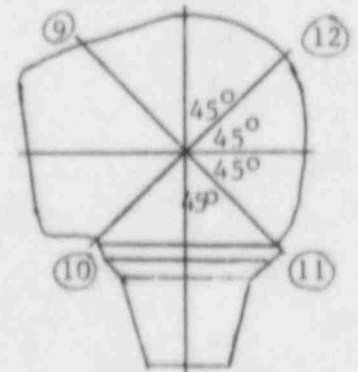
View B - Vertical  
from left front

View B	9	1.7
	10	2.4
	11	1.3
	12	0.4

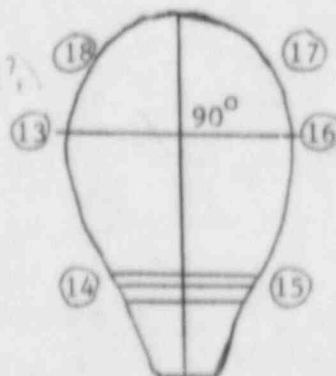
View C - Vertical from front

View C	13	2.5
	14	2.0
	15	2.0
	16	2.5
	17	0.8
	18	0.7

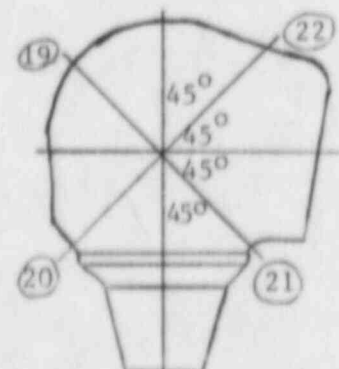
View C - Vertical  
from right front

View D	19	0.3
	20	0.9
	21	2.2
	22	2.6
