B.19 LER Number 327/92-027

Event Description: Loss of Offsite Power

Date of Event: December 31, 1992

Plant: Sequoyah 1 & 2

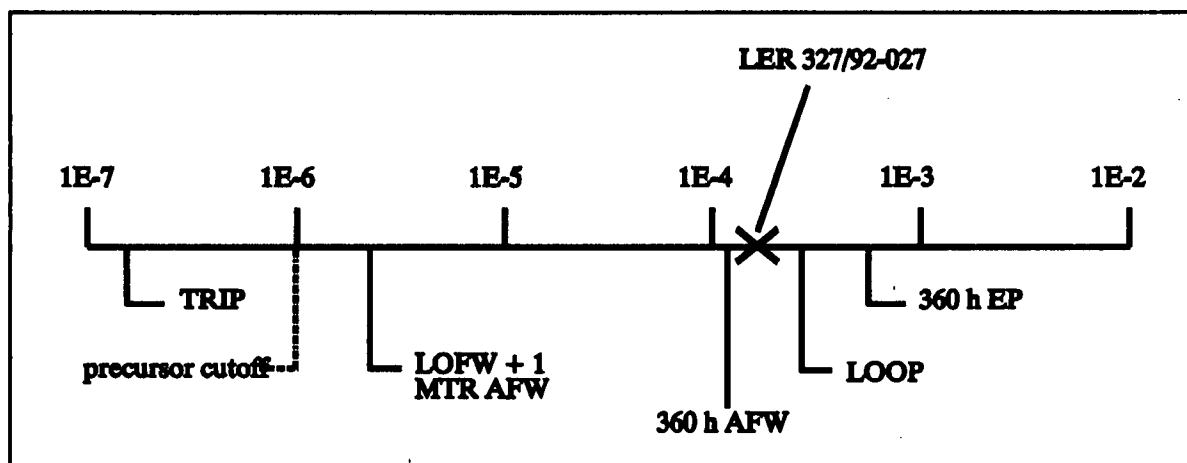
Fig. B.40. Relative event significance of LER 327/92-027 compared with other potential events at Sequoyah 1 & 2.

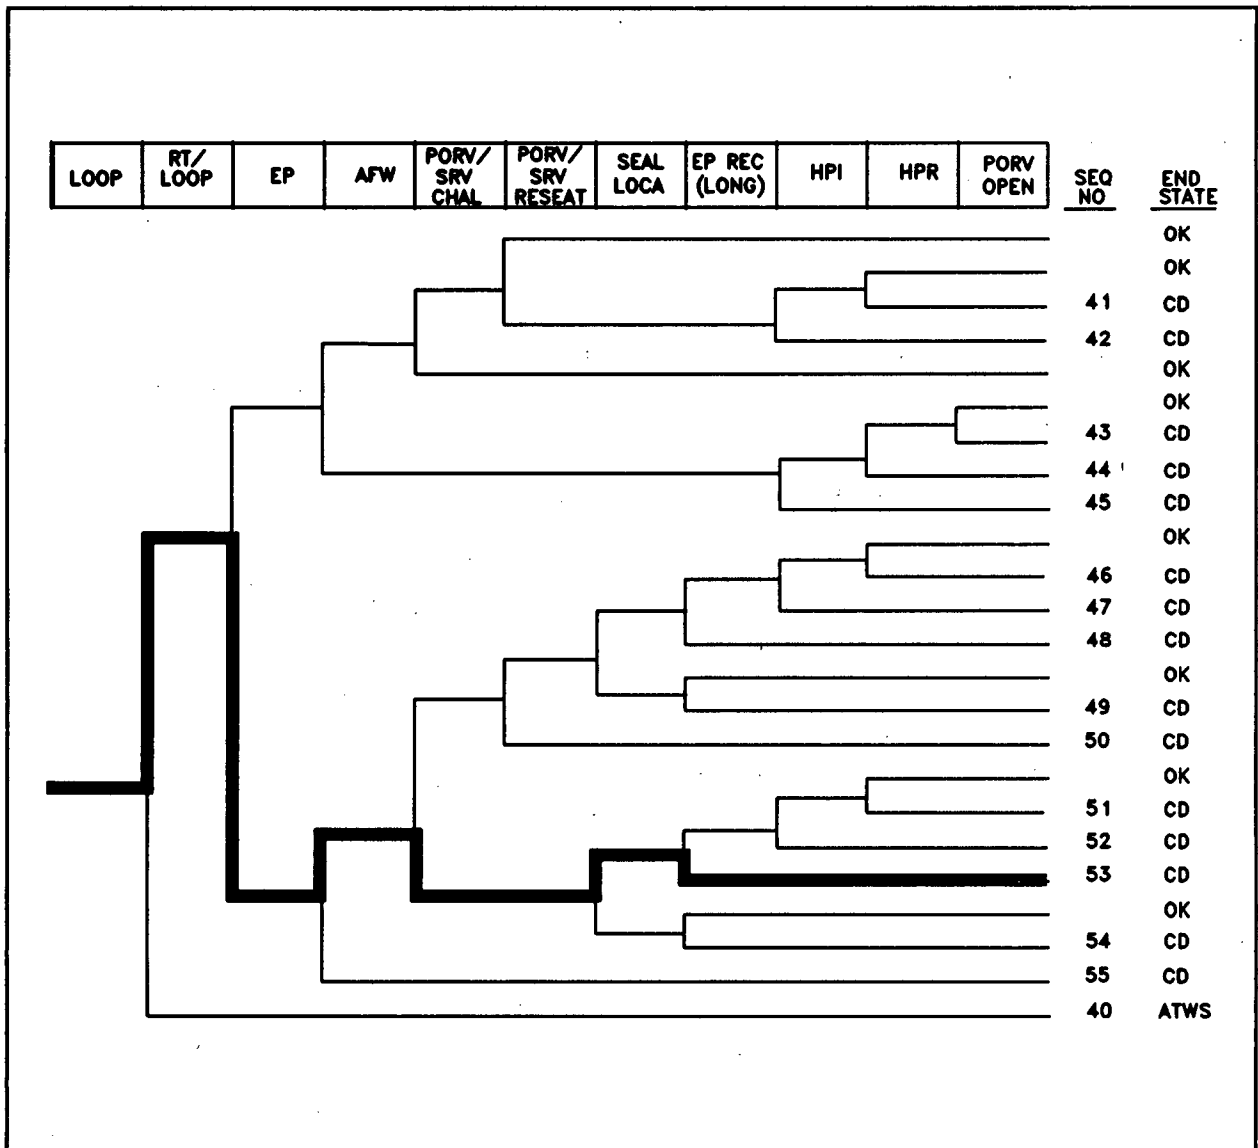
The conditional probability of core damage estimated for this event is 1.8×10^{-4} per unit. The dominant core damage sequence, highlighted on the event tree in Fig. B.41, involves failure of emergency power restoration resulting in an RCP seal LOCA.

Fig. B.41. Dominant core damage sequence for LER 327/92-027.
