## ACCIDENT SEQUENCE PRECURSOR PROGRAM EVENT ANALYSIS

LER No.: 271/91-009, 271/91-012  
 Event Description: Extended loss of offsite power  
 Date of Event: April 23, 1991  
 Plant: Vermont Yankee

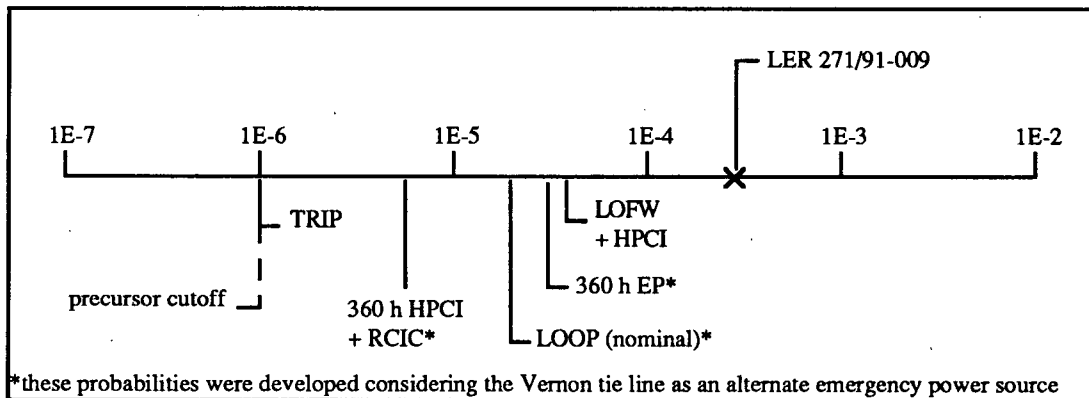
A loss of offsite power (LOOP) occurred at Vermont Yankee during switchyard maintenance activities. Both emergency diesel generators (EDGs) started and provided power to their respective safety-related buses. Recovery of offsite power, which took ~13 h, was complicated by communications and organizational difficulties and travel time for support personnel. The conditional core damage probability estimated for this event is  $2.9 \times 10^{-4}$ . The relative significance of the event compared to other postulated events at Vermont Yankee is shown below.

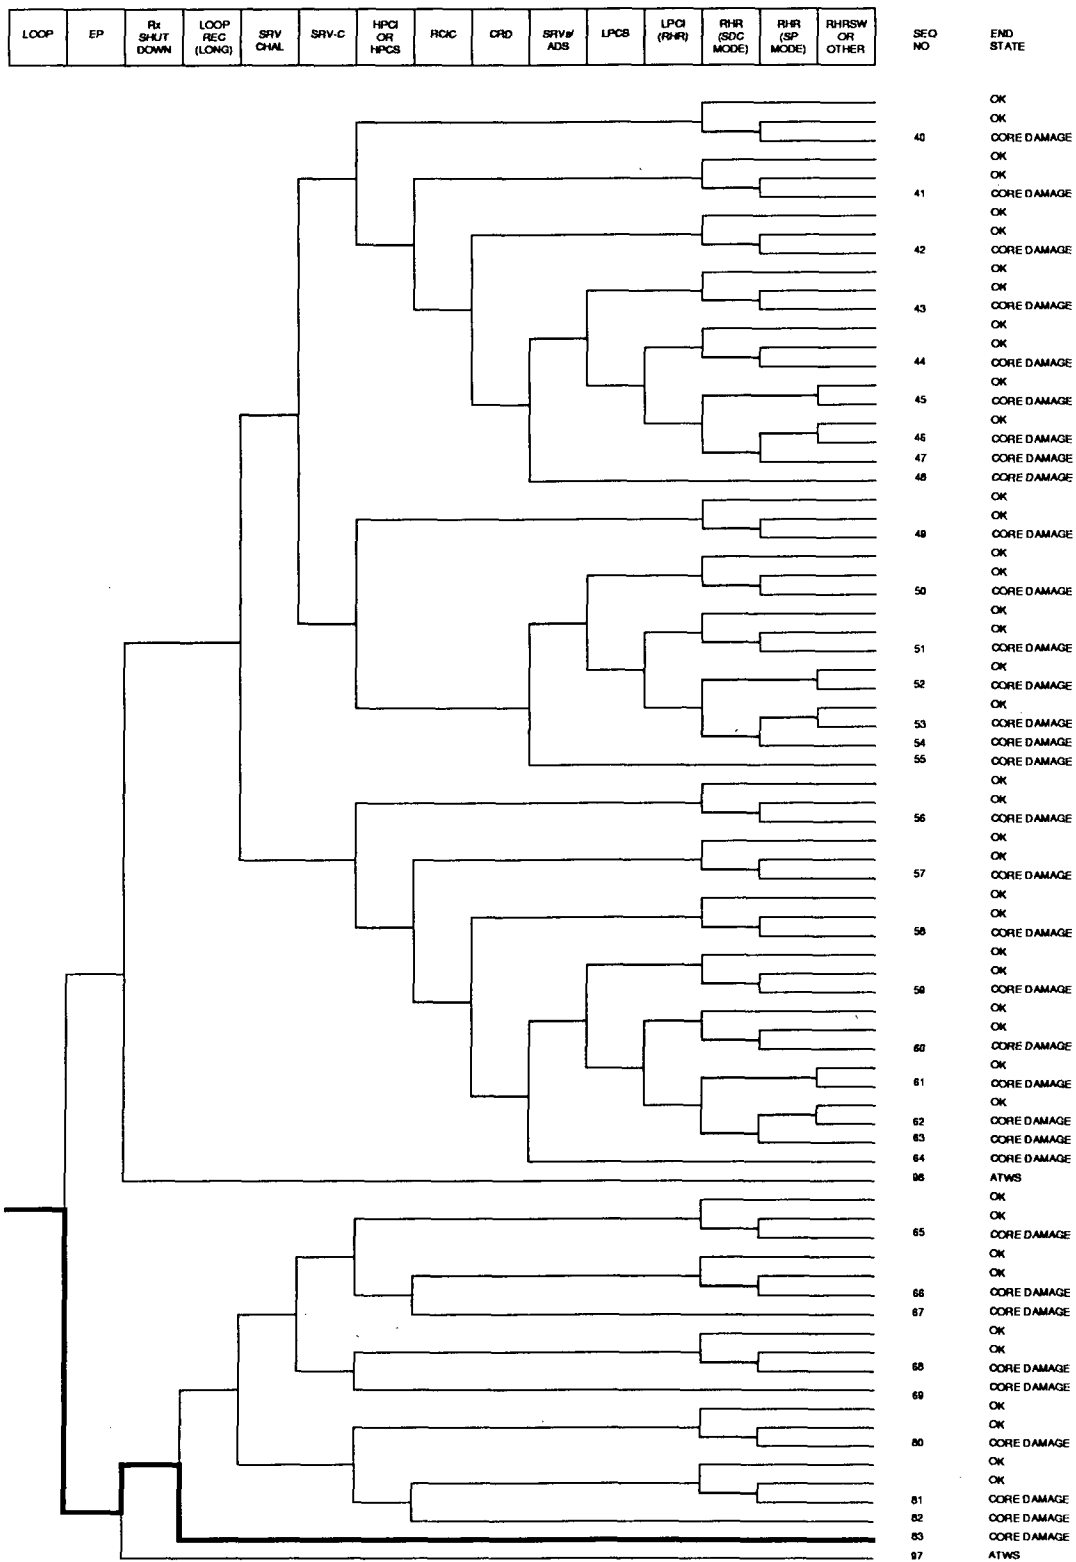
Dominant core damage sequence for LER 271/91-009

$2.9 \times 10^{-4}$ . The dominant sequence, highlighted on the following event tree, involves the loss of offsite power, failure of emergency power (including the Vernon tie line), and failure to recover AC power prior to battery depletion.
