ACCIDENT SEQUENCE PRECURSOR PROGRAM EVENT ANALYSIS

LER No.: 304/91-002
 Event Description: Loss of offsite power with one diesel generator out of service
 Date of Event: March 21, 1991
 Plant: Zion 2

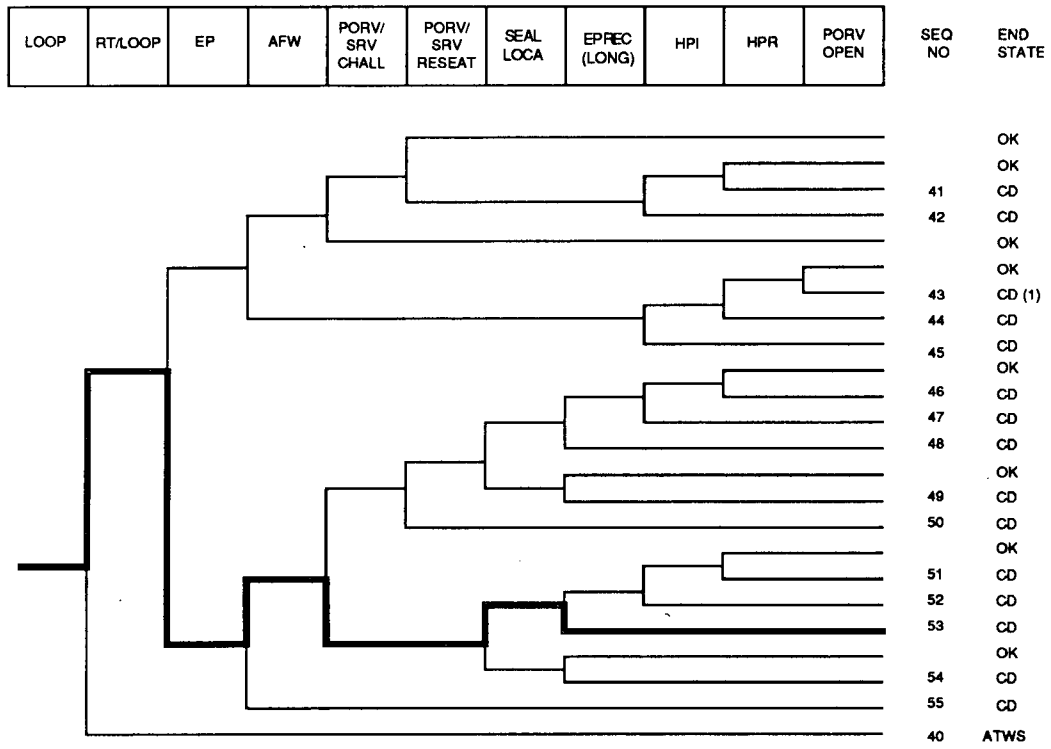
The conditional core damage probability for this event, based on the current ASP models, is estimated to be 2.1×10^{-4} . The dominant core damage sequence, highlighted on the following event tree, involves a LOOP with emergency power failure, a resulting RCP seal LOCA, and failure to recover AC power prior to core uncover.

Dominant core damage sequence for LER 304/91-002
