Prairie Island Nuclear Generating Plant

Reply to Notice of Violation (Inspection Report 97006),
Inadvertent Excessive Draining of the RCS Pressurizer While at Cold Shutdown

RESPONSE TO NOTICE OF VIOLATION

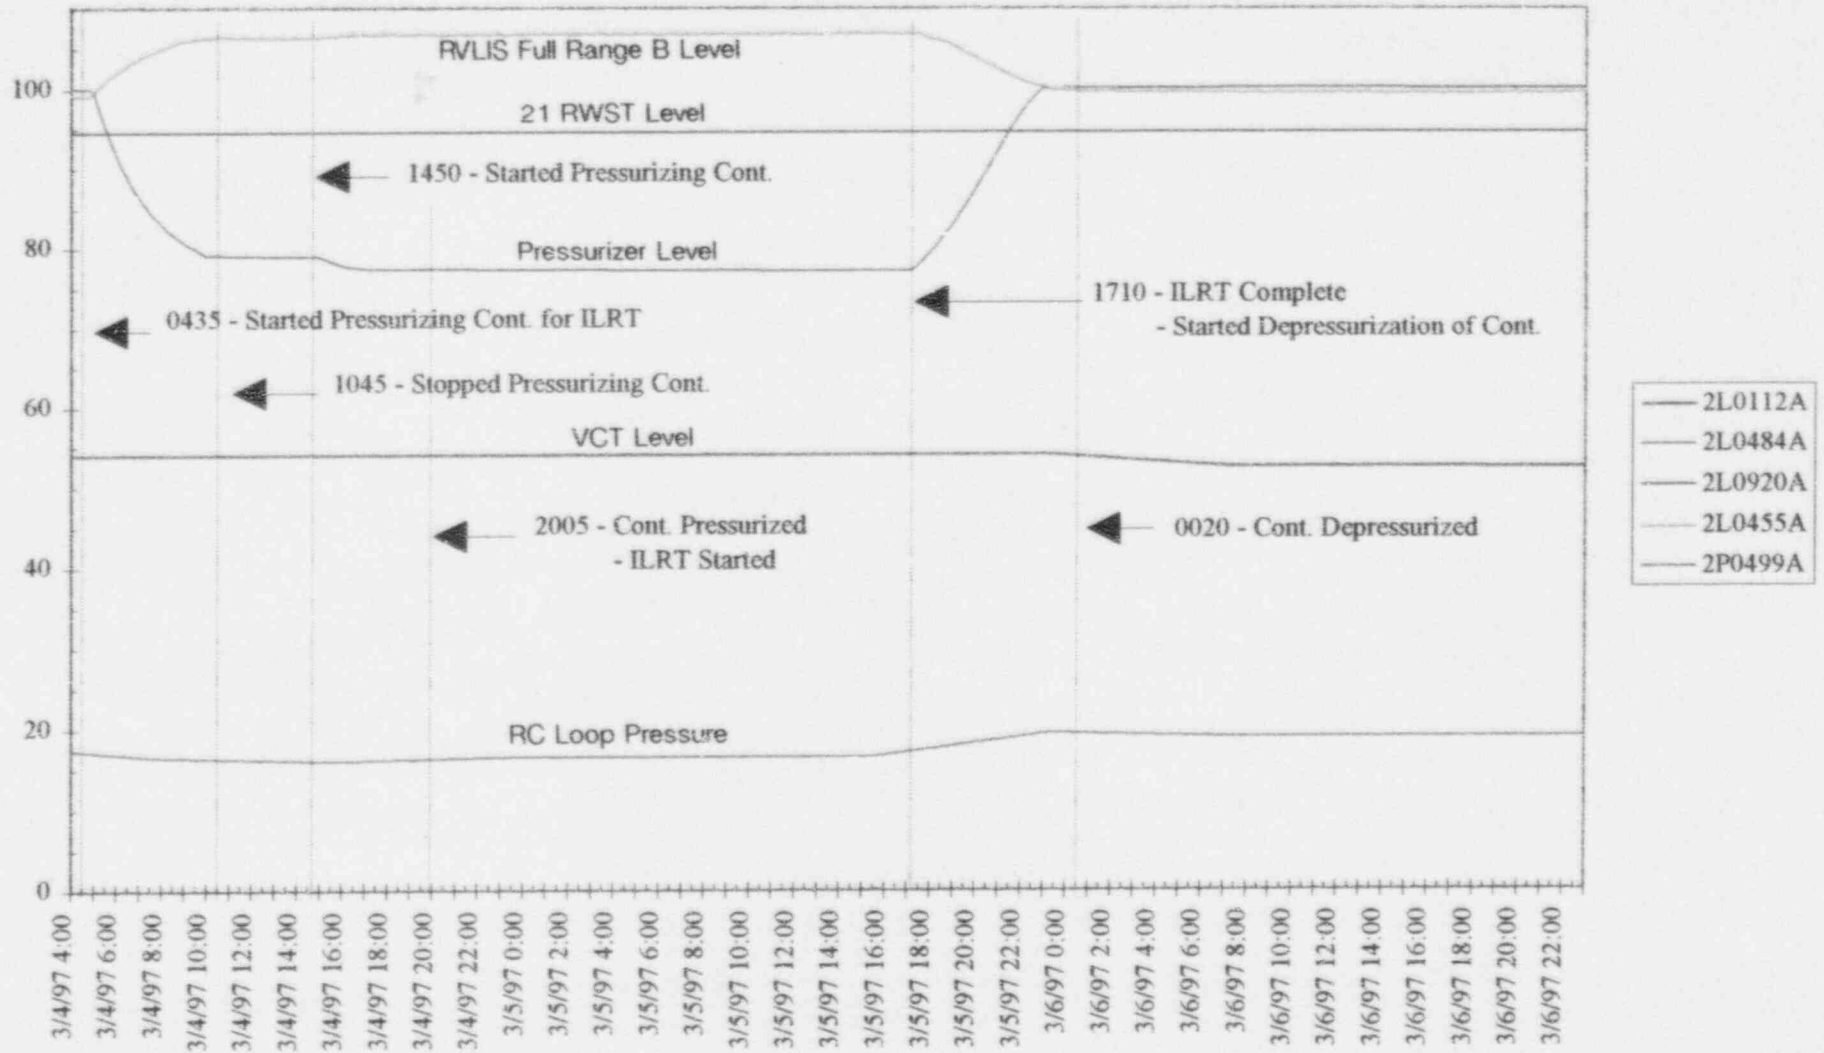
Chart 1

0435 - (Chart 1) ILRT preparations completed per SP-2071.4. Started pressurizing Unit 2 containment to 46 psig per WO 9613273, SP-2071.5 Procedure For The Containment Vessel ILRT. A precaution and limitation in SP-2071.5 states the following: "The volume of fluid in the RCS will be compressed during the I.T.

1045 - (Chart 1) Stopped pressurizing Unit 2 containment per the ILRT Lead engineer. PI computer data: PZR Lvl - 79.08%, RVLIS Upper Range B - 104.36%, RVLIS Full Range B - 106.52%, RHR Inlet Temp - 91.2 F, RC Loop Press - 16.38 psig.

1450 - (Chart 1) Resumed pressurization of Unit 2 containment per SP-2071.5. PI computer data: PZR Lvl - 78.96%, RVLIS Upper Range B - 104.45%, RVLIS Full Range B - 106.49%, RHR Inlet Temp - 91.2 F, RC Loop Press - 16.12 psig.

2005 - (Chart 1) Closed the Unit 2 containment pressurization valve per the ILRT Lead. Containment pressurized to test pressure of 46 psig and pressure test started per SP-2071.5. PI computer data: PZR Lvl - 77.35%, RVLIS Upper Range B - 105.64%, RVLIS Full Range B - 106.95%, RHR Inlet Temp - 91.2 F, RC Loop Press - 16.35 psig. The change in pressurizer level from start of the ILRT test until this time was 23%. Based on this change and the precaution at the beginning of the ILRT procedure, it can be assumed that approximately 3.3% of the RCS volume was air.

1710 - (Chart 1) ILRT surveillance procedure completed and depressurization of Unit

0020 - (Chart 1) Completed depressurization of Unit 2 containment per SP-2071.5. PI computer data (initial parameters before pressurization enclosed in []): PZR Lvl - 100.08% [100.02%], RVLIS Upper Range B - 103.07% [102.36%], RVLIS Full Range B - 99.88% [99.29%], RHR Inlet Temp - 91.0 F [91.3 F], RC Loop Press - 19.5 psig [17.28 psig].

1800 - (Chart 1) Shift change took place and the off-going crew turned over that they were aligned to drain the pressurizer and that the draining was being delayed until SV-37096 was replaced because there was no RCS vent path. SV-37096 is part of the 2D8 vent path and allows the vent path to be isolated from the control room. After shift change the decision was made to identify and establish an alternate

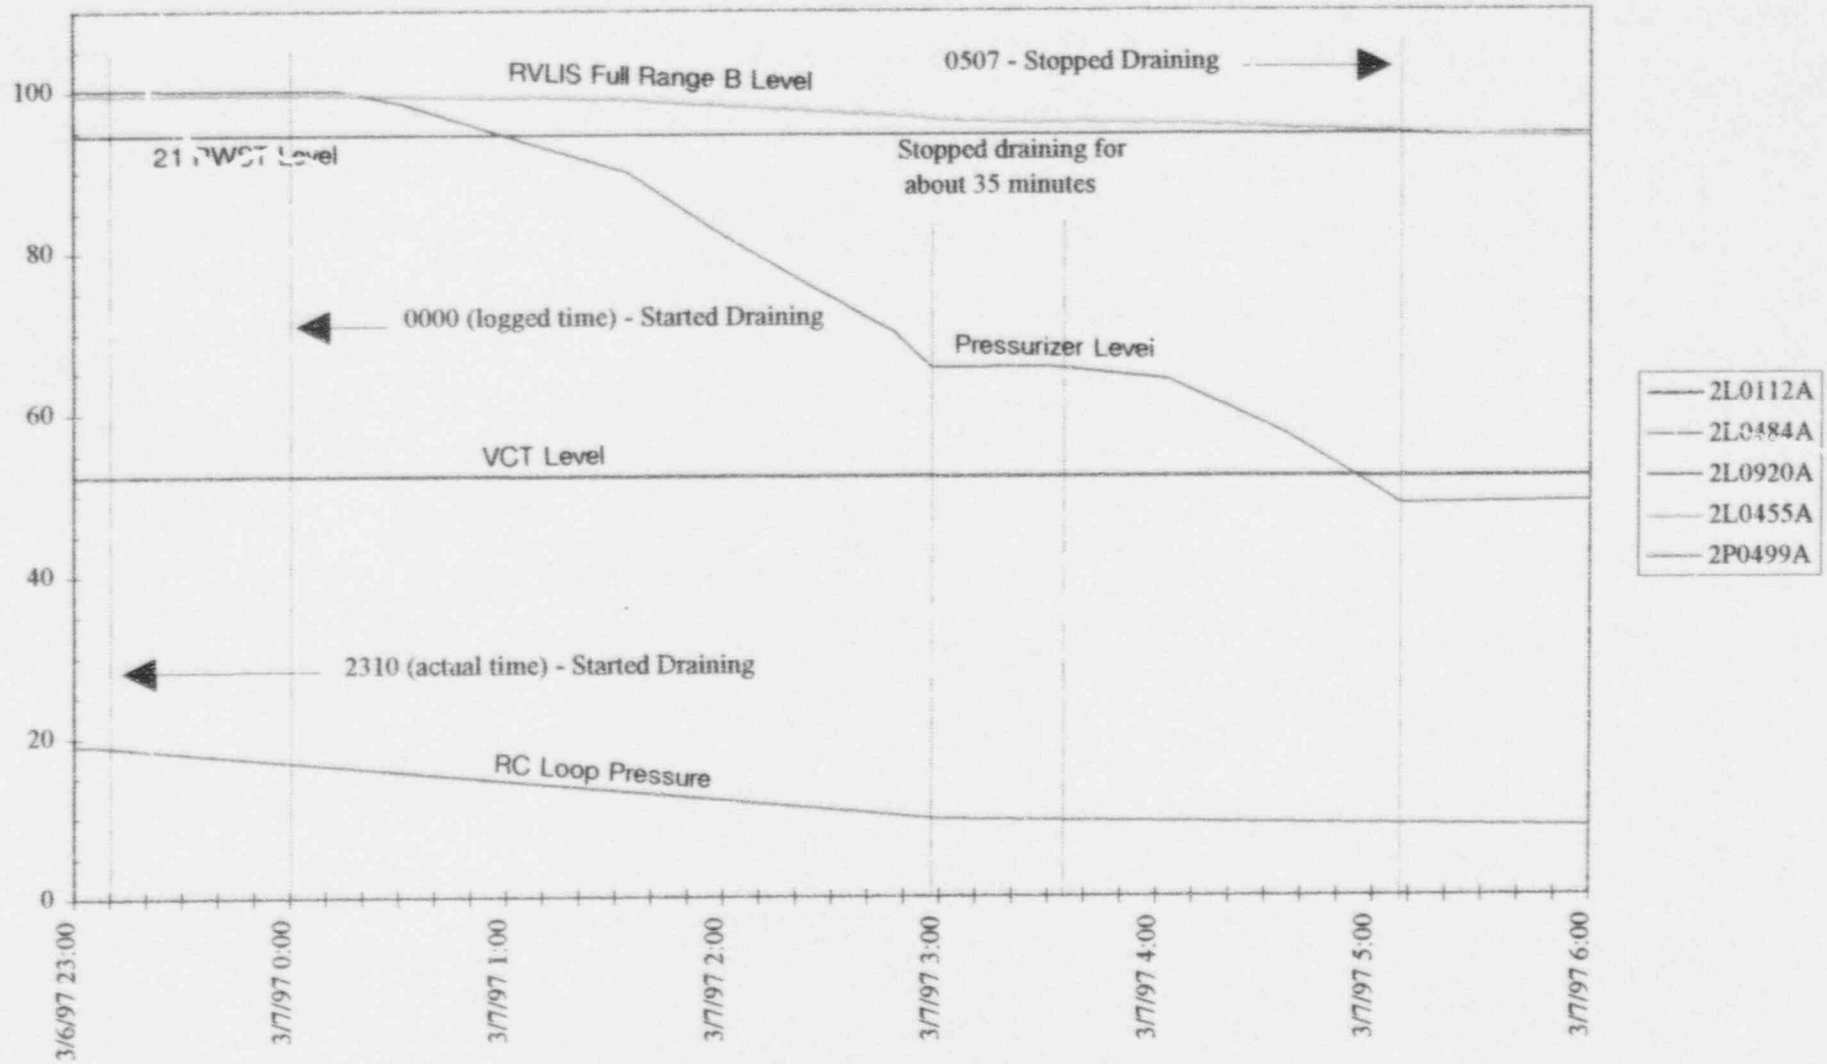
Chart 2

2330 - (Chart 2) While performing the isolation for WO 9701175, 2RC-8-16, Head Vent To PRT, was mistakenly left in the as found position of CLOSED, instead of positioning it to the OPEN position as required by the I&R and Hold Card. The Hold Card for 2RC-8-16, with an indicated isolated position of OPEN, was then hung on the valve. The failure to properly position this valve in the OPEN position maintained the alternate vent path to the containment atmosphere isolated. Around 2345 isolation 9701175 for replacing the valve and establishing the alternate RCS vent path was completed. PI computer data: PZR Lvl - 99.99%, RVLIS Upper Range B - 102.51%, RVLIS Full Range B - 99.73%, RWST Lvl - 94.44%, RHR Inlet Temp - 90.9 F, RC Loop Press - 17.44 psig.

0000 - (Chart 2) Control room operator started draining the RCS to lower pressurizer level per 2D8 step 5.2.57 B. The Purification Jumper line up with CV-31251, Letdown Divert to HUT in the "DIVERT" position was being used to drain the RCS to 21 CVCS HUT. The drain rate was being regulated by adjusting the position of CV-31228, 21 RCP Loop A PRZR Spray CV and was being monitored using control board indications along with an emergency response computer system (ERCS) quick plot that included PZR, VCT & RCDT levels. PI computer data: PZR Lvl - 99.97%, RVLIS Upper Range B - 102.48%, RVLIS Full Range B - 99.67%, RWST Lvl - 94.44%, RHR Inlet Temp - 90.9 F, RC Loop Press - 16.84 psig, 21 CVCS HUT Lvl (log reading) - 70.0%.

About 0255, (Chart 2) three hours into the evolution, the draining was stopped for

0507 - (Chart 2) Pressurizer cold cal level reached 49% and draining of the RCS was stopped. The indicated amount drained by the 51% change in pressurizer level was 3295 gallons. Because of the inadequate vent path the actual amount drained, which was determined later, was greater than the amount indicated by the change in pressurizer level. It was later determined that the actual amount drained, by using the 21.5% increase in 21 CVCS HUT level, was 7245 gallons. RCS pressure was approximately 8 psig and was recognized to be lower than what was expected (13-15 psig) at this time. However, pressure was thought to be slowly increasing and was assumed it would return to the 13-15 psig range once the RCS returned to atmospheric pressure. The control room operators thought the lower pressure was caused by a drain rate that exceeded the vent path capability. This was turned over to the on-coming crew at shift turnover. PI computer data: PZR Lvl - 48.74%, RVLIS Upper Range B - 97.38%, RVLIS Full Range B - 94.98%, RWST Lvl - 94.44%, RHR Inlet Temp - 91.0 F, RC Loop Press - 8.84 psig, 21 CVCS HUT Lvl (log reading) - 81.5%.

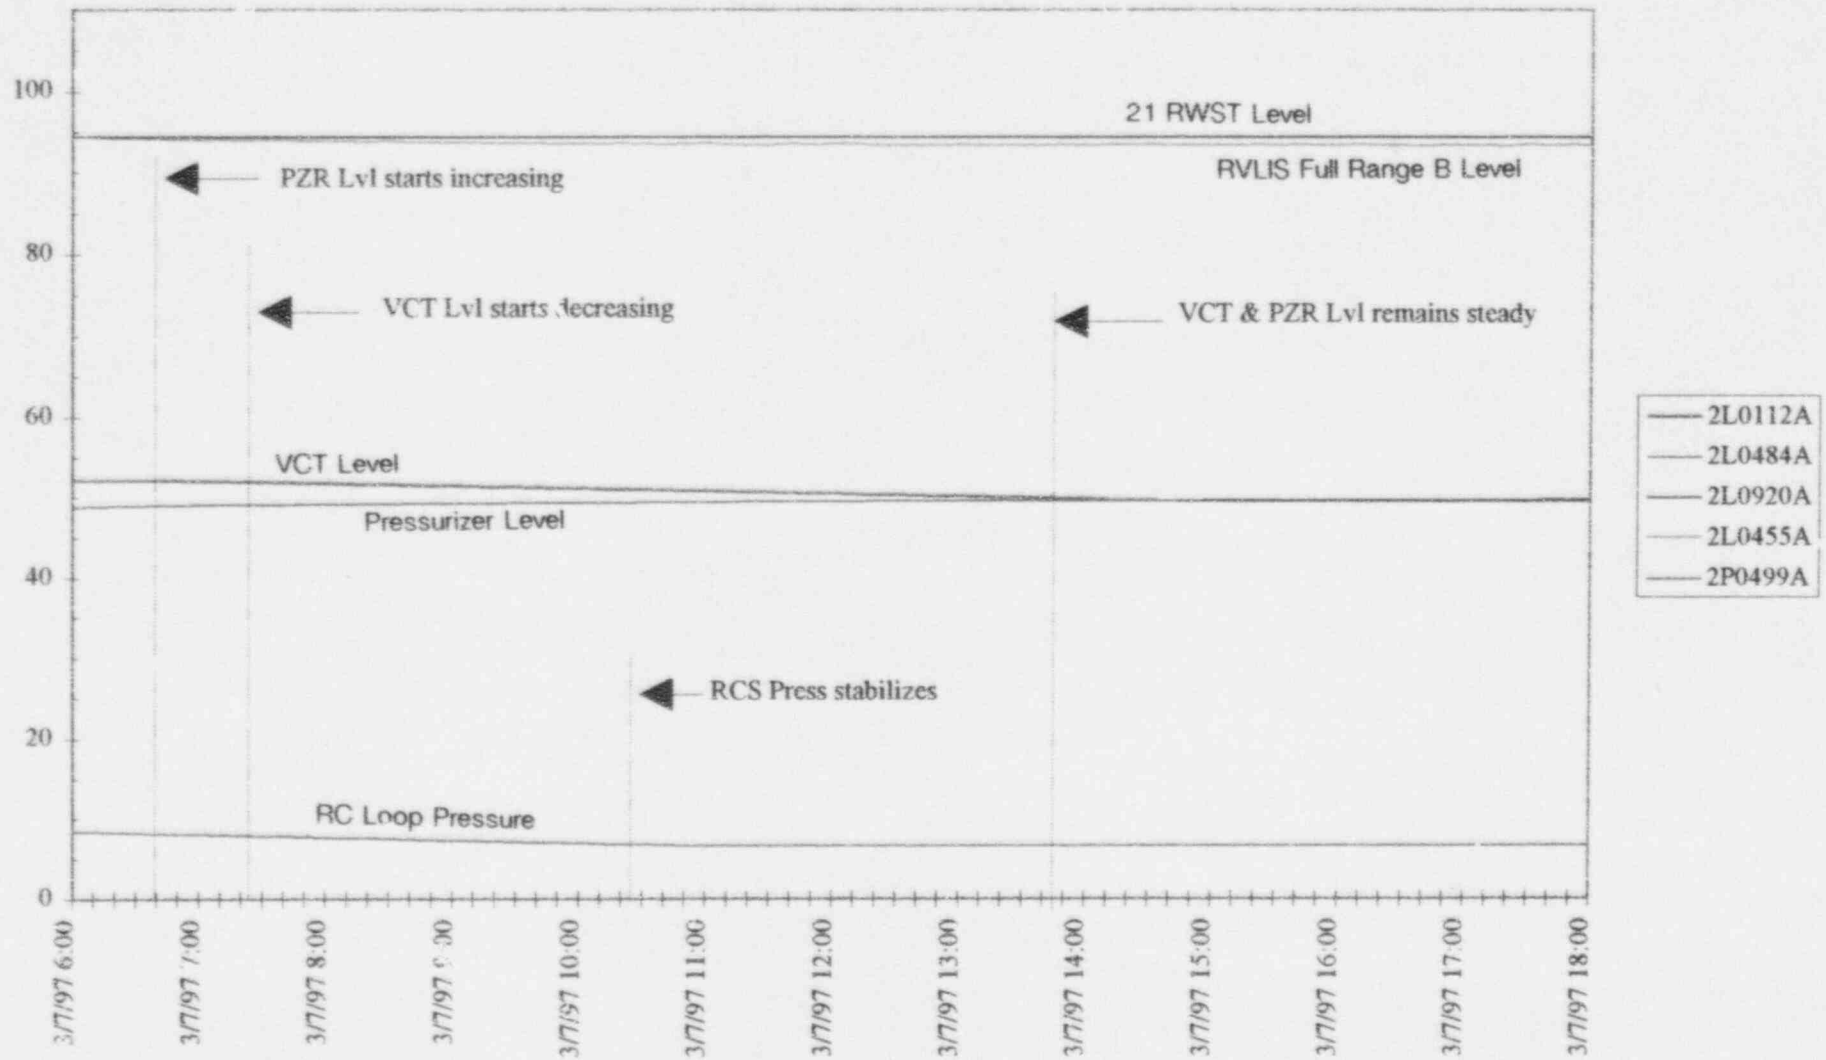
Chart 3

0600 - (Chart 3) The night shift turned over to on-coming crew. The day shift observed RVLIS Full range to be indicating around 94% (100% is full) and concluded that a possible gas void existed in the reactor vessel head. The SOC, Day Shift SM and the Outage Manager discussed this and agreed it wasn't a shutdown cooling issue. Because they did not fully understand how the void was created (they suspected an inadequate vent path but did not know the details) they decided nothing should be done until SV-32096 was repaired and the vent path could be returned to its normal lineup. Repair of SV-37096 continued under WO 9701175 through the shift. PI computer data: PZR Lvl - 48.86%, RVLIS Upper Range B - 97.01%, RVLIS Full Range B - 94.29%, RWST Lvl - 94.44%, RHR Inlet Temp - 91.1 F, RC Loop Press - 8.52 psig, 21 CVCS HUT Lvl (log reading) - 81.5%.

1800 - (Chart 3) The day shift turned over to on-coming crew. The day crew informed them that they suspected that a possible void existed in the reactor vessel head because the RVLIS indications were indicating <100%. PI computer

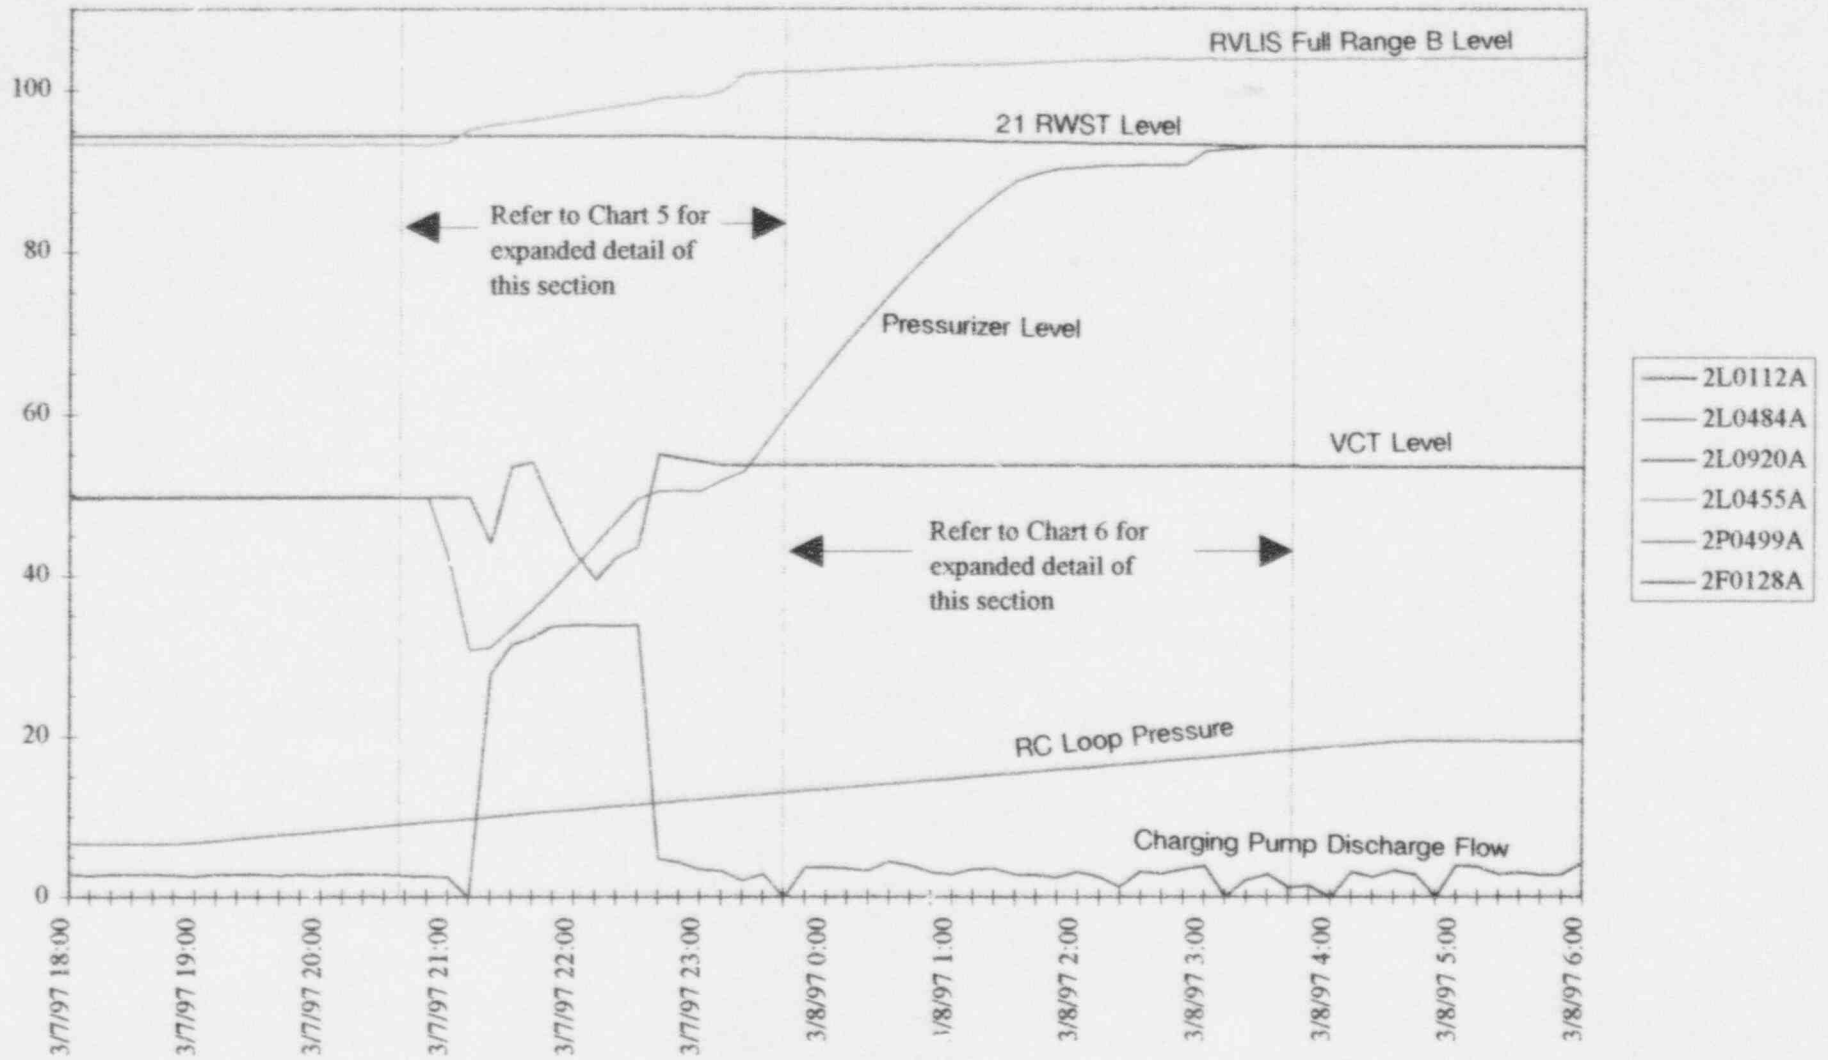
Chart 4

2055 - (Chart 4 & 5) When 2RC-8-16 was cracked open the containment operator could hear air being drawn in through the vent valve and line. The control room operators observed pressurizer cold cal level start to slowly decrease.

About 2110 (Chart 4 & 5) When pressurizer cold cal level reached approximately 30% the control room instructed the containment operator to close 2RC-8-16 so the pressurizer could be refilled. PI computer data: PZR Lvl - 48.24%, RVLIS Upper Range B - 96.45%, RVLIS Full Range B - 92.79%, RWST Lvl - 94.43%, RHR Inlet Temp - 91.5 F, RC Loop Press - 9.54 psig.

2112 - (Chart 4 & 5) The control room operator started blended make-up flow to the VCT and then started 22 Charging Pump to refill pressurizer in accordance with

2230 - (Chart 4 & 5) When pressurizer level reached 50% cold cal 22 Charging Pump was stopped and a few minutes later the blended make-up flow to the VCT was stopped in accordance with C12.1 & C12.5. About 2650 gallons of blended make-up water was charged into the RCS to increase pressurizer level back to 50%. PI computer data: PZR Lvl - 49.51%, RVLIS Upper Range B - 95.90%, RVLIS Full Range B - 98.28%, RWST Lvl - 94.43%, RHR Inlet Temp - 91.4 F, RC Loop Press - 11.65 psig.

About 2237 (Chart 4 & 5) the operator in containment was instructed to reopen and hang the Hold Card on 2RC-8-16 to vent the pressurizer. No air flow through the valve could be heard. The control room observed pressurizer and RVLIS levels for approximately 25 minutes with no noticeable change. The SS then decided to have the reactor head vented to the containment atmosphere by using manual head vent valves that weren't part of the isolation for repairing SV-37096. PI computer data: PZR Lvl - 50.22%, RVLIS Upper Range B - 95.81%, RVLIS Full Range B - 98.63%, RWST Lvl - 94.43%, RHR Inlet Temp - 91.4 F, RC Loop Press - 11.76 psig.

Approximately 2305 (Chart 4 & 5) the operator in containment opened 2RC-8-5, Reactor Vessel-Vent, 2RC-8-31, Reactor Head Vent Flushing Valve, and 2RC-8-33, Rx Head Vent Orifice Bypass, to vent the reactor head. The operator noted air coming from the vent and the control room observed RCS pressure and RVLIS levels increasing and a slow increase in pressurizer level. Around this same (Chart 5 & 7) time it appears (based on computer data that shows RWST level starting a slow decrease, a increase in pressurizer level and VCT level slow decrease leveling off and holding steady) that the control room operator opened MV-32062, 21 RWST To Chg Pump Suct MV, and closed MV-32063, 21 VCT Outlet To Chg Pump Suct Header MV. In order to close the VCT outlet to the charging pump suction MV-32062 has to be opened first to satisfy valve logic. The opening of the RWST to charging pump suction motor valve allowed RWST water to slowly flow through the charging system into the RCS. This was identified during the event evaluation by reviewing PI computer RWST level readings and confirmed by primary chemistry silica sample results which indicated an increase for this time period. PI computer data: PZR Lvl - 50.54%, RVLIS Upper Range B - 96.10%, RVLIS Full Range B - 99.05%, RWST Lvl - 94.40%, RHR Inlet Temp - 91.4 F, RC Loop Press - 12.30 psig.

0003 - (Chart 4 & 6) When RVLIS indicated that the reactor vessel head was full the operator in containment was instructed to close 2RC-8-31 and 2RC-8-33. PZR Lvl 69.7% and increasing, RVLIS Full Range 102%, RVLIS Upper Range 99%. PI computer data: PZR Lvl - 67.02%, RVLIS Upper Range B - 98.72%, RVLIS Full Range B - 102.46%, RWST Lvl - 94.10%, RHR Inlet Temp - 91.4 F, RC Loop Press - 13.65 psig.

Pressurizer level continued to slowly increase (Chart 4 & 6) after the reactor head vent valves were closed. The control room operators discussed possible sources of water (RMU tanks, RWST, BAST, SG tubes) that could be causing pressurizer level to increase. Control board tank level indicators were checked and indicated no change. The RWST MVs to the RHR system were checked and found to be closed. From these indications control room personnel concluded that the most likely source of water causing the increase in pressurizer level was from the steam generator (SG) tubes. After the reactor head vent valves were closed the pressurizer was still vented to the containment atmosphere via the PORVs, 2RC-8-16 & 2RC-14-1.

0133 - (Chart 4 & 6) Closed both PORVs because pressurizer level continued to increase. Closing the PORVs isolated the pressurizer vent path to the containment atmosphere and slowed the level increase down until it leveled off. PI computer data: PZR Lvl - 89.29%, RVLIS Upper Range B - 98.56%, RVLIS Full Range B - 103.02%, RWST Lvl - 93.69%, RHR Inlet Temp - 91.4 F, RC Loop Press - 15.57 psig.

0258 - (Chart 4 & 6) Opened both PORVs to determine if the pressurizer level had stabilized. When the valves were opened pressurizer cold cal level started to increase. PI computer data: PZR Lvl - 91.50%, RVLIS Upper Range B - 99.62%, RVLIS Full Range B - 104.27%, RWST Lvl - 93.30%, RHR Inlet Temp - 91.4 F, RC Loop Press - 17.59 psig.

0300 - (Chart 4 & 6) Closed both PORVs to stop the pressurizer level increase. PI computer data: PZR Lvl - 92.50%, RVLIS Upper Range B - 99.98%, RVLIS Full Range B - 103.63%, RWST Lvl - 93.29%, RHR Inlet Temp - 91.4 F, RC Loop Press - 17.4 psig.

0350 - (Chart 4) PI computer data (readings before drain down enclosed in []): PZR Lvl - 93.15% [93.97%], RVLIS Upper Range B - 99.51% [102.48%], RVLIS Full Range B - 103.70% [99.67%], RWST Lvl - 93.11% [94.44%], RHR Inlet Temp - 91.4 F [90.9 F], RC Loop Press - 18.50 psig [16.84 psig].
