SUBJECT: ATLAS MINERALS URANIUM MILL

REPORT ON ATLAS MINERALS URANIUM MILL TAILINGS DAM INSPECTION AND EVALUATION

DESIGN CRITERIA FOR IMPROVEMENTS
OF TAILINGS DISPOSAL SYSTEM AT
ATLAS MINERALS MILLING OPERATIONS,
MOAB, UTAH

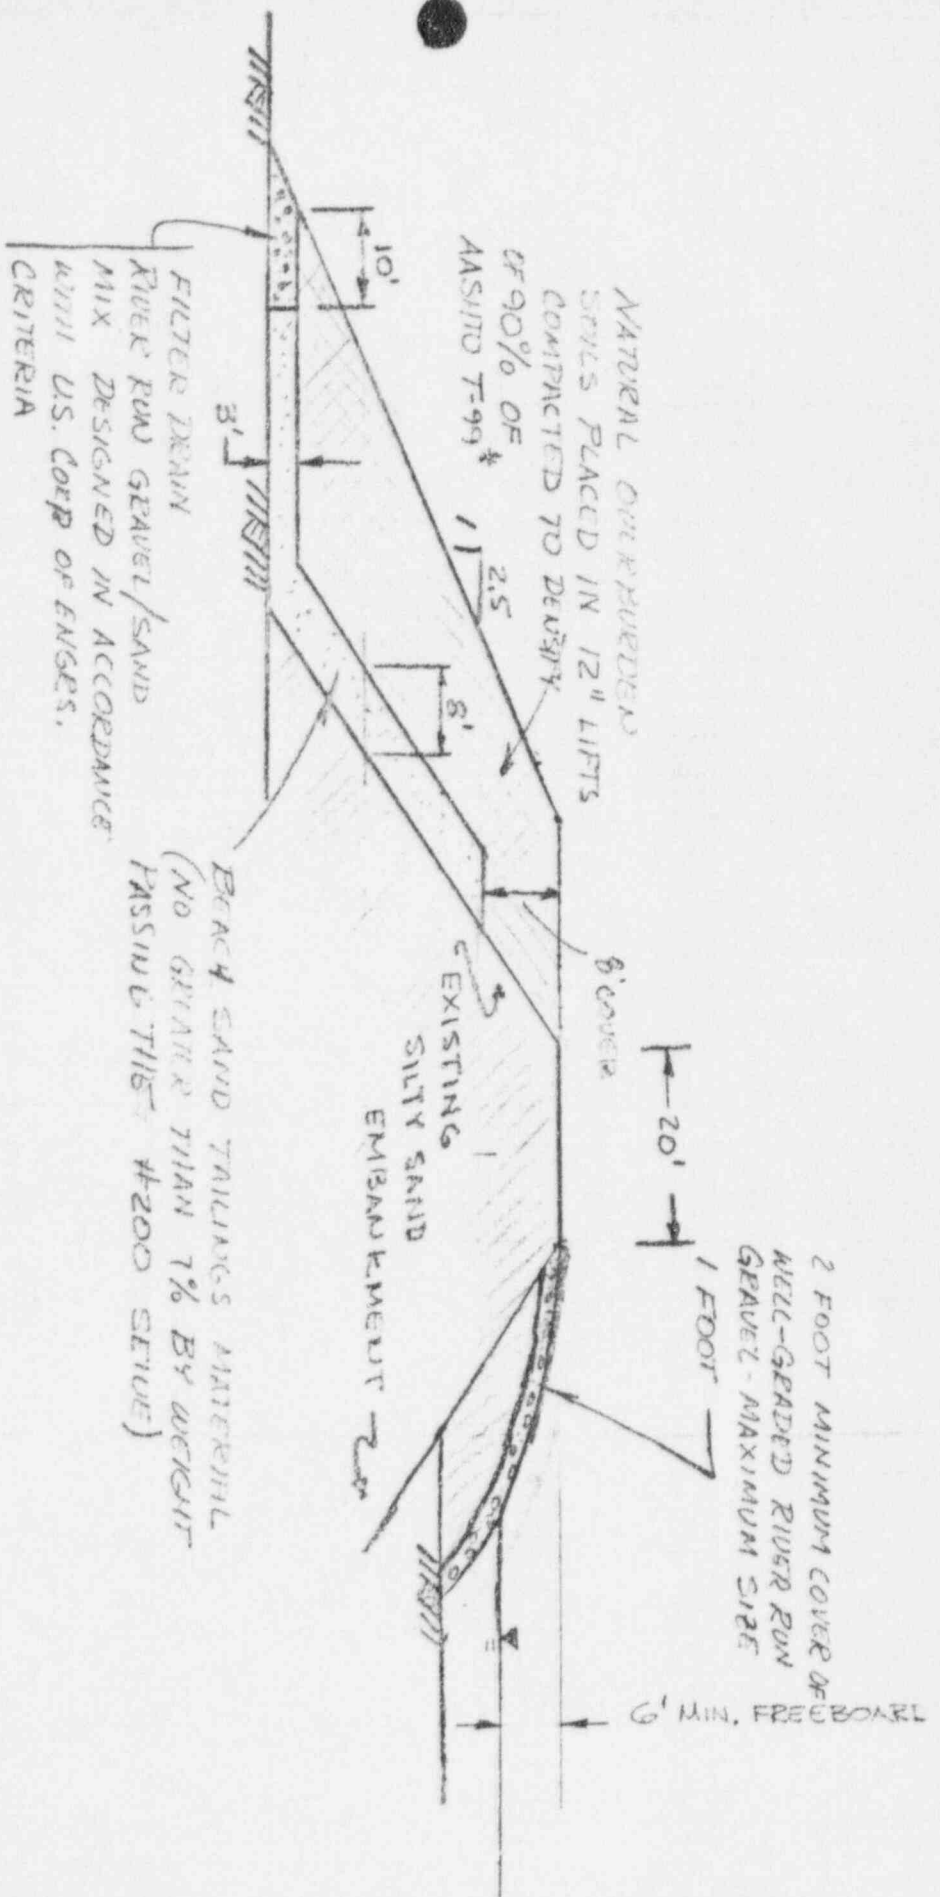
TYPICAL SECTION -
BEST AVAILABLE AREA

1. Pond liquid was actually in contact with the upstream face of the west embankment; we were informed by Dames & Moore that the liquid in contact with the embankment was from 1 to 2 feet deep;

2. Pond liquid was closer to the embankment than the required 250 feet;
3. Evidence of seepage existed at the downstream base of the west embankment; ponding of liquid and flourishing vegetation were observed. The source of the seepage was obscured by remedial earthwork in progress;

4. Imported material used to construct the west embankment consists of reddish brown silty sands with many cobbles and boulders with a small percentage of clay;

Along the western embankment area of the tailings pond the design criteria for improvements are shown on Figure 1 and include the following:

1. A minimum freeboard requirement of 6 feet must be met at all locations.
2. A 2-foot minimum cover of rip-rap material is required for wave-erosion protection over the entire upstream slope. The material will consist of well-graded river run gravel with pieces of a maximum size of one foot.

3. A crest width of 20 feet must exist at all embankment sections.
4. Beach sand tailings will be placed against the upstream slope and along the natural ground surface adjacent to the existing toe of embankment slope with the dimensions as shown on Figure 1. The tailings fill material will have particle sizes such that there will be no greater than 7% by weight passing the No. 200 sieve.

5. Filter material of river run gravel with gradation sizing designed in accordance with U.S. Corp of Engineers criteria. The dimensions of placement will be as shown on Figure 1.

6. Overburden material will be placed over the beach sand with minimum cover of 8 feet. The overburden will be of natural near-site sand and silt and will be placed to the dimensions shown on Figure 1. The fill should be placed in 12 inch lifts (loose state) and compacted to a dry density of at least 90% of the maximum density as determined by the AASHTO T-99 method of compaction.

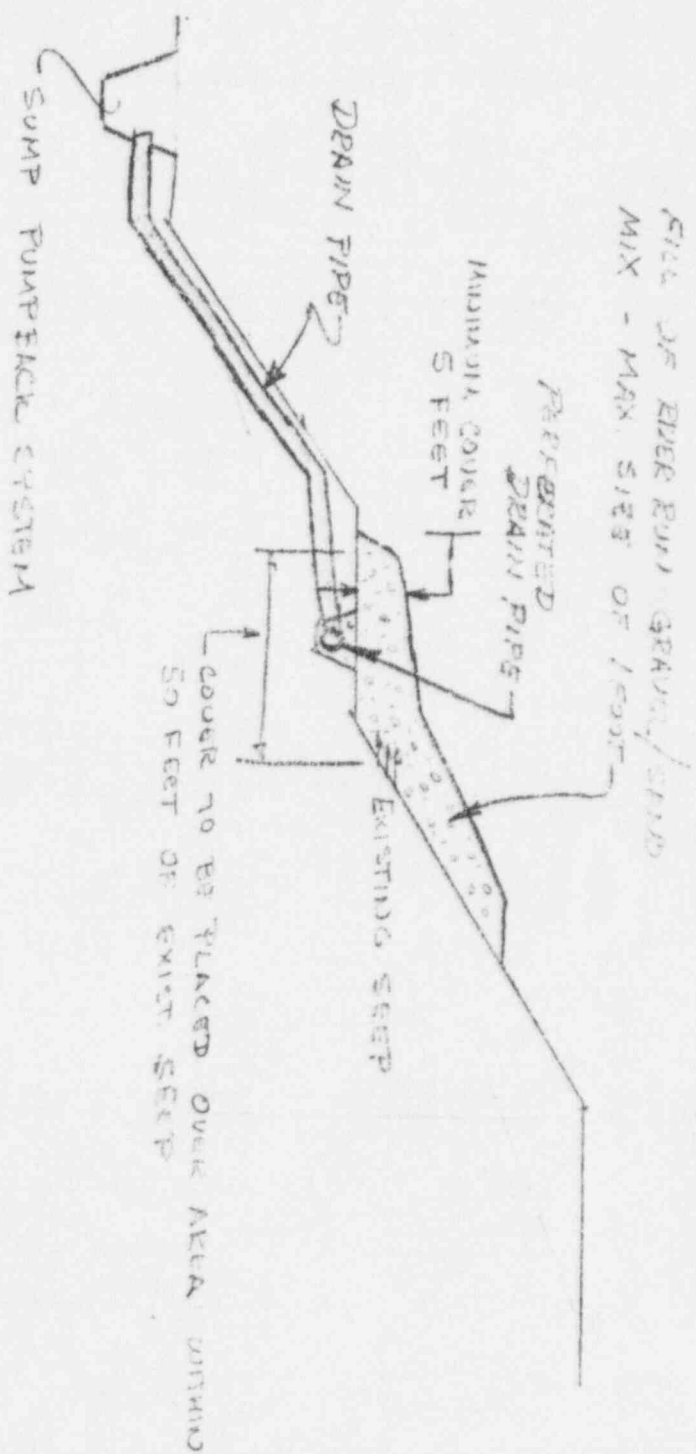
5. Evidence of seepage existed on the downstream face and lower bench of the north embankment; liquid was flowing through a drain pipe at a rate of about 1 gpm; the slope and bench immediately below the drain pipe was saturated;

Construction of an overburden fill will be placed over the seepage area located at the north embankment toe. The construction requirements and dimensions are shown on Figure 2 and include the following:

1. An overburden fill of well-graded river run gravel will be placed over the seep area a distance of at least 50 feet in all directions from the seep. The minimum fill thickness of 5 feet will be met over the above stated area. The maximum particle size of the material will be one foot.
2. A perforated drain pipe will be placed as shown on Figure 2 and drained by pipe to a sump pumpback system located near the downstream toe of slope.
