COMPLIANCE INSPECTION REPORT

1. Name and address of licensee Uranium Reduction Company 557 First Security Building Salt Lake City, Utah	2. Date of inspection May 12, 1960
	3. Type of inspection Supplementary Follow-up
	4. 10 CFR Part(s) applicable 20 - 40

Supplementary Follow-up Inspection

May 12, 1960

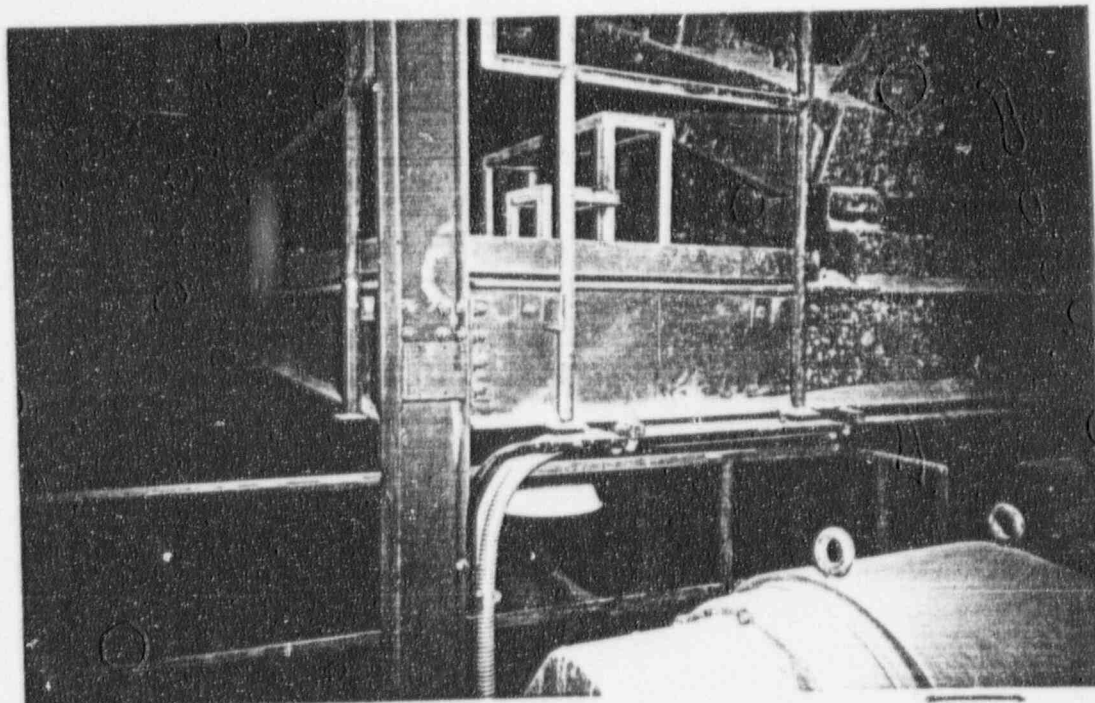
- d. An air balancing pipe has been installed, as proposed, connecting the discharge chute of the primary vibrating screen with the duct housing over the conveyor belt onto which the ore from the screen drops. This serves a purpose similar to that of the pressure equalization ducts located at transfer points on the conveyor belts. The latter were explained fully in the accompanying October inspection report. Careful examination of Photograph 2 shows the air balancing pipe. Although located in a position difficult to photograph, the pipe may be seen above and below the platform in the center background.

1. Crusher Building showing one of many signs posted as a result of October 26-29, 1959, inspection.
2. Air balance pipe connecting the discharge chute of #1 vibrating screen with the dust collection duct housing below. (See center background)

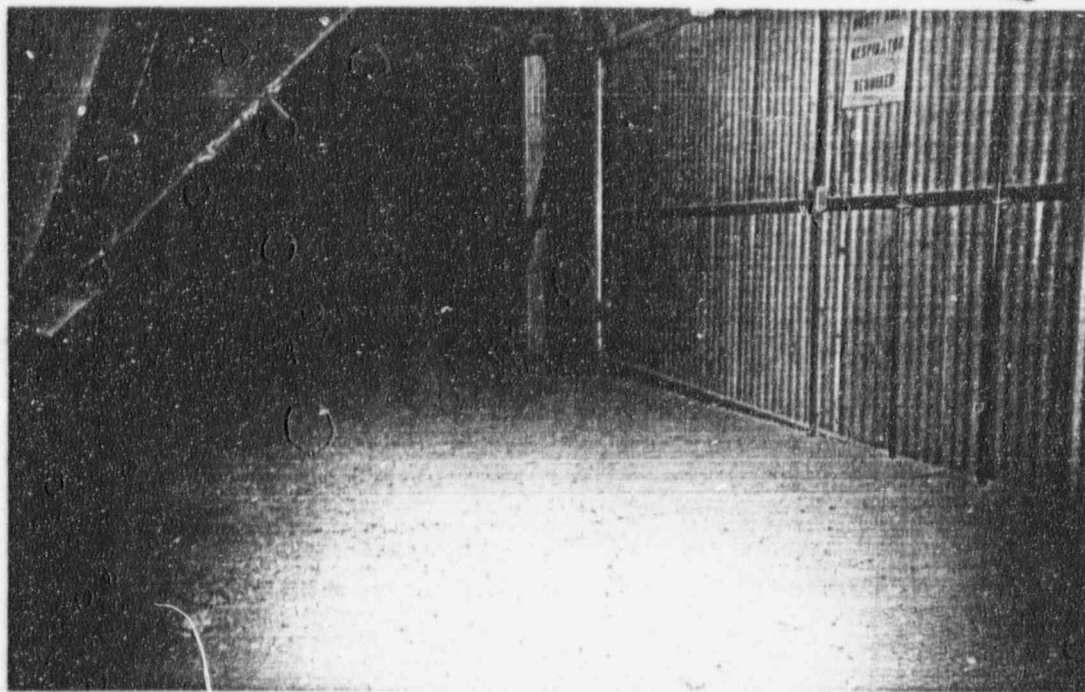
16. While touring the mill with Mr. Izzo, the inspector noted the following:
 - a. The ore deposition in the area of the #2 and #3 vibrating screens, mentioned in the report of the October 26-29, 1959, inspection, was still a problem and a dust generation point (see Photograph 3). (According to Mr. Izzo, however, the cause of the ore falling from the belt had been discovered.

A divider plate which divides the moving ore between the #2 and #3 vibrating screens had been nearly disintegrated by the moving ore. Mr. Izzo explained that replacement of this steel plate was to be made and the problem thereby solved).

- b. The centrally located vacuum cleaning plant for the crushing area has been installed in the fine ore bin gallery, and outlets may be utilized throughout the crushing facility. (Note Photographs 3, 4 and 5).

3. Area behind #2 and #3 vibrating screens. (Note vacuum cleaner outlet and piping in center of photograph)
4. Centrally located vacuum cleaning plant for crushing area -- Fine ore bin gallery.

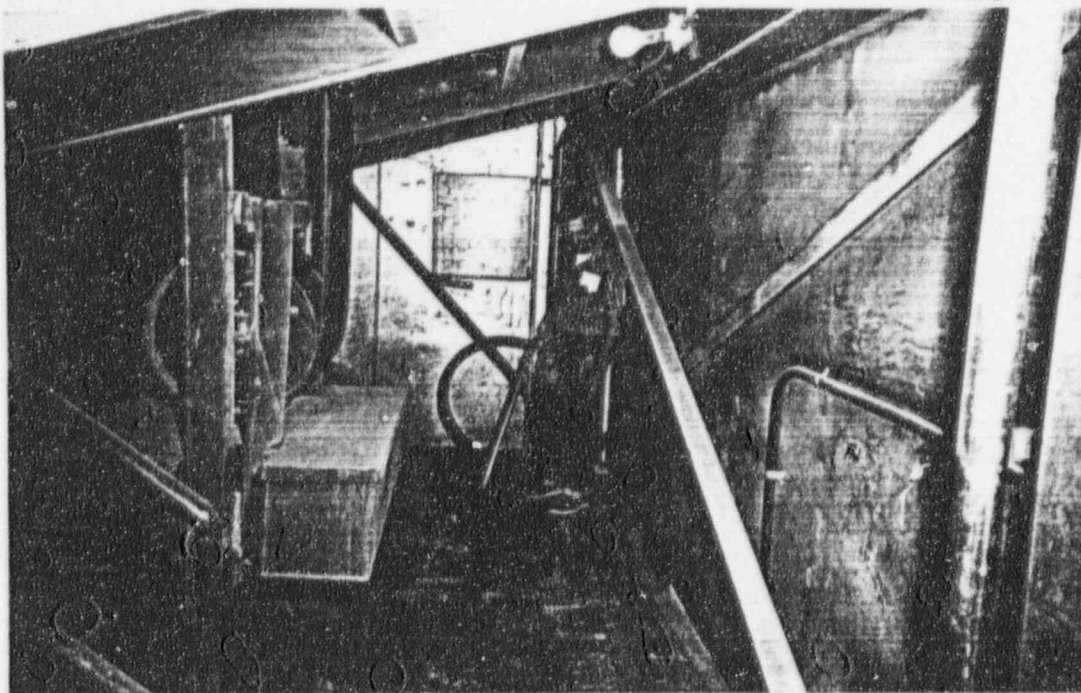
5. Mr. Iaso with cleaning tool and hose in crushing-sampling area.
(Note vacuum piping right foreground)

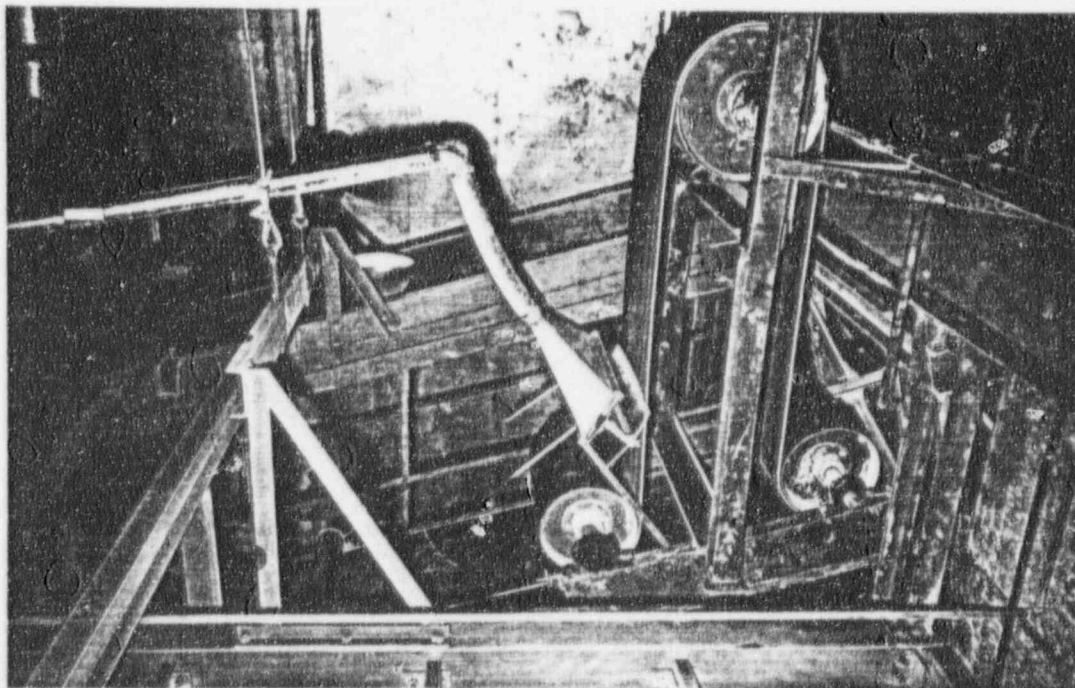
- b. The use of a belt beater and brush, or similar arrangement, to prevent accumulation of dust at the tension points on the conveyor belts has been resolved with an apparatus depicted in Photograph 6. The belt is cleaned of crusted ore by the pliable scraper and the dust thereby generated is vented to the dust collection system via the vent shown in the photograph.

6. Conveyor belt tension point showing belt cleaner and dust collection ductwork.

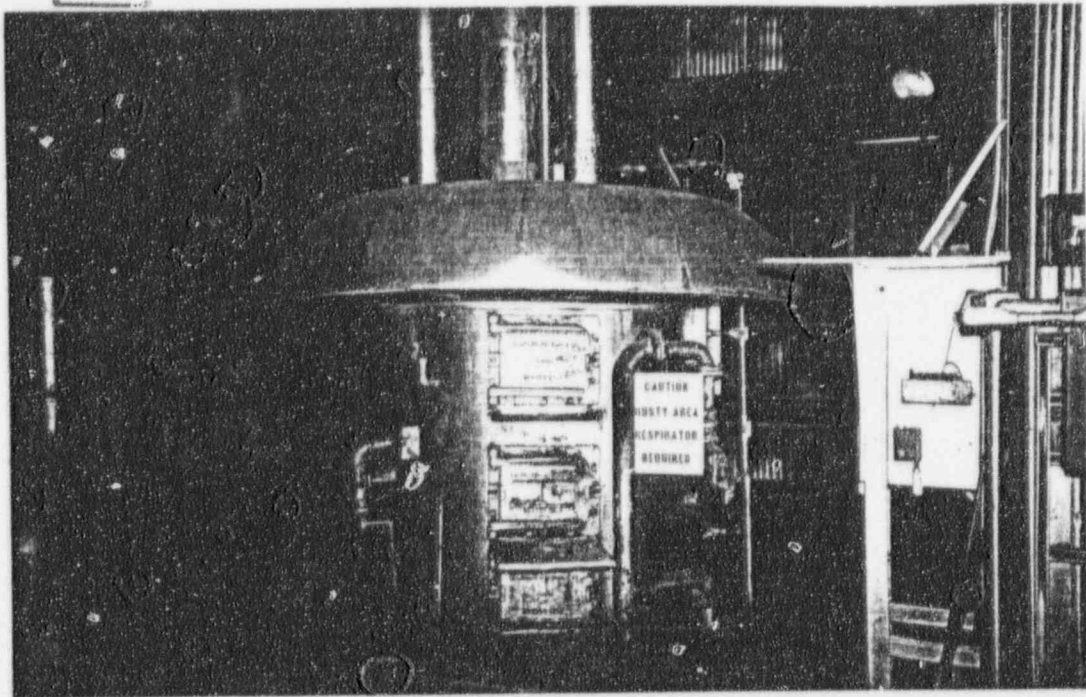
- a. Installation of a vacuum outlet on the hearth drier doors was considered by URC but testing resulted in abandoning the idea in favor of the use of the vacuum and catch tray arrangement (reported in the October 26-29, inspection report), and the newly installed hood over the yellow cake roaster (See Photograph 7).

- d. A recently installed hood over the top of the yellow cake roaster is being utilized along with the catch tray vacuum procedure in lieu of the vacuum outlet installation on the hearth drier doors. The latter did not prove adequate, according to Mr. Izzo. The hood and catch tray apparatus may be seen in Photograph 7.

7. Top of yellow cake roaster showing new hood and flues. (Note sign, and tray beneath hearth door)

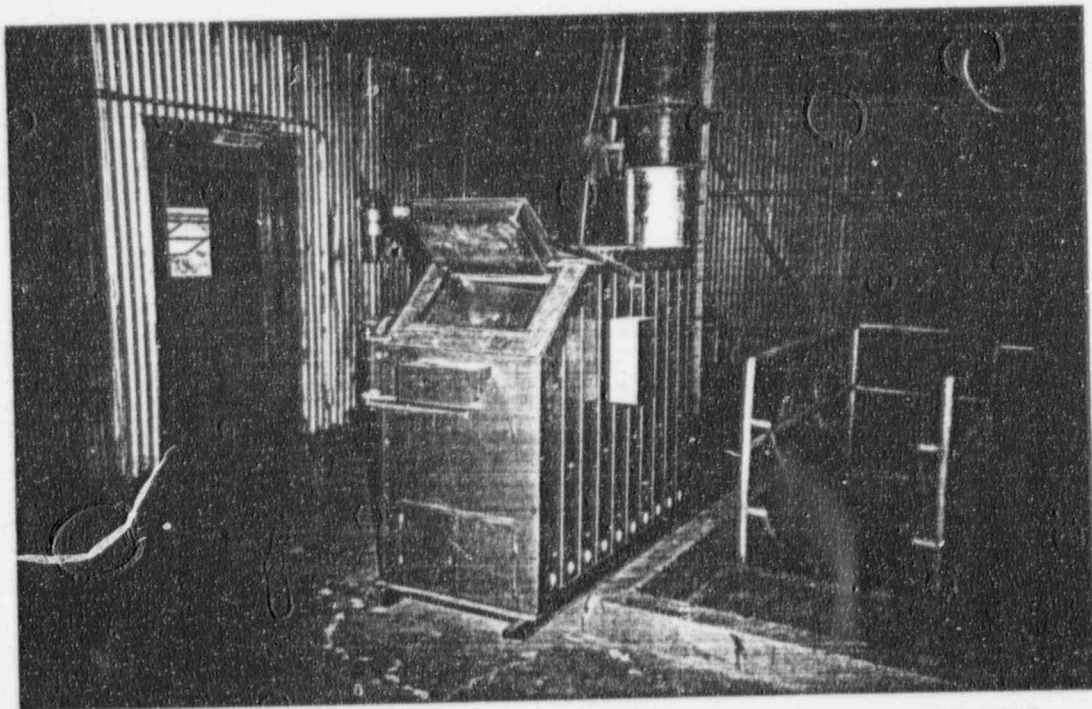
- c. A burner for ashing Shriver Press filters and recovering the yellow cake has been installed near the roaster on the fourth level of the drying area (see Photograph 8). [The burner was not operating at the time of the inspection, but Mr. Izzo assured the inspector that it would be operative in about one week. In the meanwhile, as shown in Photograph 10, the filter papers are stored in an isolated area. The burner will be exhausted through the same flue as the roaster (see Photograph 9).]

8. New burner for ashing Shriver Press filter papers.

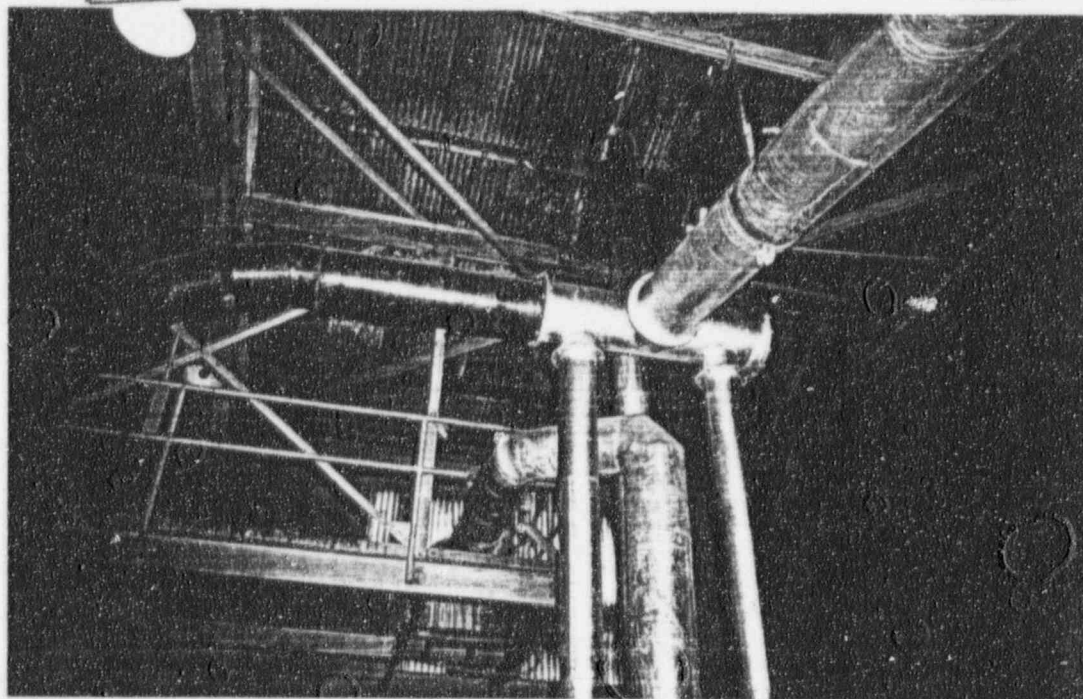
9. Yellow cake roaster exhaust flues. (Note: Dark pipe from left is from new burner shown in photograph 8. Roaster and burner exhaust are integrated.)

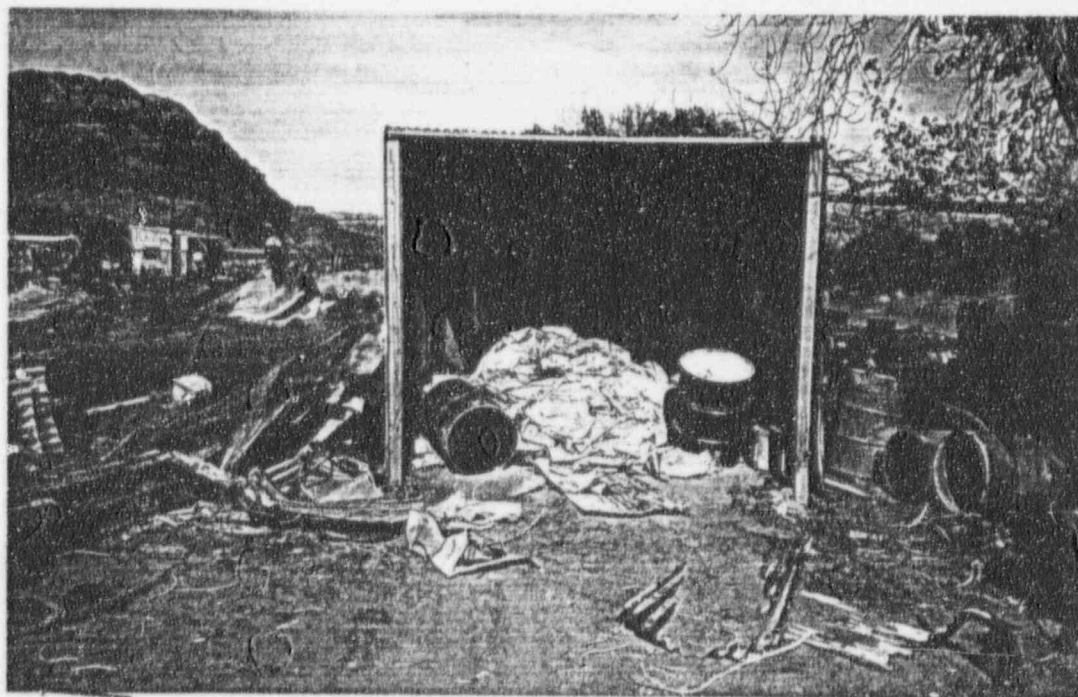
10. Isolated storage shed for Shriver Press filters (until new burner is operative).

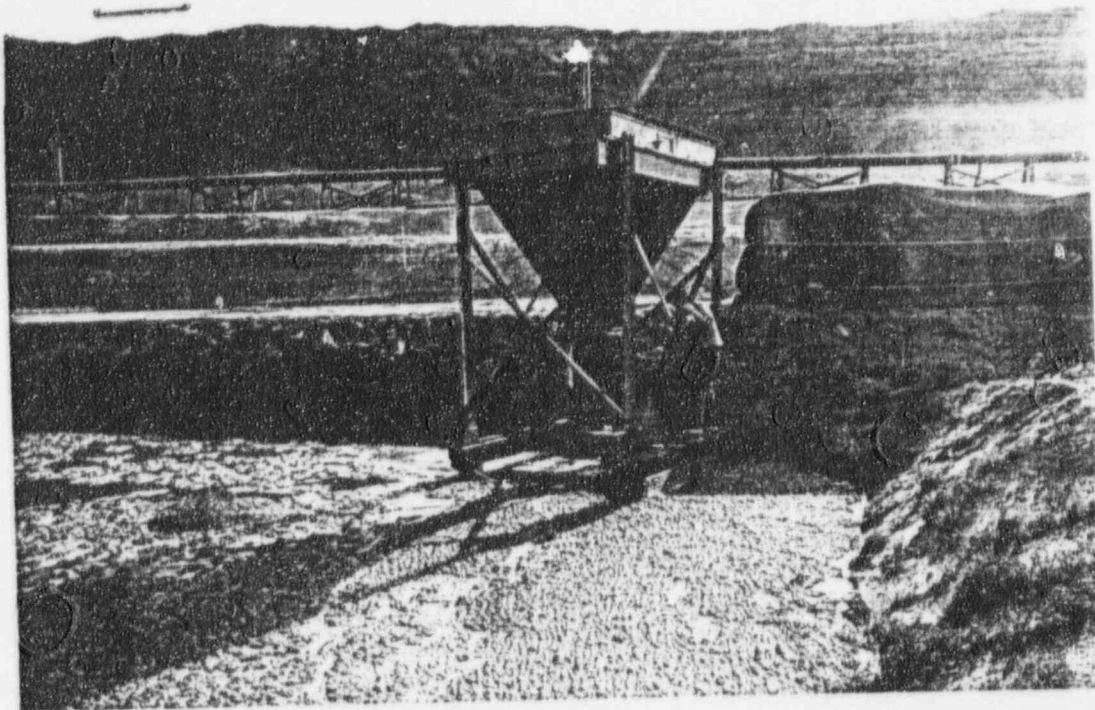
11. Inlet to barite treatment retention pond showing barite introduction equipment. (Note tailings pond dike in background)

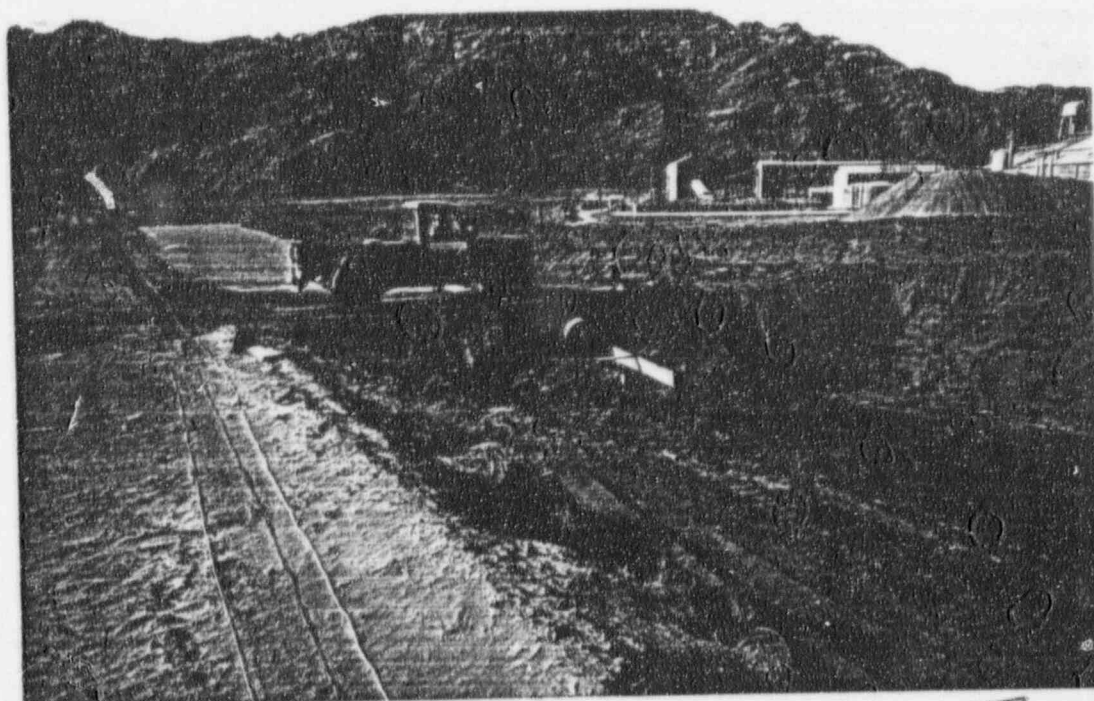
12. Barite treatment retention pond showing overflow to ditch bound for Colorado River. (Note barite introduction equipment in distant background)

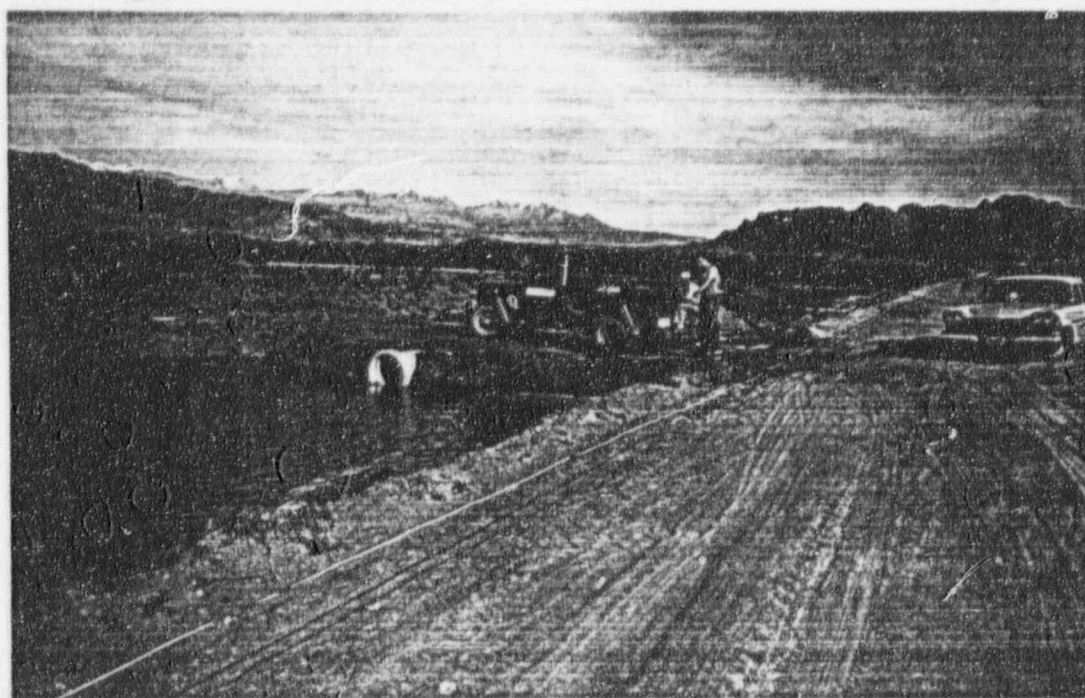
13. Overflow weir in barite retention pond. (Note ditch to Colorado River in background)
