# UNITED STATES NUCLEAR REGULATORY COMMISSION

ADVISORY COMMITTEE ON REACTOR SAFEGUARDS  
QUALIFICATION PROGRAM FOR SAFETY-RELATED  
EQUIPMENT

DATE: WEDNESDAY, JANUARY 15, 1986

# **SUMMARY OF THE EFFECTS OF THE CHILE AND MEXICO EARTHQUAKES OF 1985**

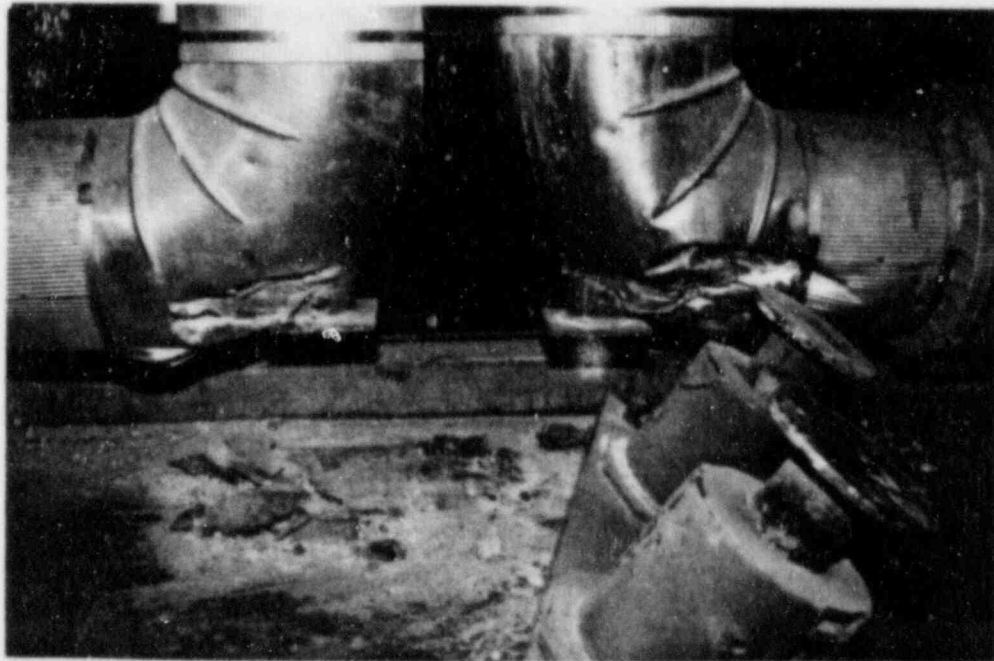
Damage to Feedwater Pipe Supports  
Pipe was not damaged  
Las Ventanas Power Plant  
Chile Earthquake, March 1985  
Magnitude 7.8

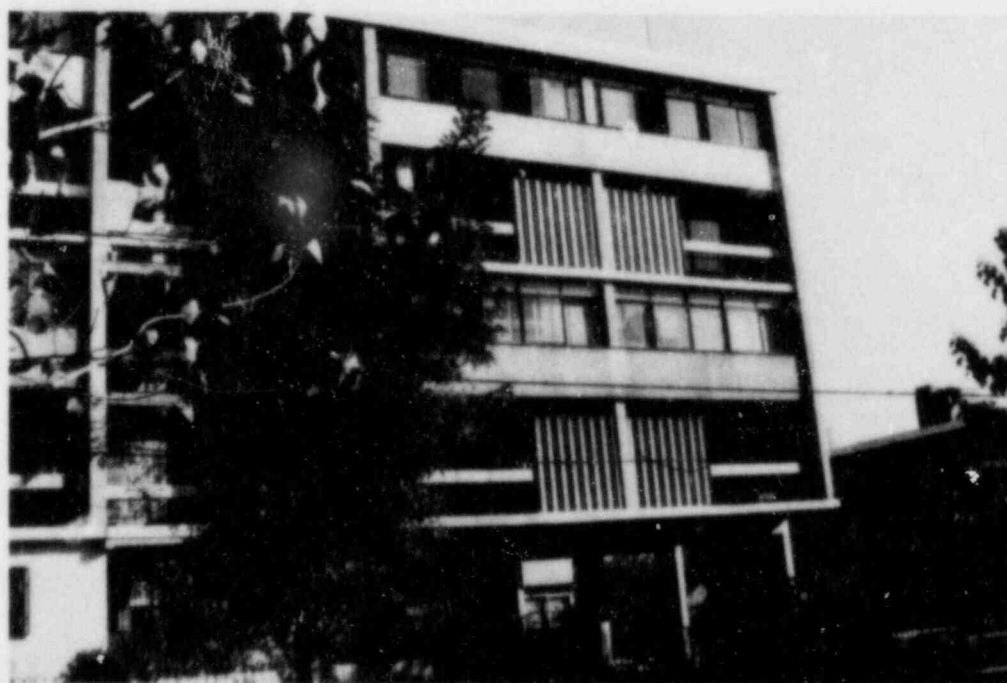
One apartment building in Santiago, over 70 miles from the earthquake epicenter, experienced a partial collapse. The continuous concrete shear walls of the upper stories of these two similar buildings are not continued down to the ground. This created a weak or soft story at ground level which caused the partial collapse of one of the walls.

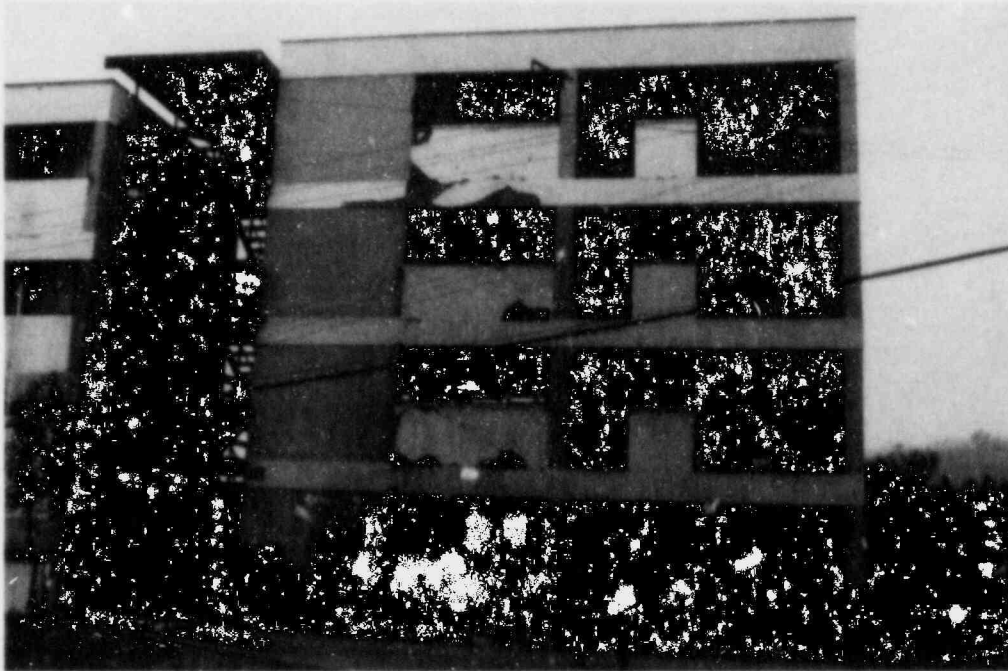
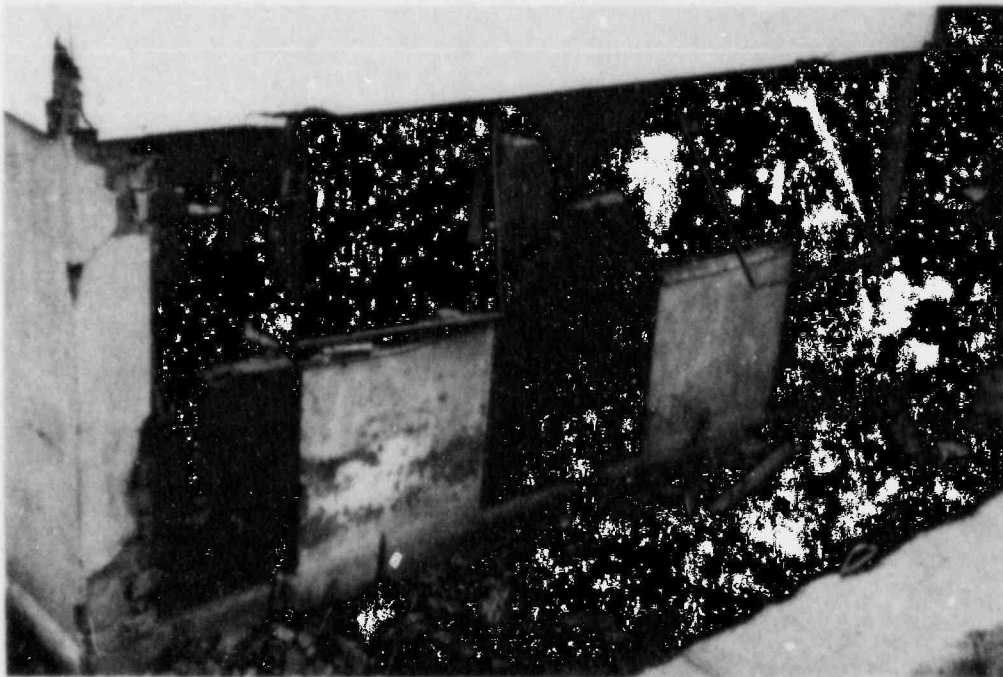
Many low-rise apartment buildings with reinforced concrete shear walls and frames with masonry infill were severely damaged. The four-story and five-story Canal Beagle apartments in the coastal town of Viña del Mar were damaged and abandoned by approximately 500 families. The buildings follow a standard design utilized throughout Chile. The severity of the damage was unexpected. The apartments are located on the steep slopes of two ridges, and the angles and heights of these sites amplified the ground motions. At the base of one ridge, two buildings identical to the badly damaged buildings suffered little damage.

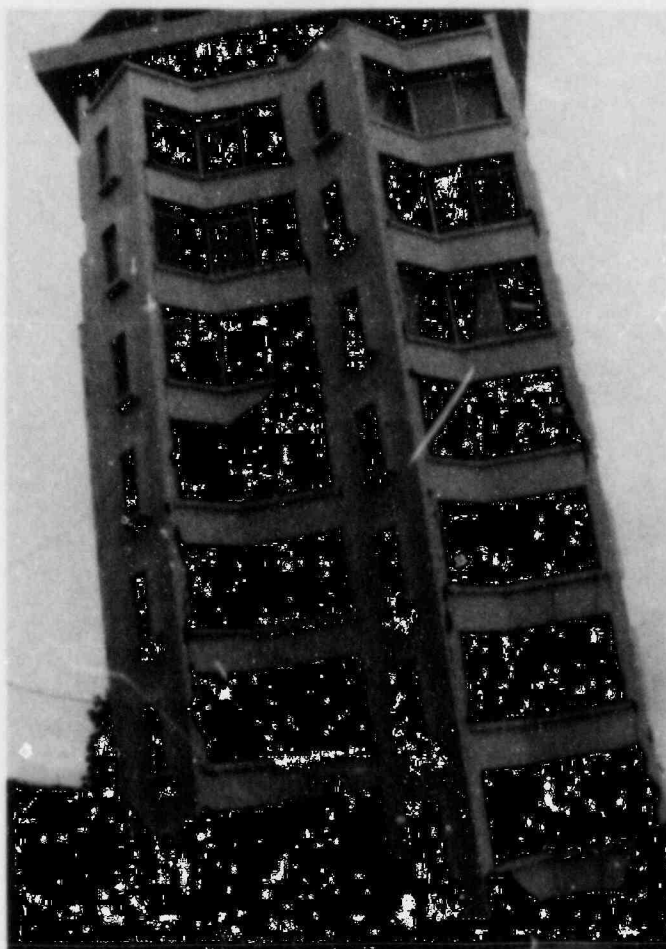
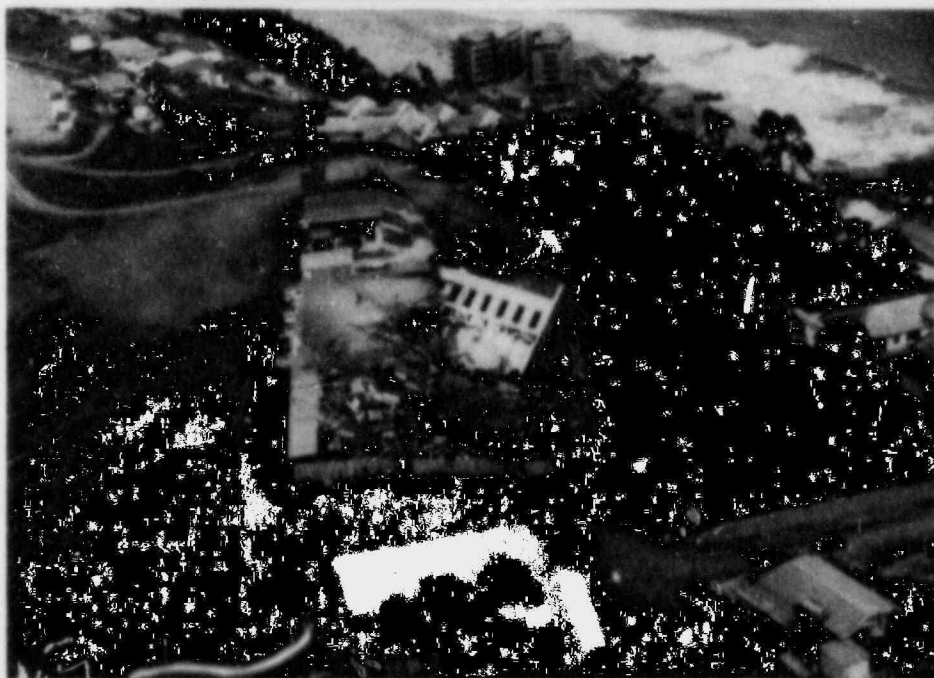
The El Faro apartment building, located north of the coastal city of Viña del Mar, was badly damaged when the ground floor collapsed. The building was condemned and demolished a few days after the earthquake. A poor conceptual design and construction problems contributed to the collapse. Soil failures were noted in the surrounding area. The same area was heavily damaged in previous earthquakes. Note several lightly damaged or undamaged buildings in the lower photograph.

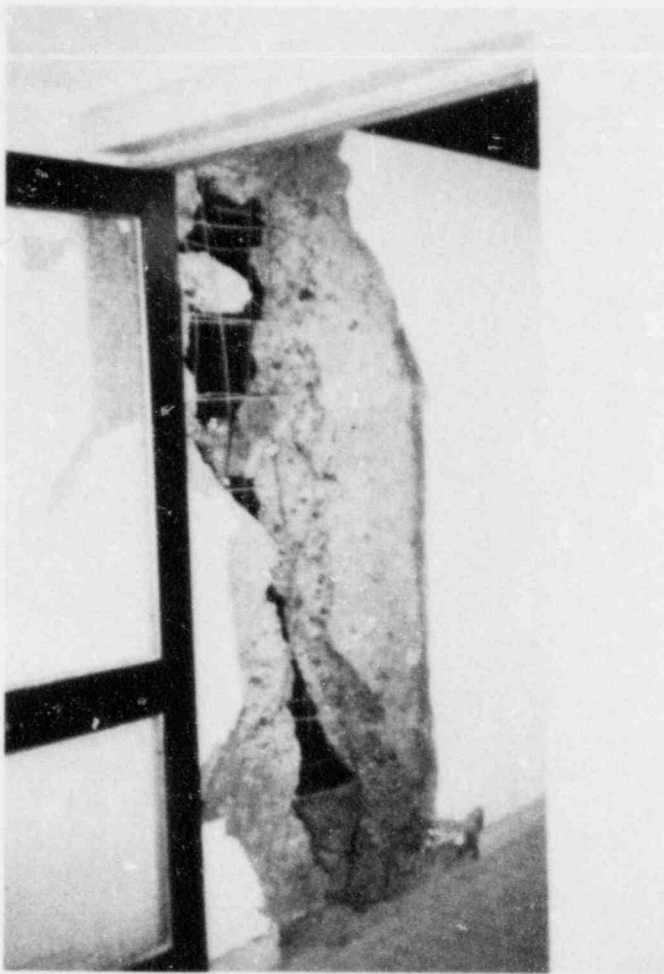
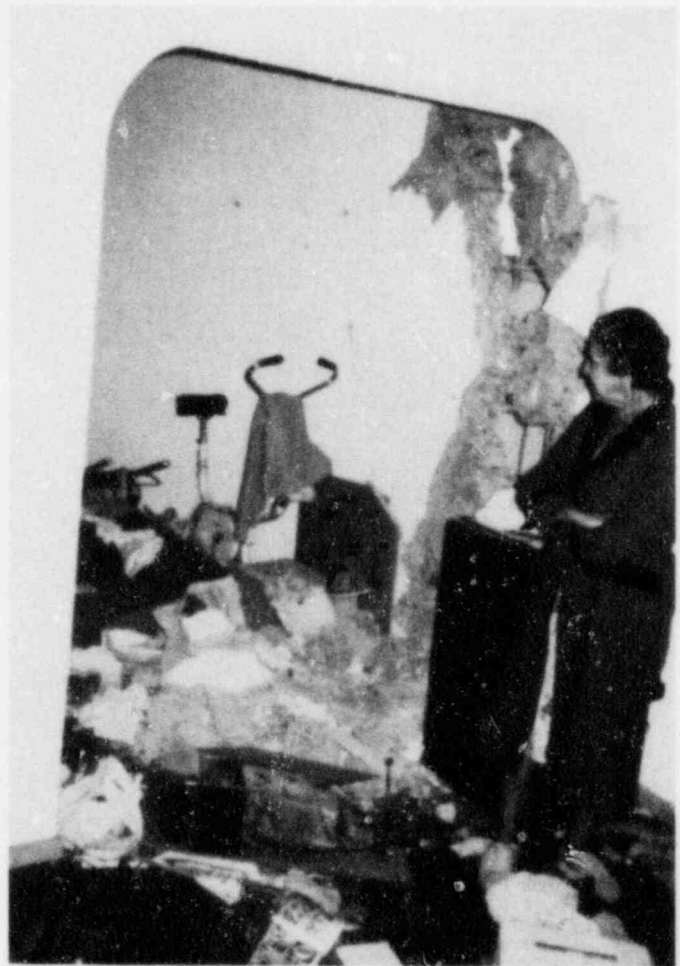
One concrete shear wall in the Hanga Roa apartment building sustained a crack approximately 1 foot wide that extends the full height of the building. The tenants inside were subjected to violent motions and the contents of their apartments were thrown onto the floor. Some of the doors jammed shut and power in the building was lost. The building was evacuated as of June 1985.

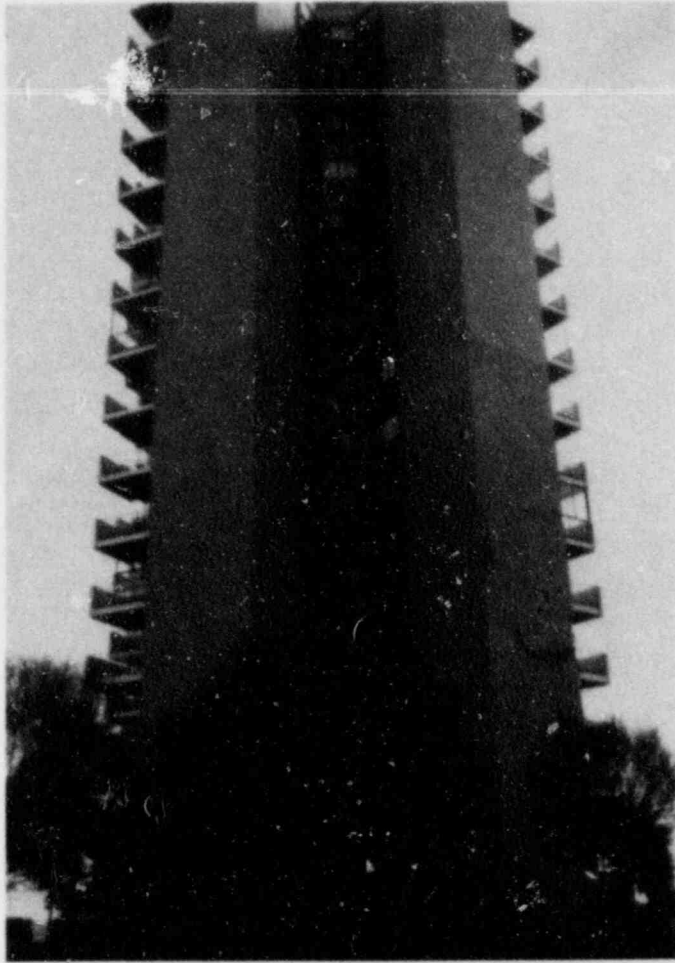
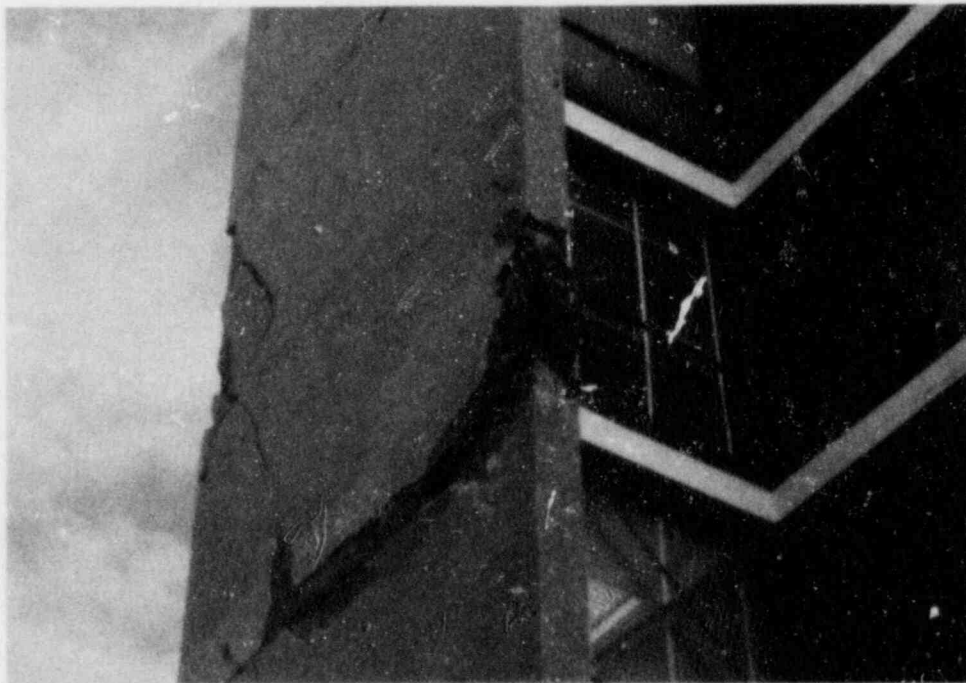
The 15-story Acapulco apartment building, adjacent to the Hanga Roa, was also severely damaged. The shear wall on the east side of the building cracked, exposing buckled reinforcing steel. Damaged interior walls revealed damage from previous earthquakes that had not been properly repaired. This building was evacuated after the earthquake, but will be repaired.

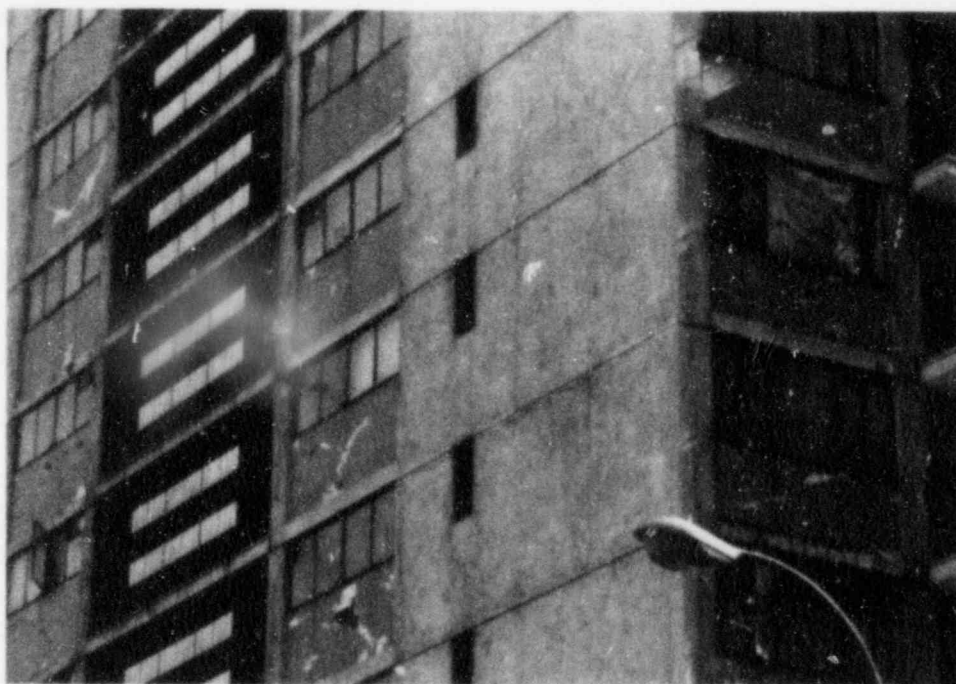
The buildings on the landfill area of Valparaiso were particularly hard hit. These high-rise apartment buildings were damaged, but not abandoned. The concrete spandrel beams were extensively cracked and many of the windows were broken. Pounding between one of the buildings and a walkway connecting it to an adjacent building caused significant damage.

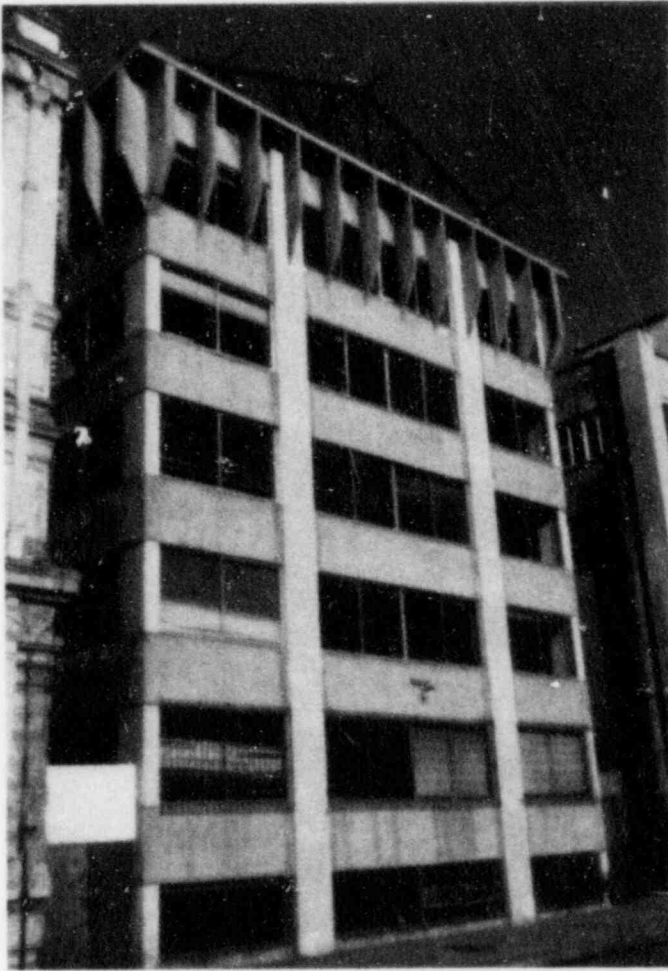
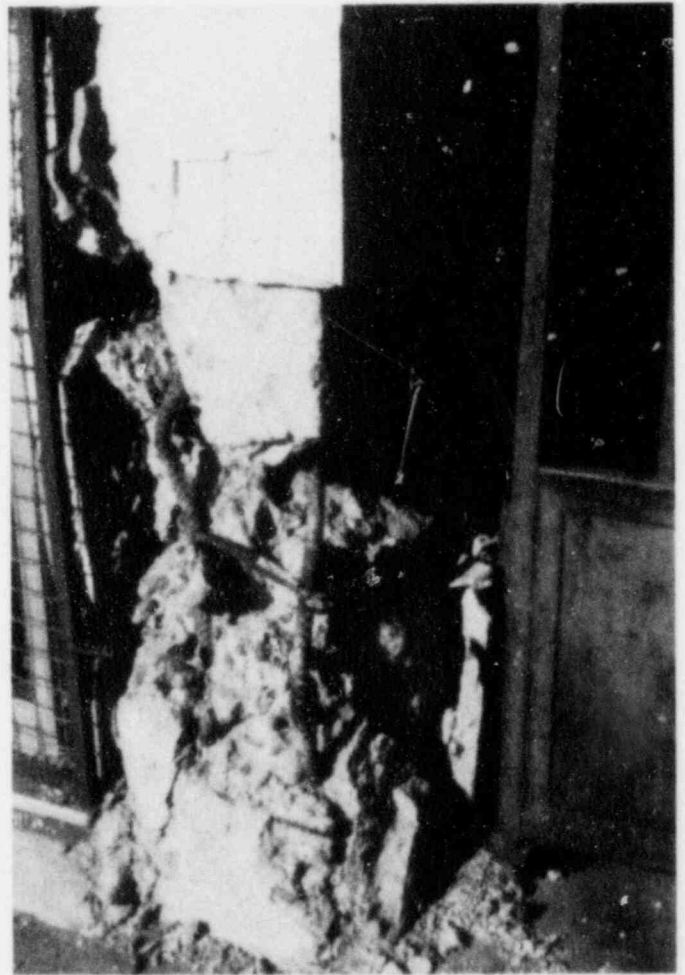
This six-story building in Valparaíso was also located in the landfill area near the port. Several concrete columns at the lower level were badly damaged. Due to a sloping terrain, these columns were shorter and, thus, stiffer than others at the same level. The shorter columns absorbed more lateral earthquake load than the more flexible taller columns and failed.

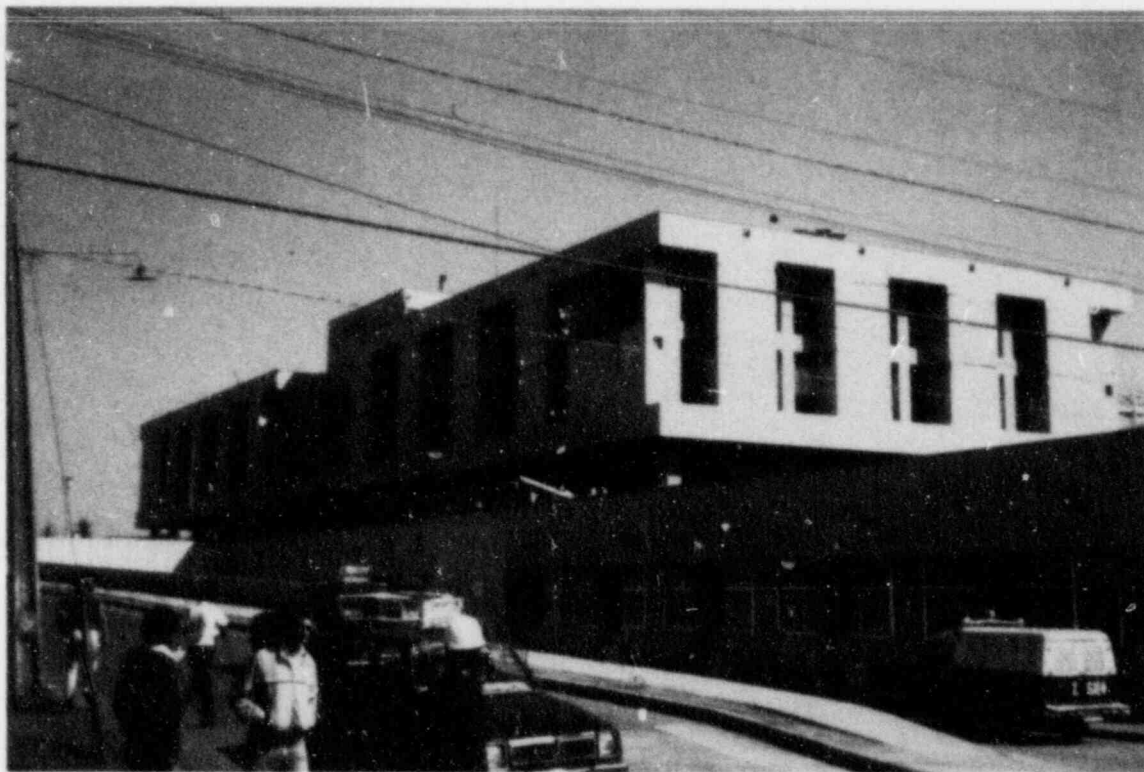
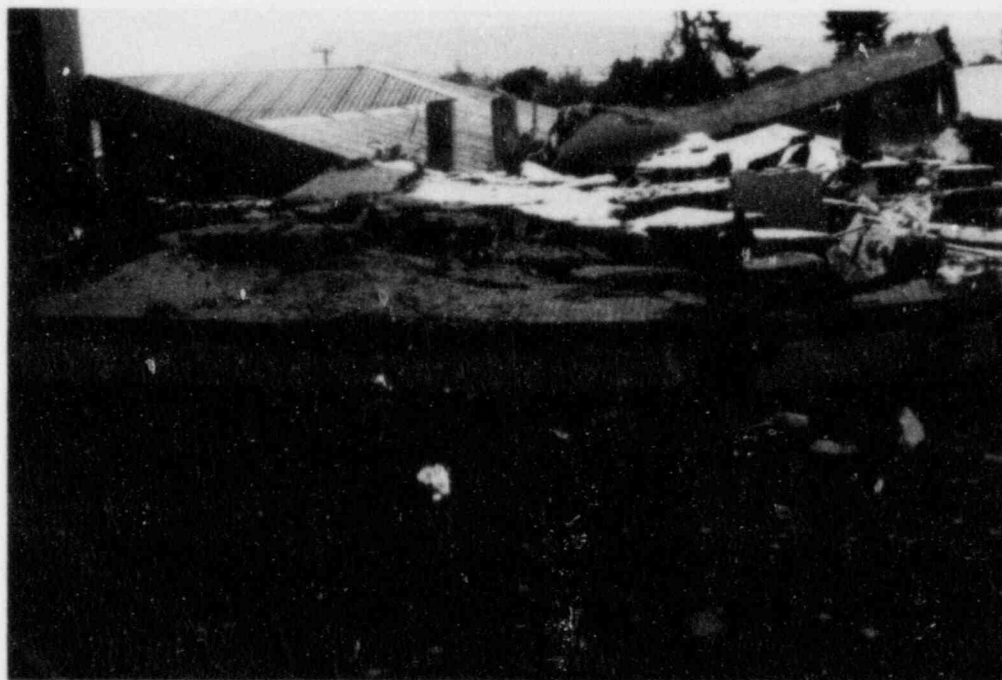
The Claudio Vicuna Hospital in San Antonio is located on a hill overlooking the port. It is a four-story concrete frame building with masonry infill panels between the frames. The panels are isolated from the concrete frames by seismic joints filled with styrofoam. This procedure is intended to minimize damage during an earthquake. However, the builders did not provide minimal connections between the infill and the frames to prevent the infill from falling. In one case a panel from the top floor fell to the ground

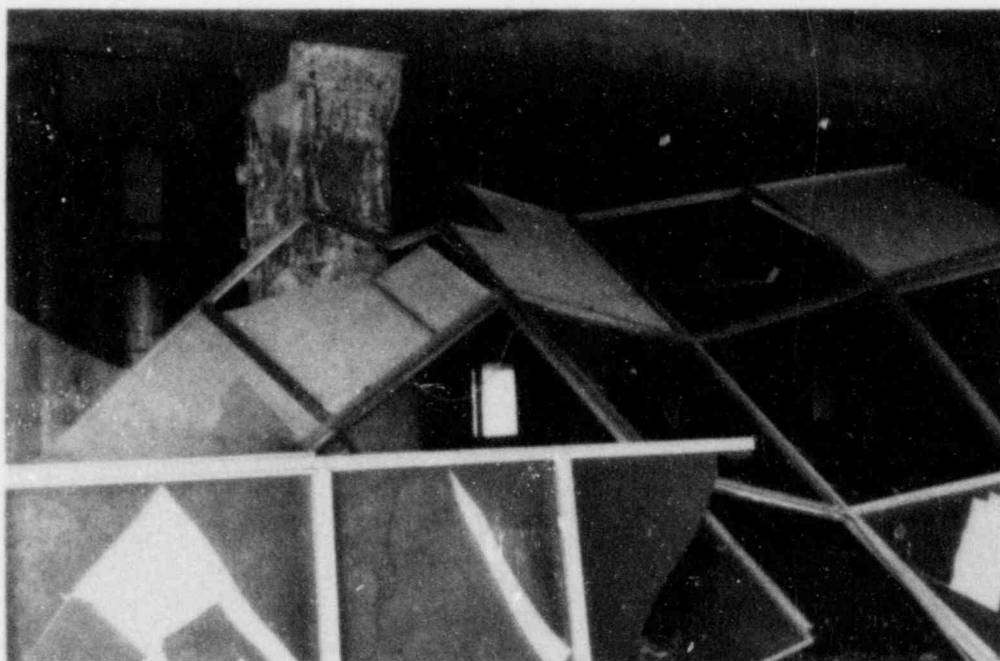
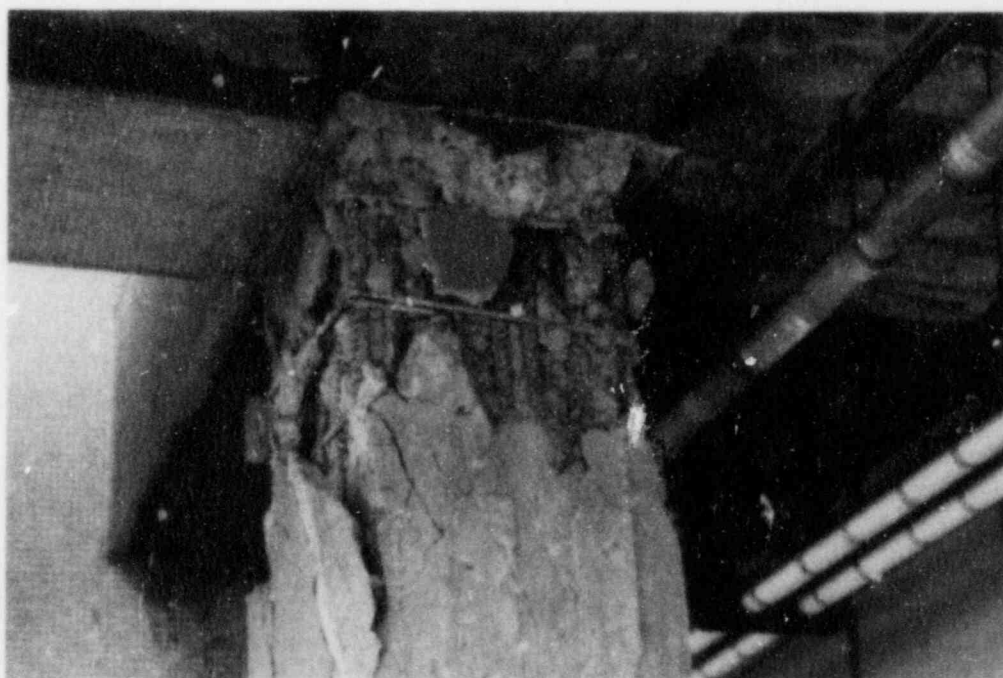
The Claudio Vicuna Hospital experienced large deformations because of its heavy construction and lack of shear walls. Though the damage seems quite severe, most is non-structural and probably repairable (upper photograph). Many concrete columns cracked or spalled, but the reinforcing steel and concrete within them appeared undamaged. The hospital was temporarily abandoned after the earthquake; the heavily damaged portion was still not in use in June.

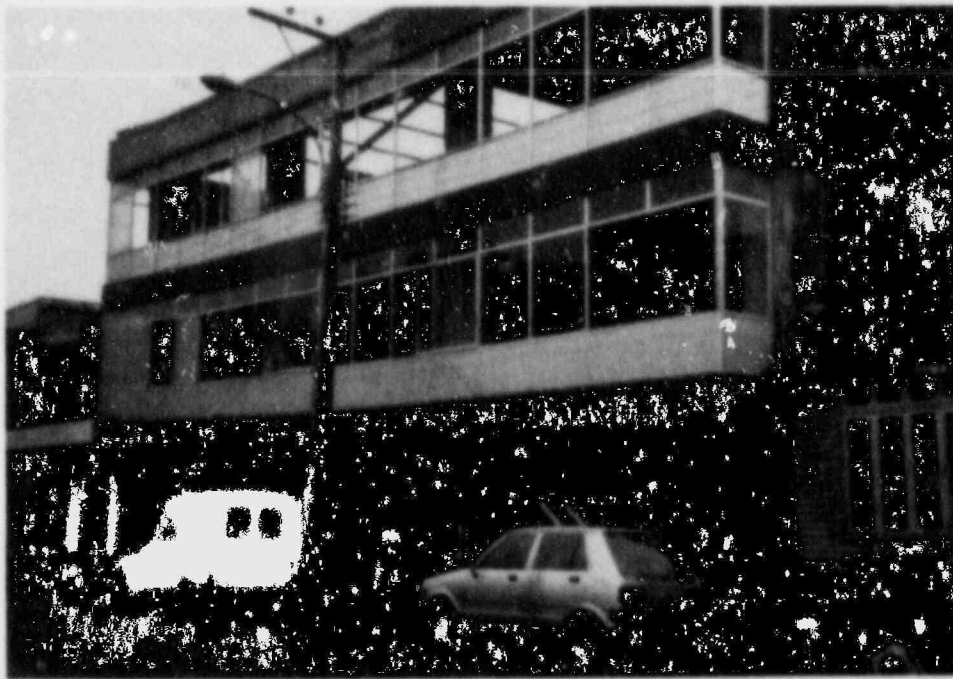
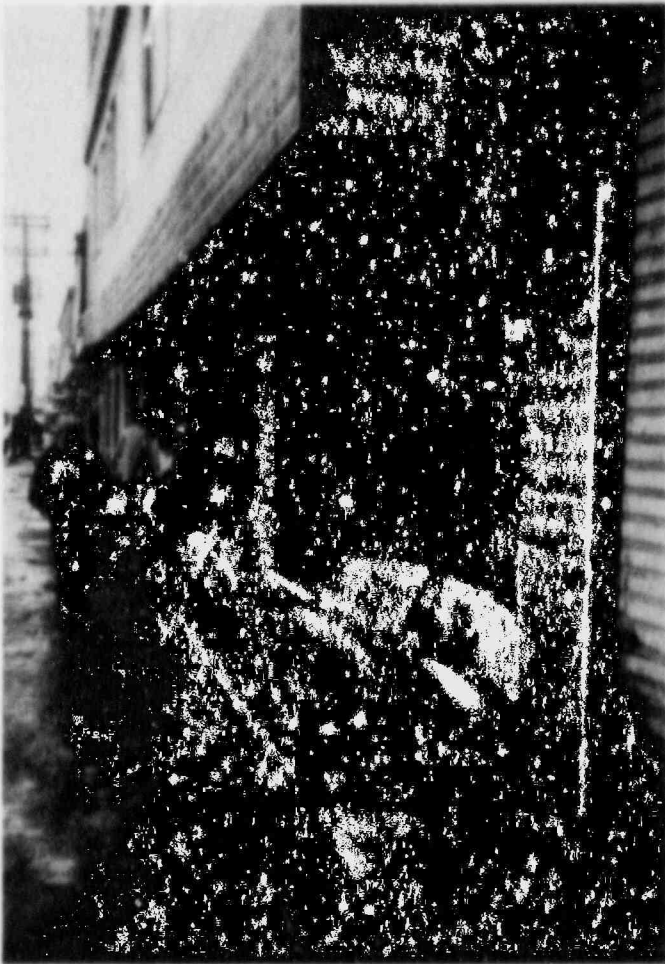
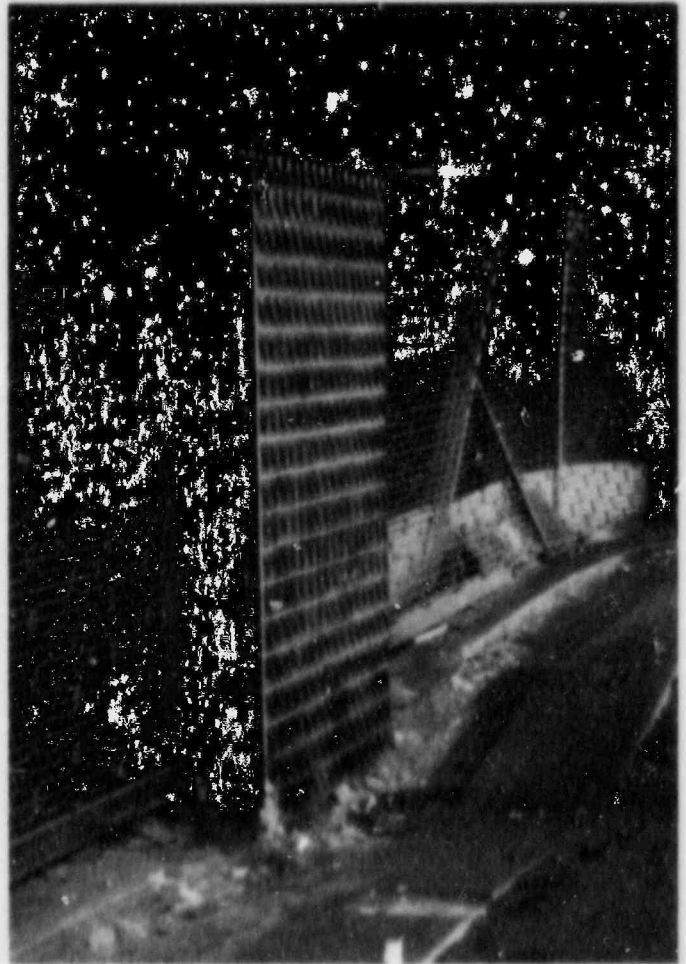
Just north of the port of San Antonio there was a spectacular soil failure beneath some storage tanks (top photograph). Large ground cracks 4 to 5 feet deep and 1 foot wide opened all around the tanks and cracks were observed as far as 20 feet from the tanks. In the port of Valparaiso, large vertical settlements and lateral spreading of soils were observed. The lateral spreading prevented the use of cranes for unloading ships.

The three-story concrete building looks undamaged from a distance. However, the columns for the building experienced differential settlement of approximately 1 foot. The building was abandoned and will most likely be demolished.

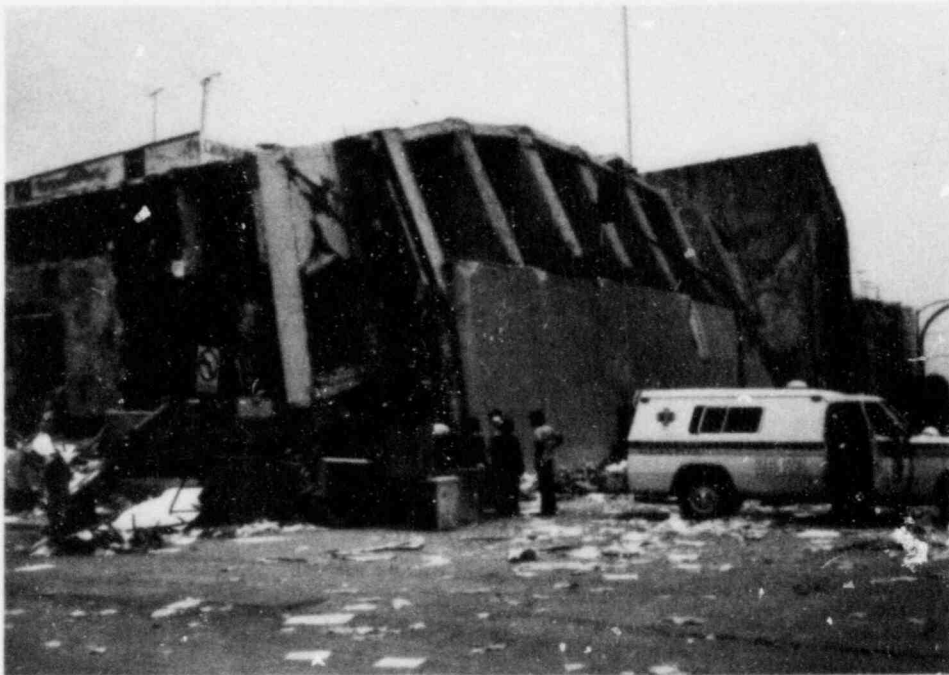
Mexico City. Building damage was mostly to concrete frame structures with masonry infills. These buildings either collapsed or were damaged so heavily that they will have to be torn down. The failure modes included pancaking, toppling, and pounding. Pounding damage was due to the flexibility of these framed structures.

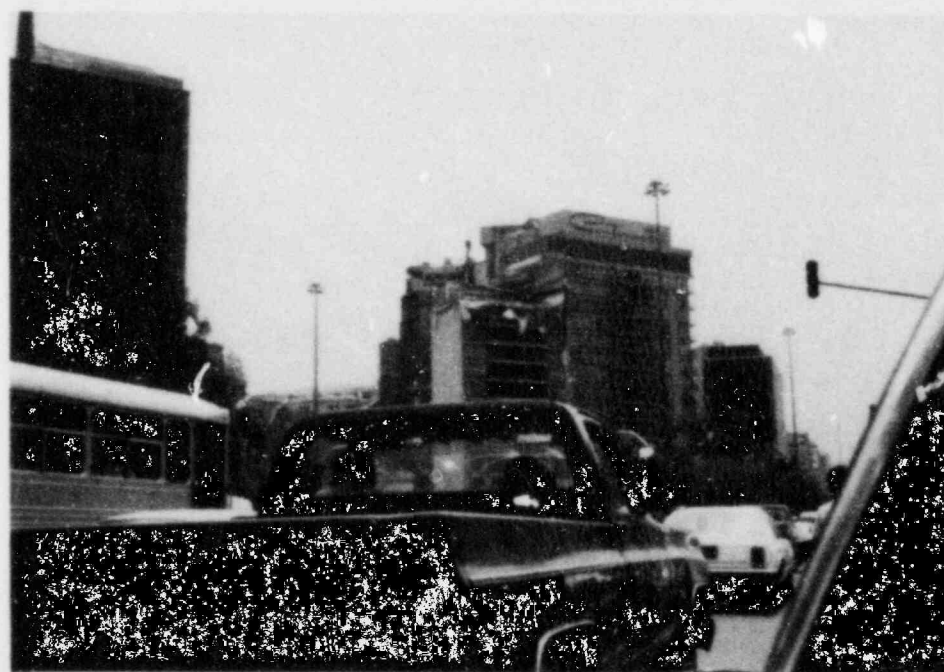
Mexico City. Several hotels in the Zona Rosa district (near the downtown area) suffered major damage or collapsed. The Regis Hotel collapsed and burned, trapping many guests in the rubble. The top floor of the Hyatt Continental's east wing pancaked.

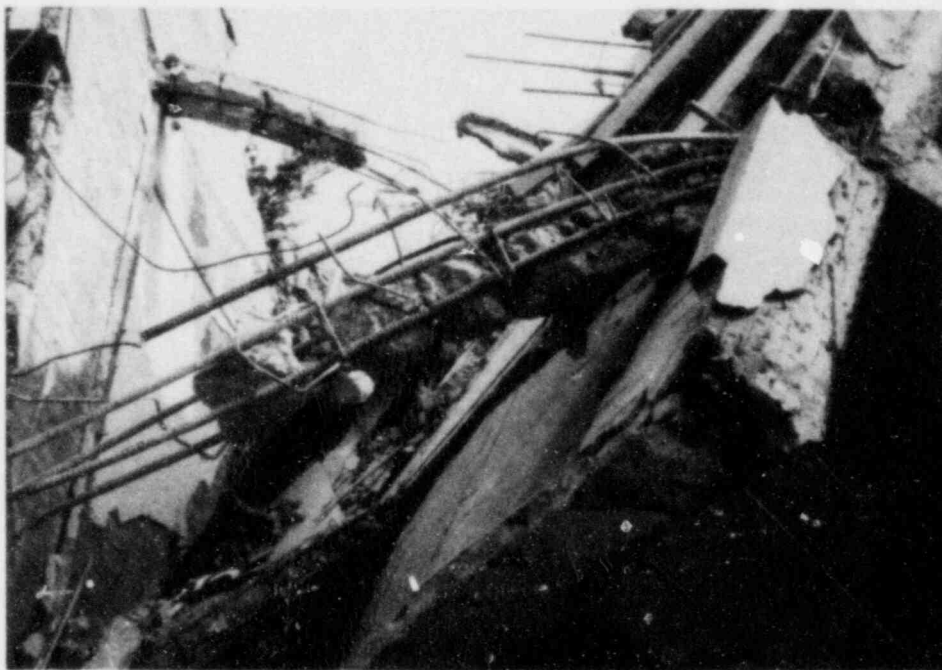
Mexico City. Soil failure occurred beneath some of the damaged buildings on the ancient lake bed. This building toppled and pulled up the foundation and piles. The exposed steel reinforcing bars and spalled concrete of the damaged column illustrate the nonductile design of the building.

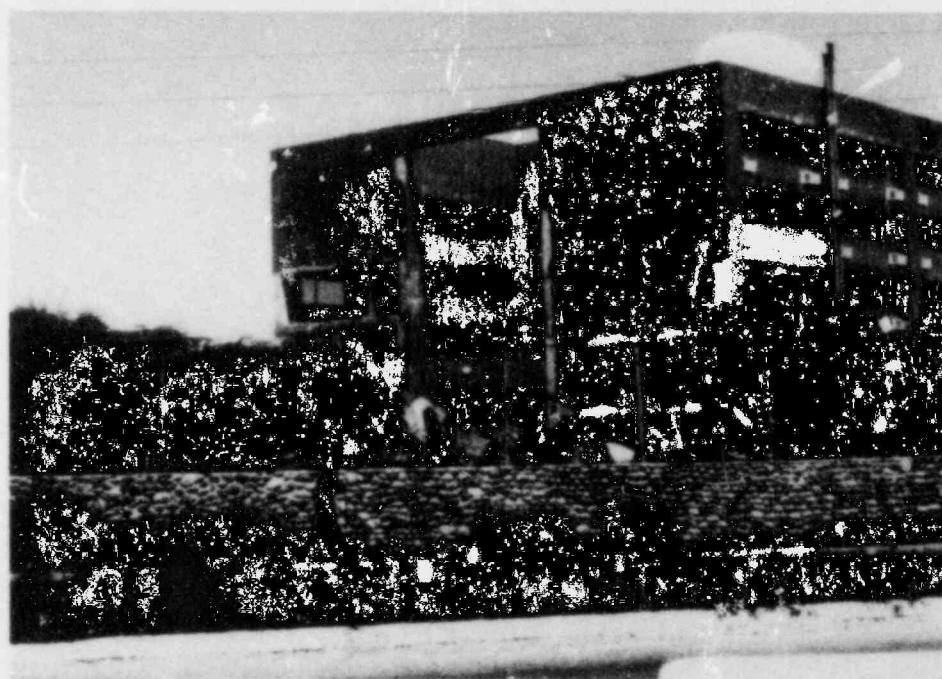
**Lazaro Cardenas.** This is one of the more developed towns in the epicentral region. Damage was extensive throughout the town and could be seen in about one of every four structures. The top photograph shows severe cracking in the discontinuous shear walls between virtually all the front balconies. The minimal reinforcement in these walls probably prevented collapse of this structure. In the bottom photograph, a complete section of an unreinforced masonry curtain wall fell.

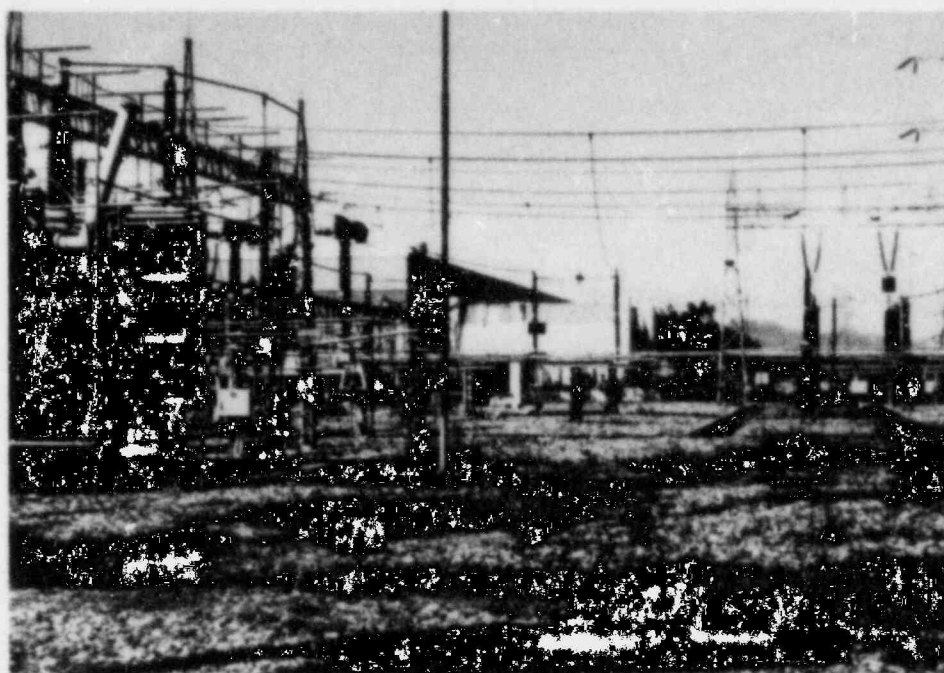
SICARTSA Steel Mill. The top photograph shows the switchyard where a disconnect switch similar to the one seen near the center of the photograph fell due to a cracked ceramic insulator. A transformer similar to the one at the left also suffered a cracked oil seal. The lower photograph shows a pipe support structure with a large structural steel building in the background. Both are representative of the types of components located at this plant, all of which performed well during the earthquake. A concrete frame administration building had severe damage to masonry panels and was evacuated.

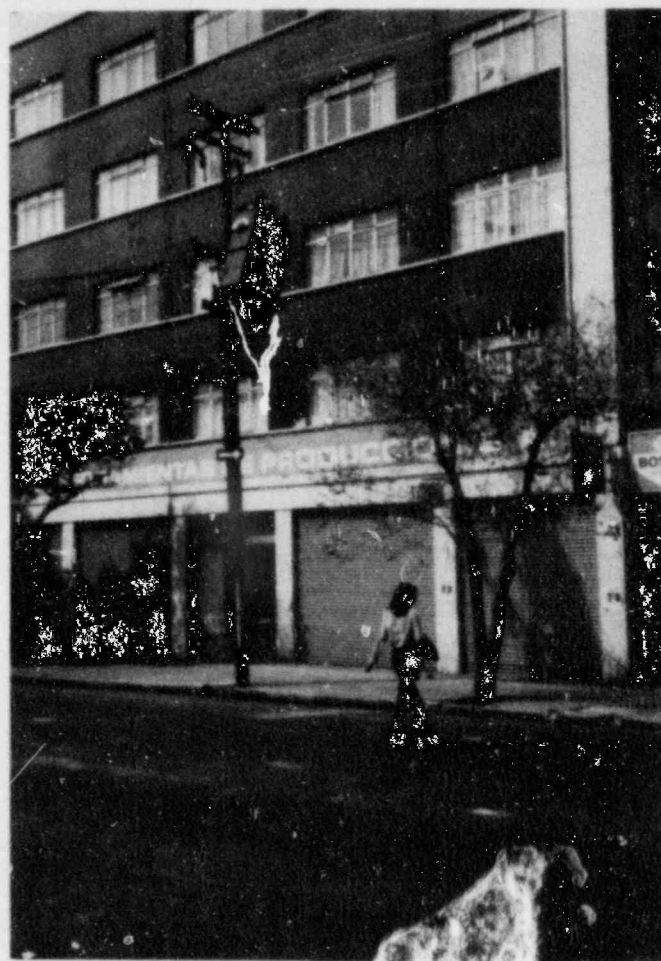
Mexico City. The upper photograph shows two buildings that were damaged from fire originating from ruptured gas lines. These buildings were adjacent to the collapsed Regis Hotel. Collapsed buildings damaged many main power lines and underground cables. In the lower photograph, a pole mounted transformer has damaged supports.
