Our Ref: QCG-10389

Subject: 10 CFR 21 Notification, Cooper-Bessemer  
KSV Emergency Diesel Generator Power Piston Failure

ATTACHMENT TO QCG-10389

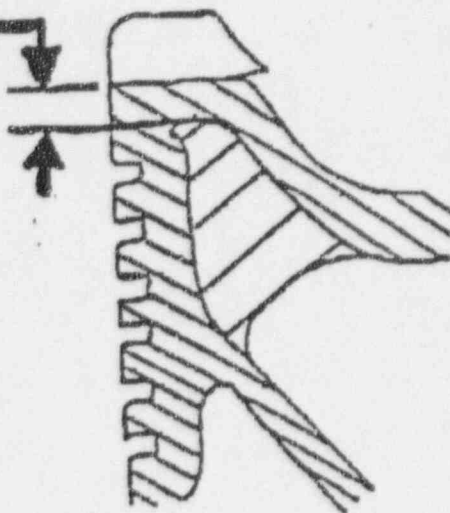
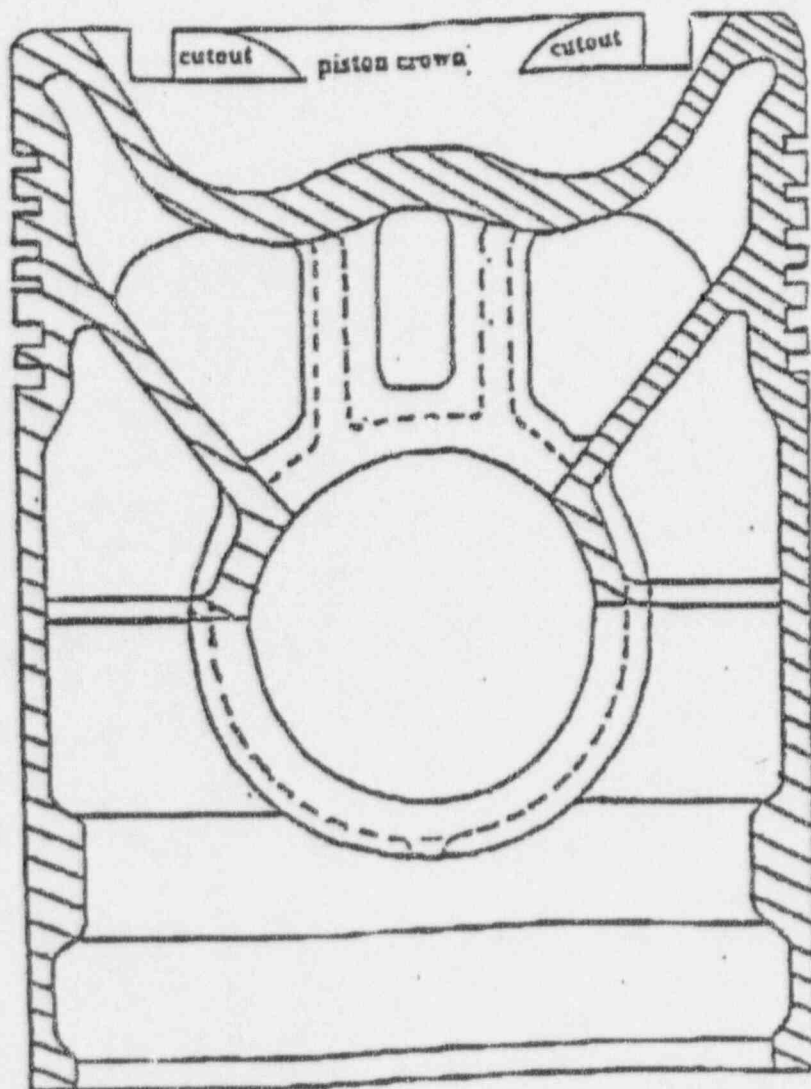
The potential defect concerns the thickness of the piston crown in the valve cutout area (see attachment) that provides clearance for the intake and exhaust valves. The nominal design thickness for this area is .438. The failed piston at CECo had an area that tapered down to a minimum thickness of .040.

Finite Element Analysis performed by CES subsequent to the failure has indicated an acceptable minimum thickness in the valve cutout area of .100. The analysis also indicated that a .040 thick piston should not fail in normal operation, but the factor of safety is below normally accepted values. Examination of pistons in CES stores noted many in the .25-.31 range and one as low as .070.

The root cause of the deficient condition was an incorrect foundry pattern.

Minimum crown  
thickness is measured  
in cutouts

Using Ultrasonic or similar measuring equipment, the crown thickness at the valve cutout should be verified to be .100 minimum. For pistons currently installed in engines this can be done during normal maintenance activities when the pistons become accessible. Immediate verification is not considered necessary based on the following:

Users with spare pistons in stores should verify the subject thickness prior to installation.
