This forwards a copy of a letter from Promatec, dated February 17, 1986, for your information. This letter was a 10 CFR Part 21 report concerning defective material used in fire stops and may be applicable to the installations in your facility.

Reference: 10 CFR Part 21 - Notification of Defects

Pursuant to the provisions of 10 CFR Part 21 - Reporting of Defects and Non-compliance, notification is hereby given of the existence of defective conduit seals at Waterford 3 and other nuclear generating stations as identified herein. Final information leading to this report was obtained on February 13, 1986 at 12:00 p.m. and verbal notification as required by § 21.21 (2) was given on February 14, 1986 at 8:36 p.m. to Mr. David Powell, U.S. Nuclear Regulatory Commission, Washington, D.C.

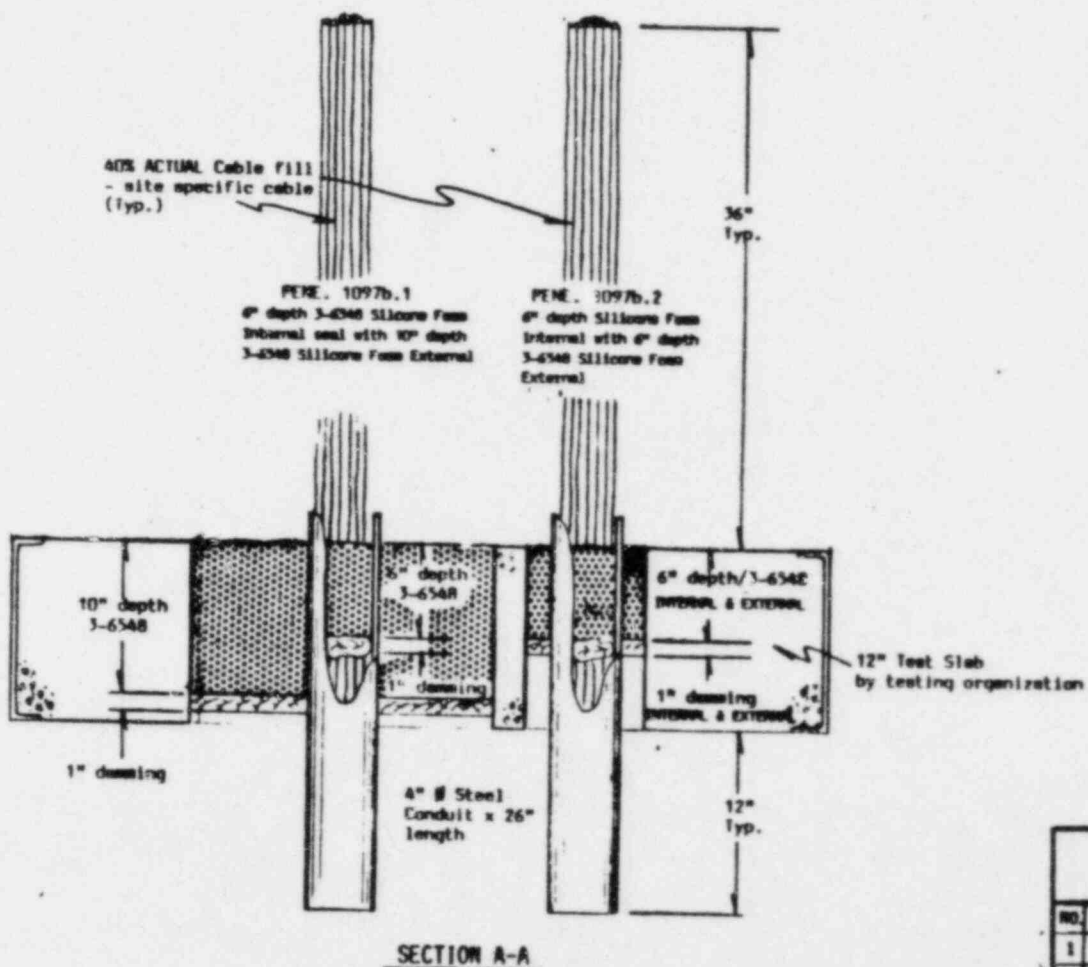
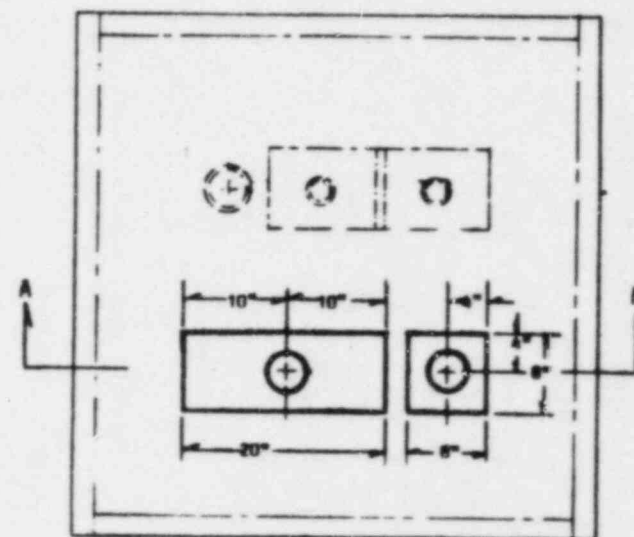
NO.	DATE	BY	NO.	DATE	BY	DESIGNED BY	DRAWN BY	DATE
1			1			LCS	RTS	01/13/86
2			2					
3			3					
4			4					
5			5					
						CTP 1097b CONDUIT TEST TEST LAYOUT AND DETAILS B-519

One 8" x 8" blockout and one 8" x 20" blockout in a 12" thick concrete slab with two (2) conduit penetrators as described below and detailed on drawing no. B-519 (attachment 1).

2.2.1 Configuration 1097b.1 - Conduit seal with a minimum depth of 6" plus 1" damming as measured from the top of the slab; penetration seal with a minimum depth of 10" plus 1" damming as measured from the top of the slab.

2.2.2 Configuration 1097b.2 - Conduit seal with a minimum depth of 6" plus 1" of damming as measured from the top of the slab; penetration seal with a 6" depth plus 1" of damming as measured from the top of the slab.

- 3.3 While no flame through was noted on the unexposed side and hose stream tests did not cause openings, heat transmission as indicated by the field thermocouples exceeded the maximum temperature requirement of 325° F above ambient. An autopsy was performed and resulted in the discovery that both conduit seals were reduced to ash.

- (3) Other tests were conducted satisfactorily to provide potential corrective actions that may be taken for those seals determined to be unacceptable for the operability time periods previously referenced. Possible corrective action measure include:
- (a) Evaluation of affected conduit seals to determine if exception can be taken to the required three (3) hour rating.
 - (b) Rework of conduit seals that can not be excepted from a three (3) hour rating by installing:
 - (1) Installing a 3" depth silicone RTV foam seal boxed off with 1" alumina silica board at the conduit termination point (attachment 3). This would also require the installation of an additional 6" depth seal at the nearest accessible point on the continuous run side of the conduit.
 - (2) Installing an additional 6" depth conduit seal at the nearest accessible point on the continuous run side of the conduit.

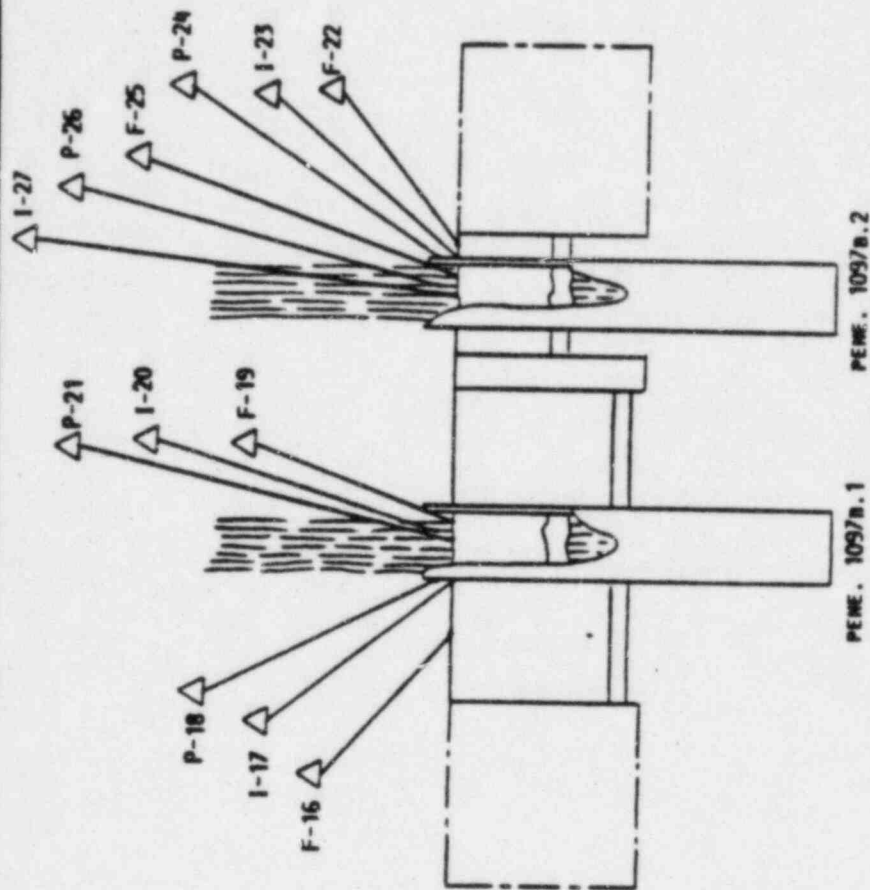
PROSSMATIC			
CTP 1097/n CONDUIT TEST					
THERMOCOUPLE PLACEMENT					
DRAWN BY LCS	CHECKED BY HTS	DATE 1/13/96	SCALE 1" = 1'	REVISION NO. B-520	DRAWING NO. B-520

- 3.1 Thermocouples were located in accordance with the requirements of IEEE 634 and ASTM E119 as shown on drawing no. B-520 (attachment 2).
 - 3.2 The prepared test slab assembly was exposed to the standard time temperature curve established by ASTM E119 for a period of three (3) hours with the following results:

- 3.2.1 Configuration 1097b.2 - Thermocouple F-19 exceeded the maximum allowable with a temperature of 401° F at 1 hour, 23 minutes and a three (3) hour reading of 659° F.

- 3.2.2 Configuration 1097b.1 - Thermocouple F-25 exceeded the maximum allowable with a temperature of 401° F at 2 hours, 14 minutes and a three (3) hour reading of 446° F.
