Nuclear Safety Information Center

REVIEW OF THE OPERATING EXPERIENCE HISTORY
OF OYSTER CREEK THROUGH 1981 FOR THE
NUCLEAR REGULATORY COMMISSION'S
SYSTEMATIC EVALUATION PROGRAM

July, 1982

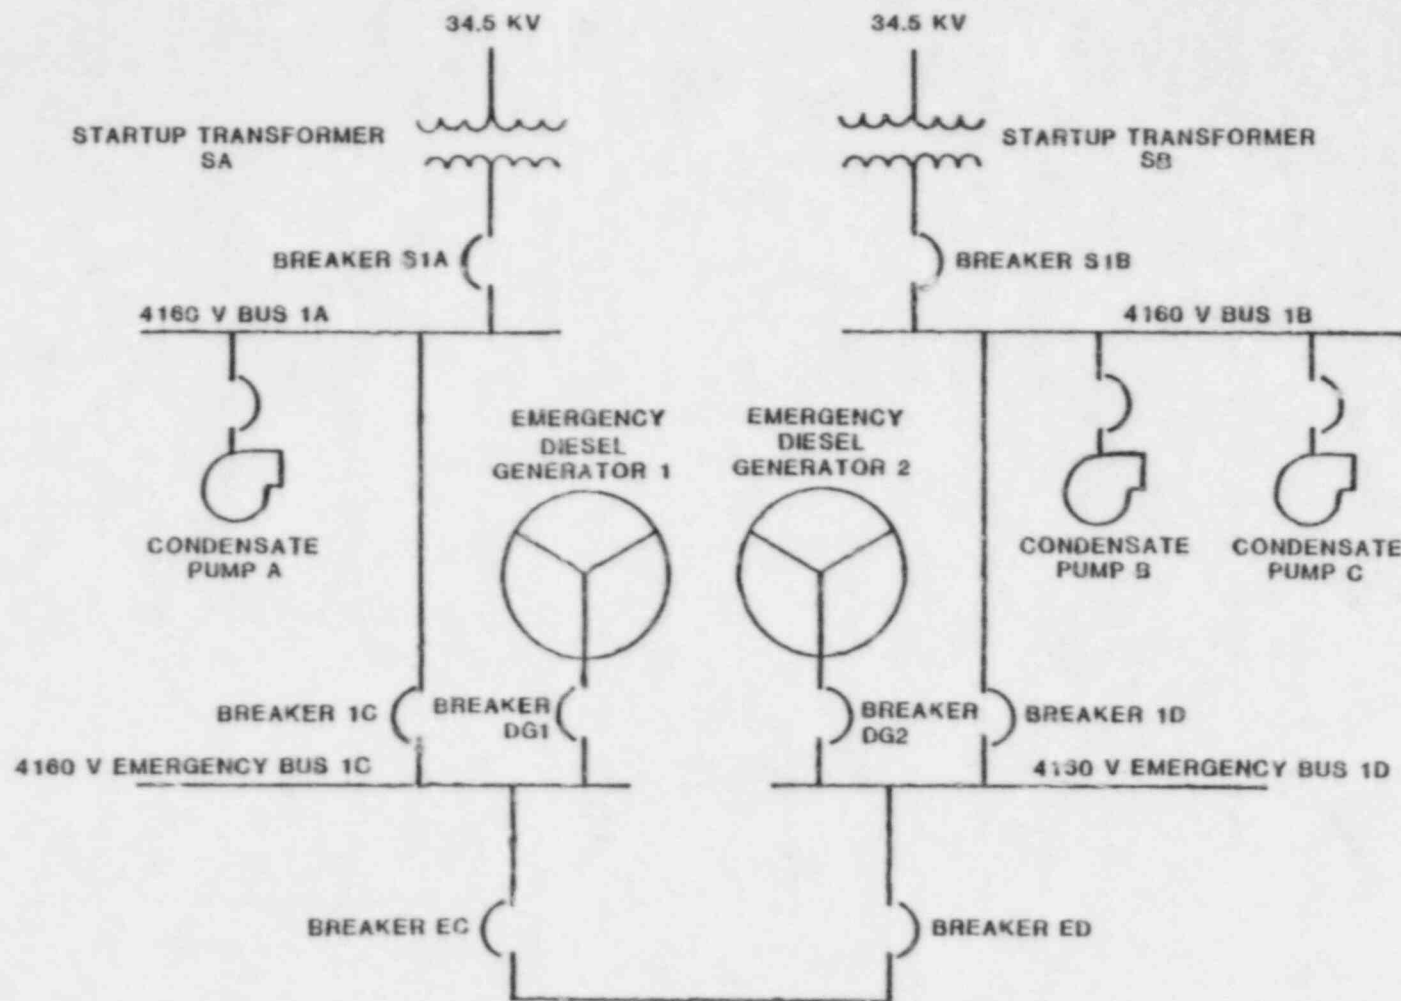
Figure 4.2 Simplified Electric Power System Diagram

4.5.2.5 Loss of onsite power sources coincident with loss of offsite power sources. During a plant shutdown on September 8, 1973, a design error prevented the startup of both diesel generators while offsite power was unavailable to their respective safety buses. An operator was attempting to transfer station loads to the startup transformers (Fig. 4.2). When a closing signal was applied to the S1A breaker, a loss of power occurred on 4160 V ac bus 1A, tripping one of two 4160V emergency buses (emergency bus 1C), two circulating water pumps, three reactor recirculation pumps, and the operating condensate and feedwater pumps. A fast start was initiated on diesel generator (DG) 1 and power restored to bus 1C and the safety systems which it powers. The reactor scrambled due to low water level.

Following the scram, startup transformer SB powered bus 1B. Breaker S1A was then successfully closed and DG 1 secured. The operator attempted to start the 'A' condensate pump, but the inrush current tripped the S1A

breaker for a second time. At this point, the design problem with the diesel generators appeared. DG 1 failed to start because the engine lock-out relay had been actuated. Emergency bus 1C was totally without power. An attempt was made to start the 'B' and 'C' condensate pumps, tripping the S1B breaker and deenergizing emergency bus 1D. A fast start was initiated on DG 2.

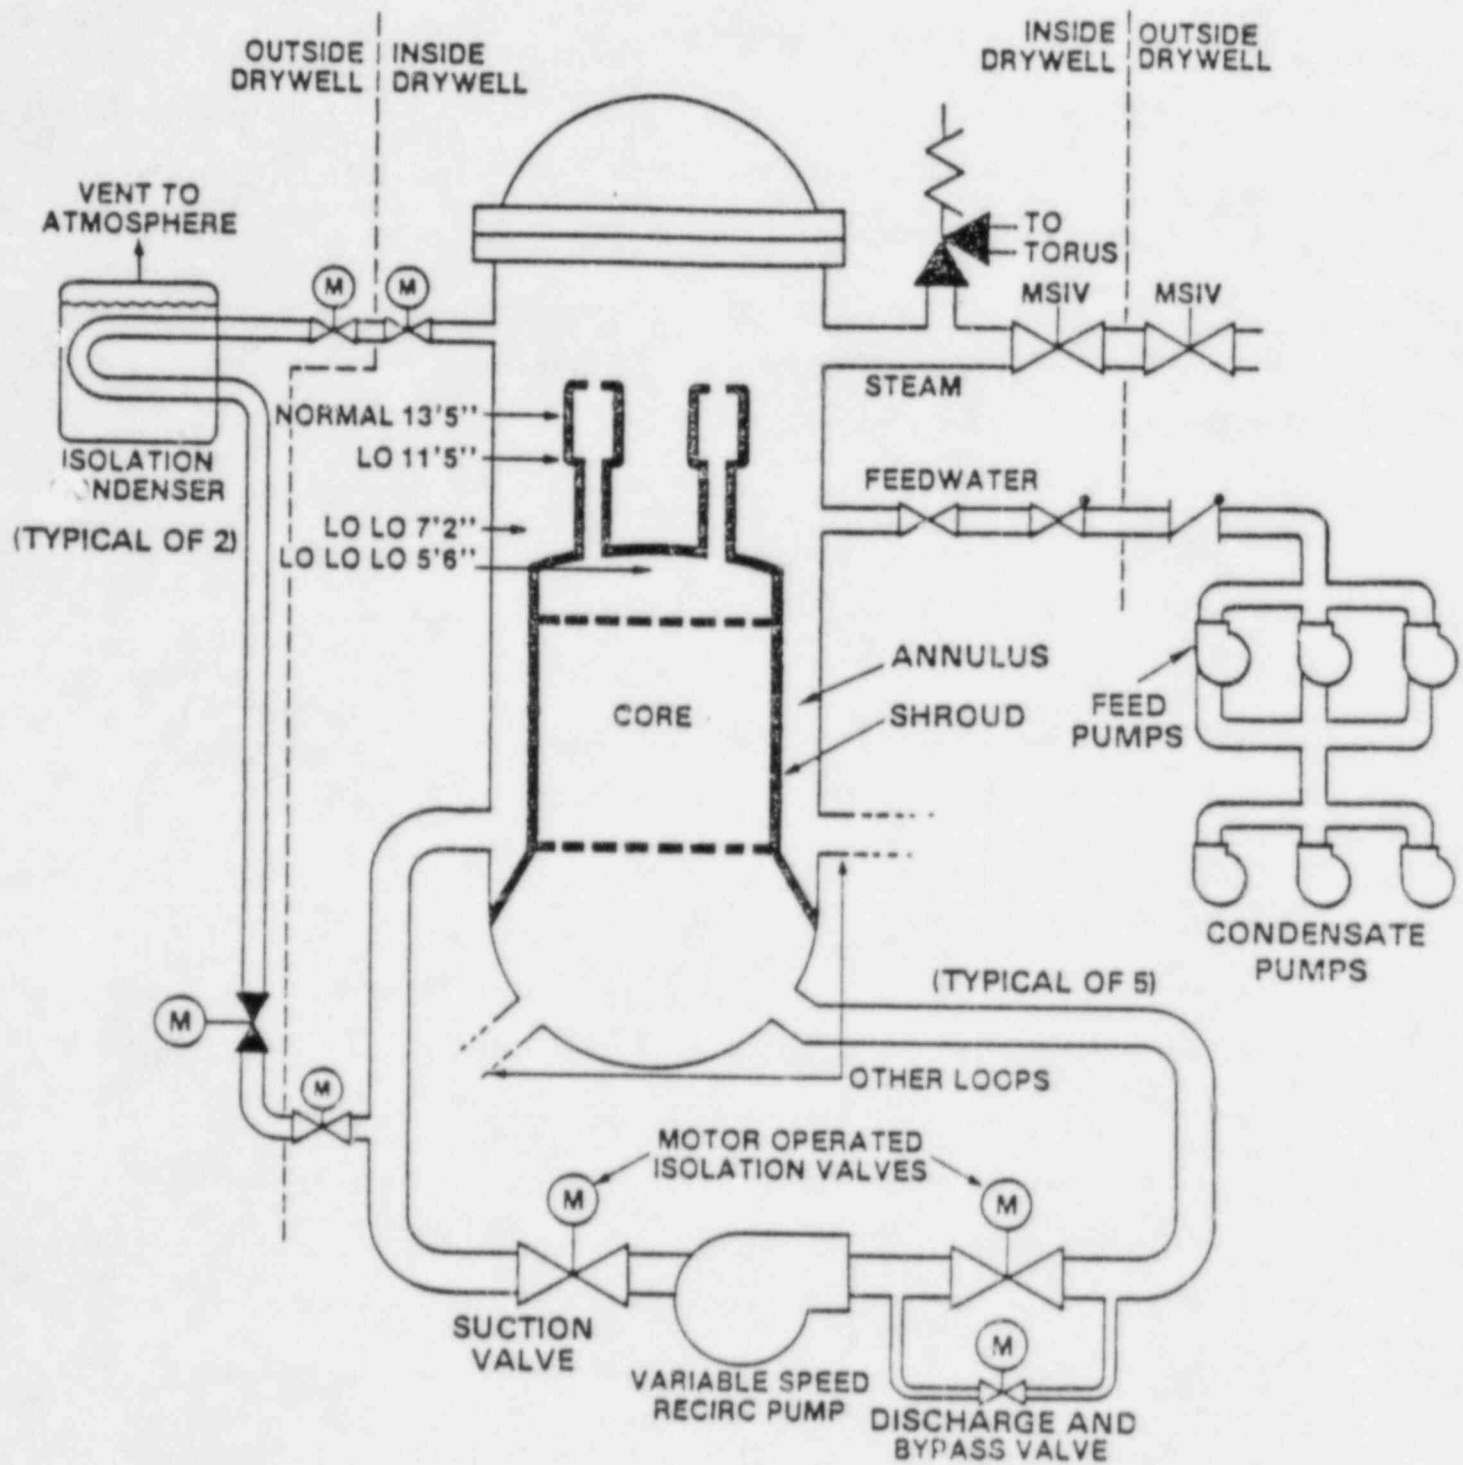
Figure 4.3 Recirculation, Steam, and Isolation Condenser Schematic³⁷

Following the standing order, the operator closed the 'A' and 'E' recirculation loop discharge valves. He then closed the 'B' and 'C' discharge valves in preparing to attempt a restart of one or both of their associated recirculation pumps. As previously mentioned, loop 'D' was out of service. Therefore, all five loop discharge valves were closed. All five two-inch discharge valve bypass lines were open. Flow through these and flow from two control rod drive pumps which the operator had started were the only sources of flow available to the reactor. At a point 172 seconds into the event, the triple low water level in the reactor was reached.

By intermittent manual operation of the isolation condensers, the operator was able to remove heat from the system. Recirculation pump 'C'

was started about half an hour into the transient, but it was tripped and the discharge valve reclosed when the water in the annulus was observed to drop rapidly. A feedwater pump was successfully started about five minutes later. The annulus water level began to rise, and two minutes later a recirculation pump was placed in service. The triple low water level in the core region was cleared and the reactor brought to a cold shutdown.
