VERMONT YANKEE NUCLEAR POWER CORPORATION

Subject: IE Information Notice 86-13

IE INFORMATION NOTICE NO. 86-13: STANDBY LIQUID CONTROL SYSTEM SQUIB VALVES
FAILURE TO FIRE

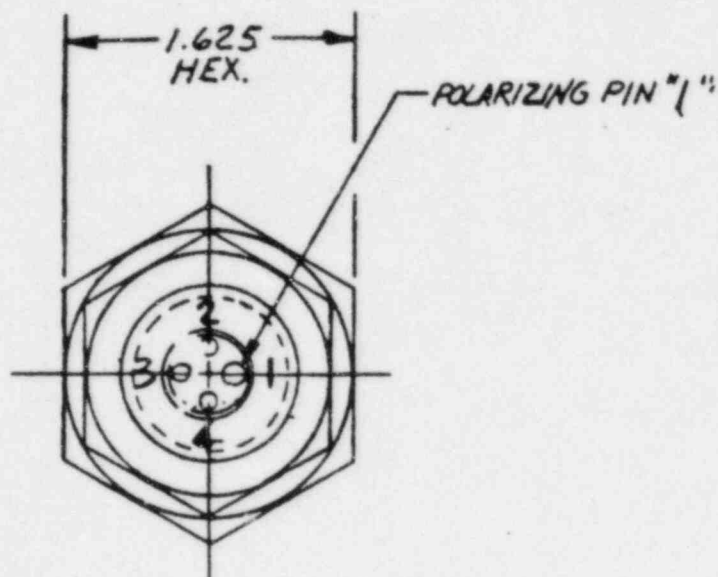
WIRING DIAGRAMS

The explosive primer charge assembly for the SLCS at Vermont Yankee was supplied by Conax Corporation. The explosive primer charge assembly has two sets of resistance wires, i.e., bridgewires, internal to the charge either of which will fire the explosive. However, some of the charges were manufactured with incorrect pin-to-bridgewire groupings so that when connected at Vermont Yankee, two high-side leads were connected to one bridgewire set and two neutral leads were connected to the other bridgewire set internal to the explosive primer. Examination of spare squibs at Vermont Yankee identified four others with incorrect pin-to-bridgewire groupings.

though the pin-to-bridgewire connection was incorrect. (See Attachment 1.) In addition, at Vermont Yankee the control room indication of SLCS circuit status indicated circuit continuity due to the presence of a sneak curcuit.

CORRECT
PIN-TO-BRIDGEWIRE
CONNECTION

INCORRECT
PIN-TO-BRIDGEWIRE
CONNECTION

The explosive primer charge assembly may be tested for correct pin-to-bridgewire grouping with an ohmmeter that is current limited to no more than 10 millamperes. Larger currents will cause the charge to explode.
