RADIOLOGIC AND ENGINEERING ASSESSMENT

DOE ID NO.: GJ-03783-RS
ADDRESS: 2030 ELM AVENUE

JUNE 1985

BENDIX FIELD ENGINEERING CORPORATION
P.O. Box 1569
Grand Junction, Colorado 81502

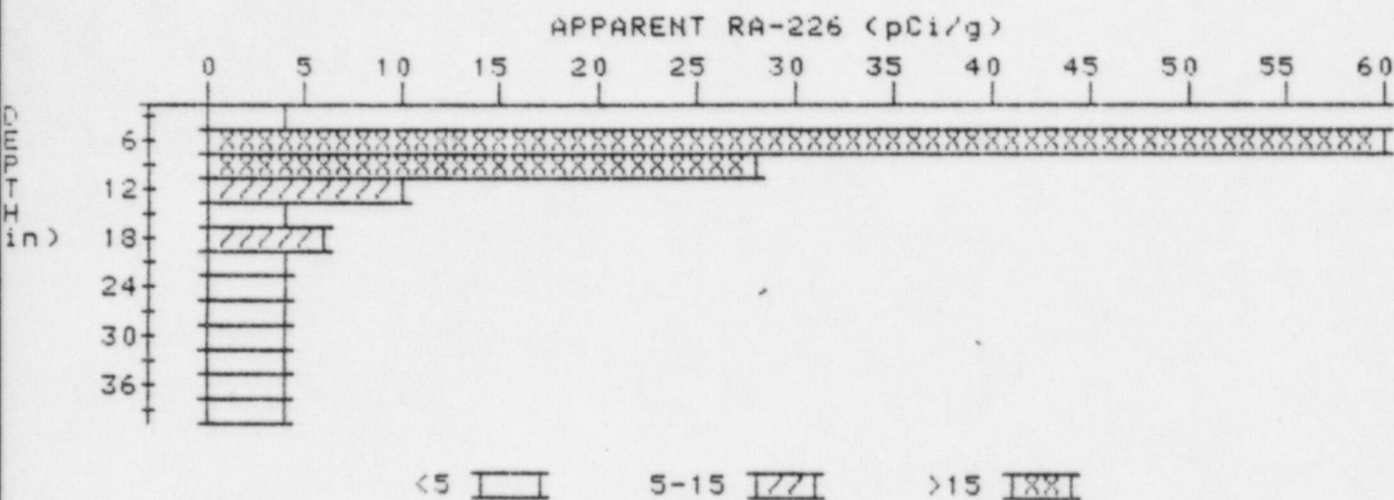
5

Depth (in)	Apparent Radium-226 (pCi/g) Undeconvolved	Apparent Radium-226 (pCi/g) Deconvolved
3	40.4	40.4
6	51.7	102.9
9	34.2	28.0
12	20.2	10.1
15	11.9	3.5
18	8.3	5.6
21	6.2	4.2
24	5.2	4.3
27	4.7	4.3
30	4.4	4.2
33	4.2	3.8
36	4.2	4.4
39	4.1	4.1

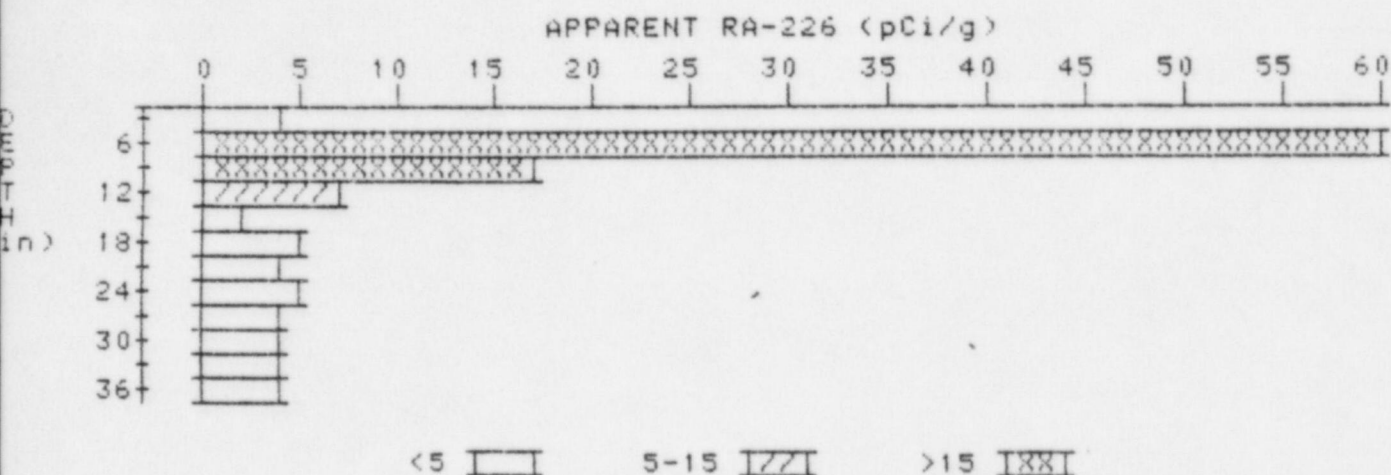
APPARENT RADIUM-226 CONCENTRATION 13 DECONVOLUTION GRAPH

Depth (in)	Apparent Radium-226 (pCi/g) Undeconvolved	Apparent Radium-226 (pCi/g) Deconvolved
3	37.1	37.1
6	43.0	82.5
9	26.7	17.5
12	15.6	7.4
15	9.1	1.8
18	6.7	4.6
21	5.5	4.4
24	4.9	4.7
27	4.4	3.7
30	4.3	4.3
33	4.2	3.8
36	4.3	4.3
