RADIOLOGIC AND ENGINEERING ASSESSMENT

DOE ID NO.: GJ-11586-RS
ADDRESS: 2005 ELM AVENUE

JUNE 1985

BENDIX FIELD ENGINEERING CORPORATION
P.O. Box 1569
Grand Junction, Colorado 81502

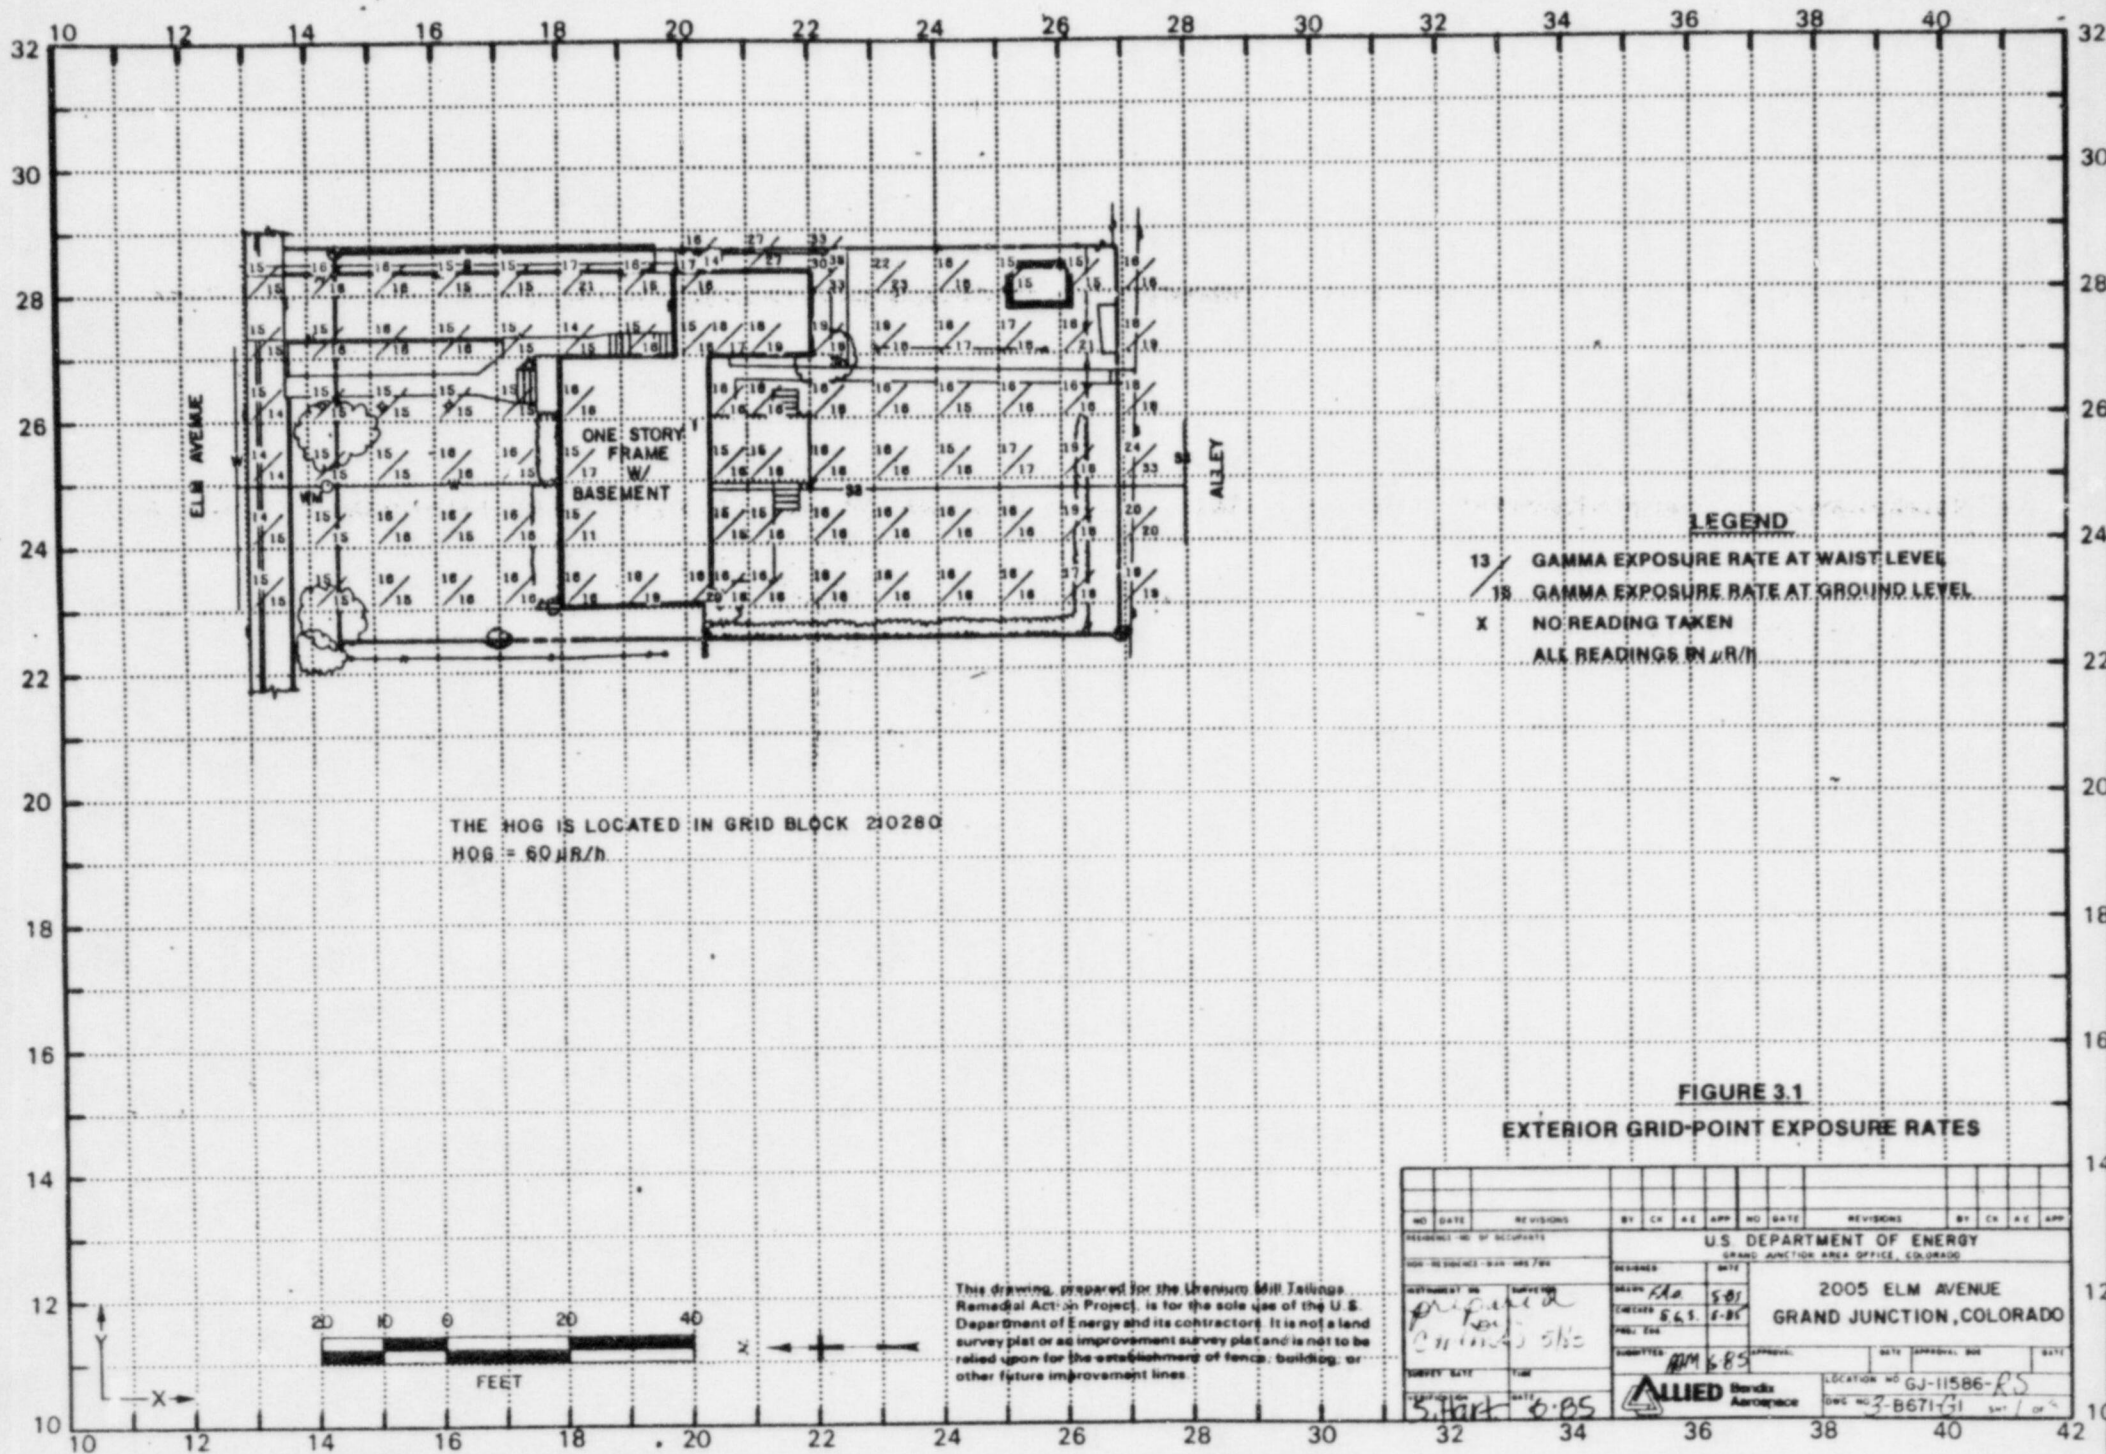
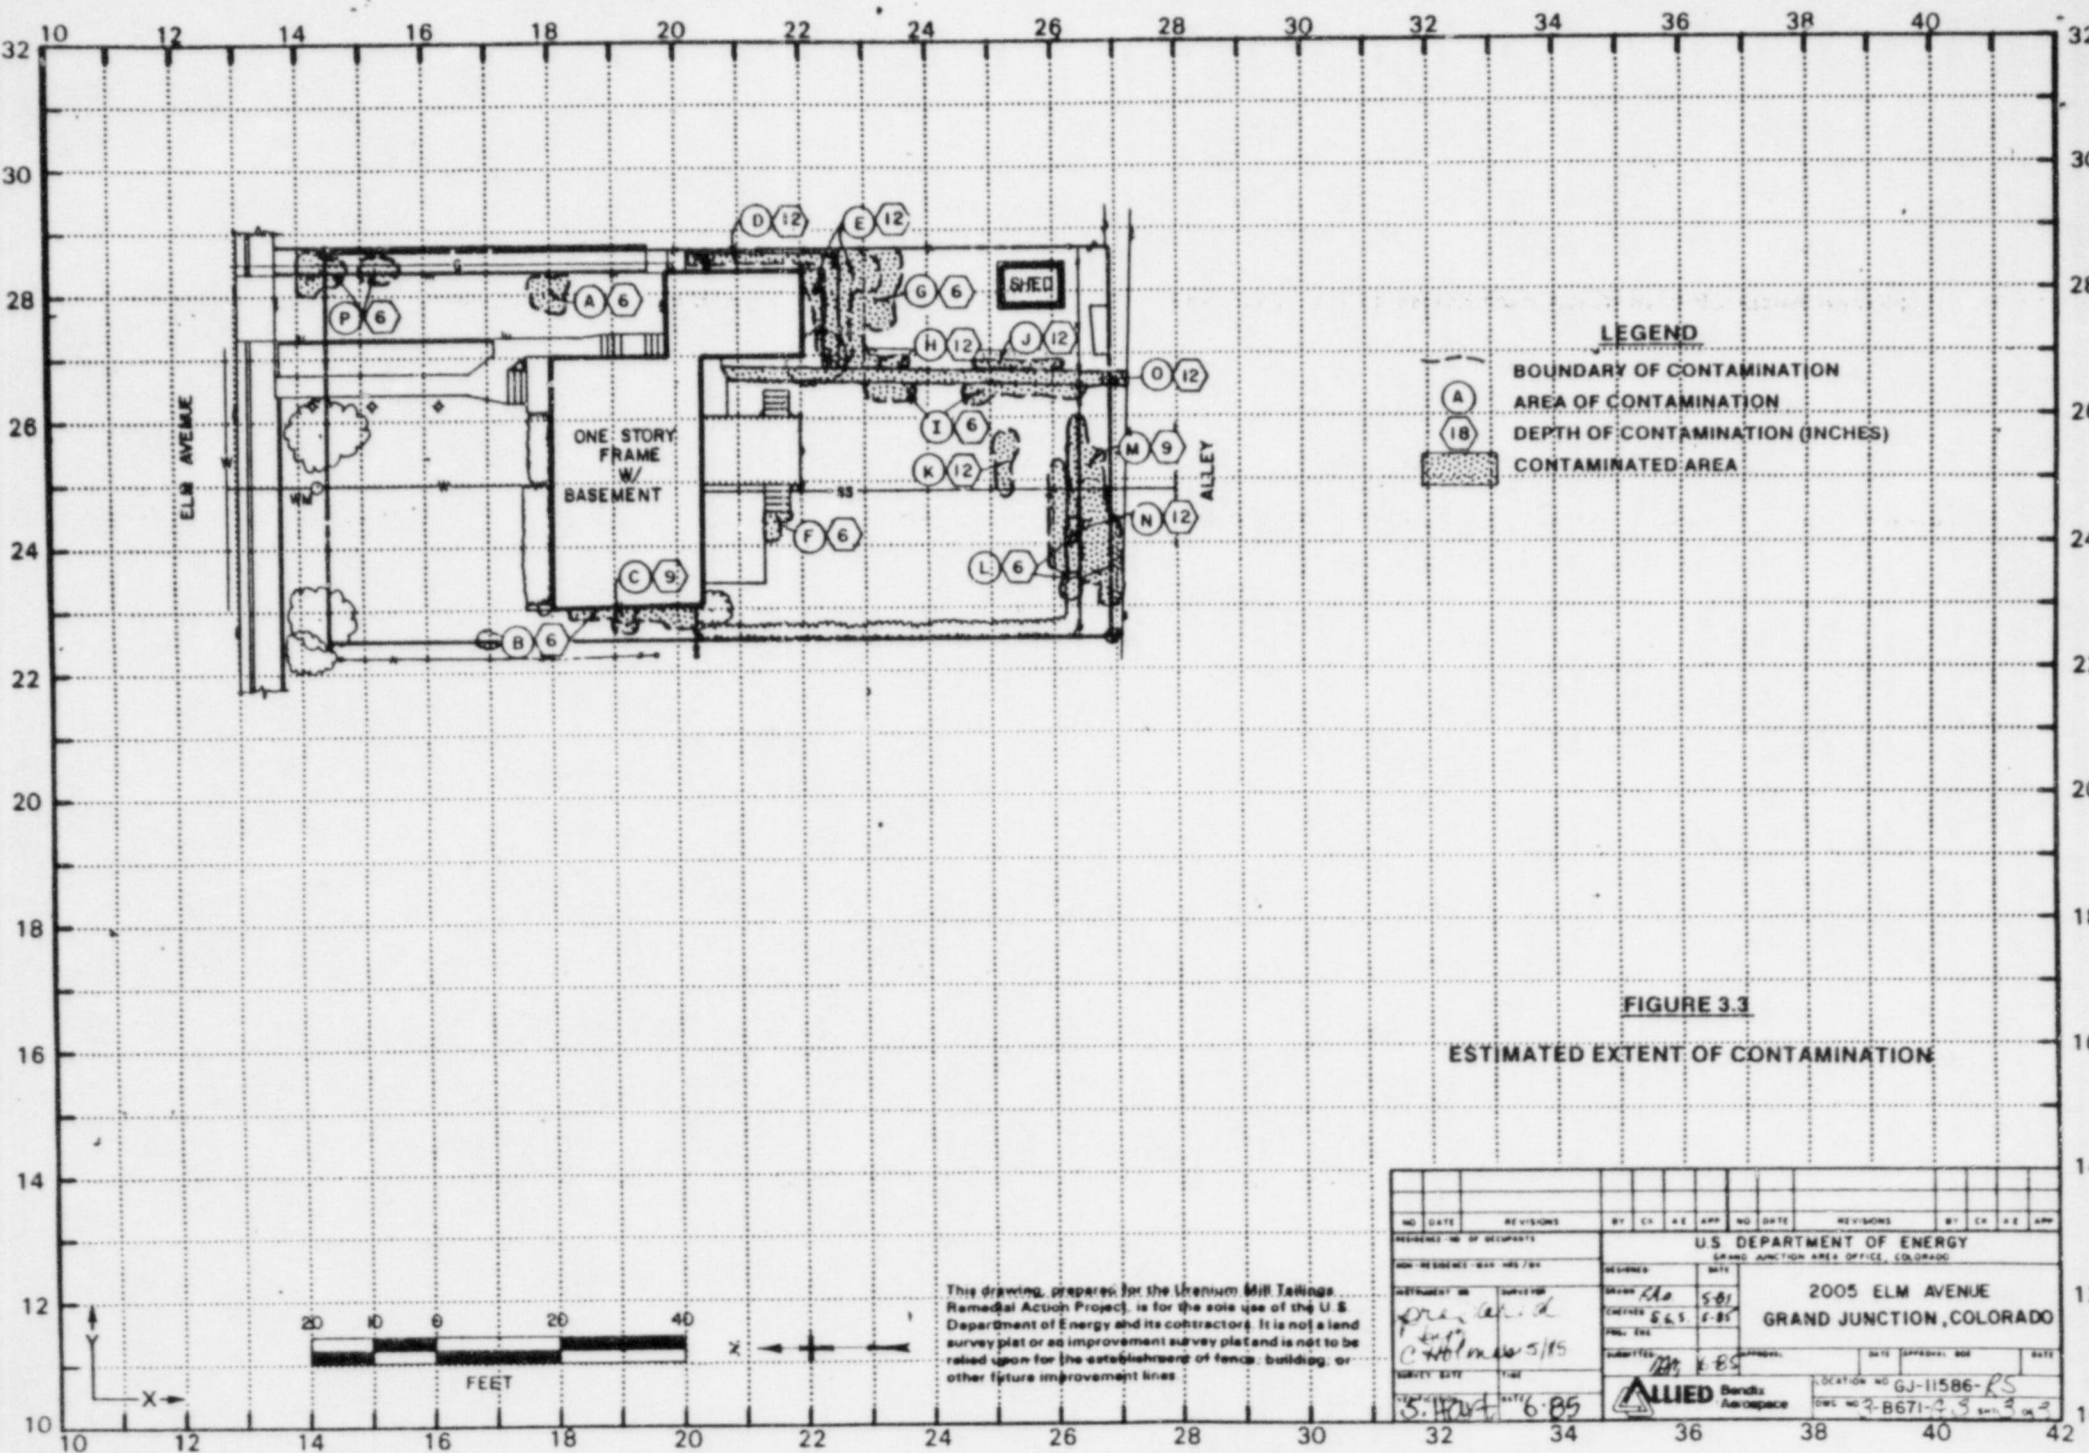
FIGURE 3.3

Appendix Figure 3.3 shows identified areas and estimated depths of contamination on this property, based on assessments of all measurements taken. As noted in this figure, areas recommended for remedial action that contain identified residual radioactive materials are:

- (AREA A) A deposit beneath the asphalt driveway northeast of the primary structure is contaminated to a total depth of 6 inches (approximately 49 sf).

- (AREA B) The lawn west of the primary structure is contaminated to a 6-inch depth (approximately 68 sf).
- (AREA C) A portion of the lawn west of the primary structure is contaminated to a depth of 9 inches (approximately 12 sf).

- (AREA D) A brick walk that surrounds the east and south sides of garage is contaminated to a depth of 12 inches (approximately 120 sf).
- (AREA E) Soil on either sides of the brick walk is contaminated to a depth of 12 inches (approximately 113 sf).

- (AREA F) A deposit at the base of the deck stairs, south of the of the primary structure, is contaminated to a 6-inch depth (approximately 16 sf).
- (AREA G) Directly south of the garage there is a deposit which extends to a 6-inch depth (approximately 100 sf).

- (AREA H) A deposit east of the concrete sidewalk, which is south of the primary structure, extends to a depth of 12 inches (approximately 10 sf).
- (AREA I) Two deposits, west of the concrete sidewalk, are contaminated to a depth of 6 inches (approximately 84 sf).

- (AREA J) South of the primary structure, along the east side of the sidewalk, there is a contaminated deposit that extends to a 12-inch depth (approximately 28 sf).

- (AREA K) A deposit in the south yard is contaminated to a 12-inch depth (approximately 40 sf).
- (AREA L) A contaminated deposit in the south yard, southwest of Area K, extends to a depth of 6 inches (approximately 153 sf).

- (AREA M) A deposit on both sides of the south fence is contaminated to a depth of 9 inches (approximately 140 sf).
- (AREA N) A contaminated deposit north of the south fence extends to a depth of 12 inches (approximately 15 sf).
- (AREA O) The uncontaminated 2-inch-thick concrete sidewalk, south of the primary structure, is underlain with contamination to a depth of 10 inches. The total depth of contamination is 12 inches (approximately 130 sf).
- (AREA P) A deposit beneath the asphalt driveway northeast of the primary structure is contaminated to a depth of 6 inches, based on data collected in Area A (approximately 76 sf).

The recommended remedial action for this property, DOE ID No. GJ-11586-RS, includes removal of all areas identified as containing radioactive material (as discussed in Section 3.5 and shown in Appendix Figure 3.3) and transport of removed material to the disposal site.

After remedial action is completed, the areas involved will be restored to original condition in accordance with the Bendix drawings, Vicinity Properties General Construction Specification (Bendix Field Engineering Corporation, 1984), and Statement of Work for Construction Subcontractor.

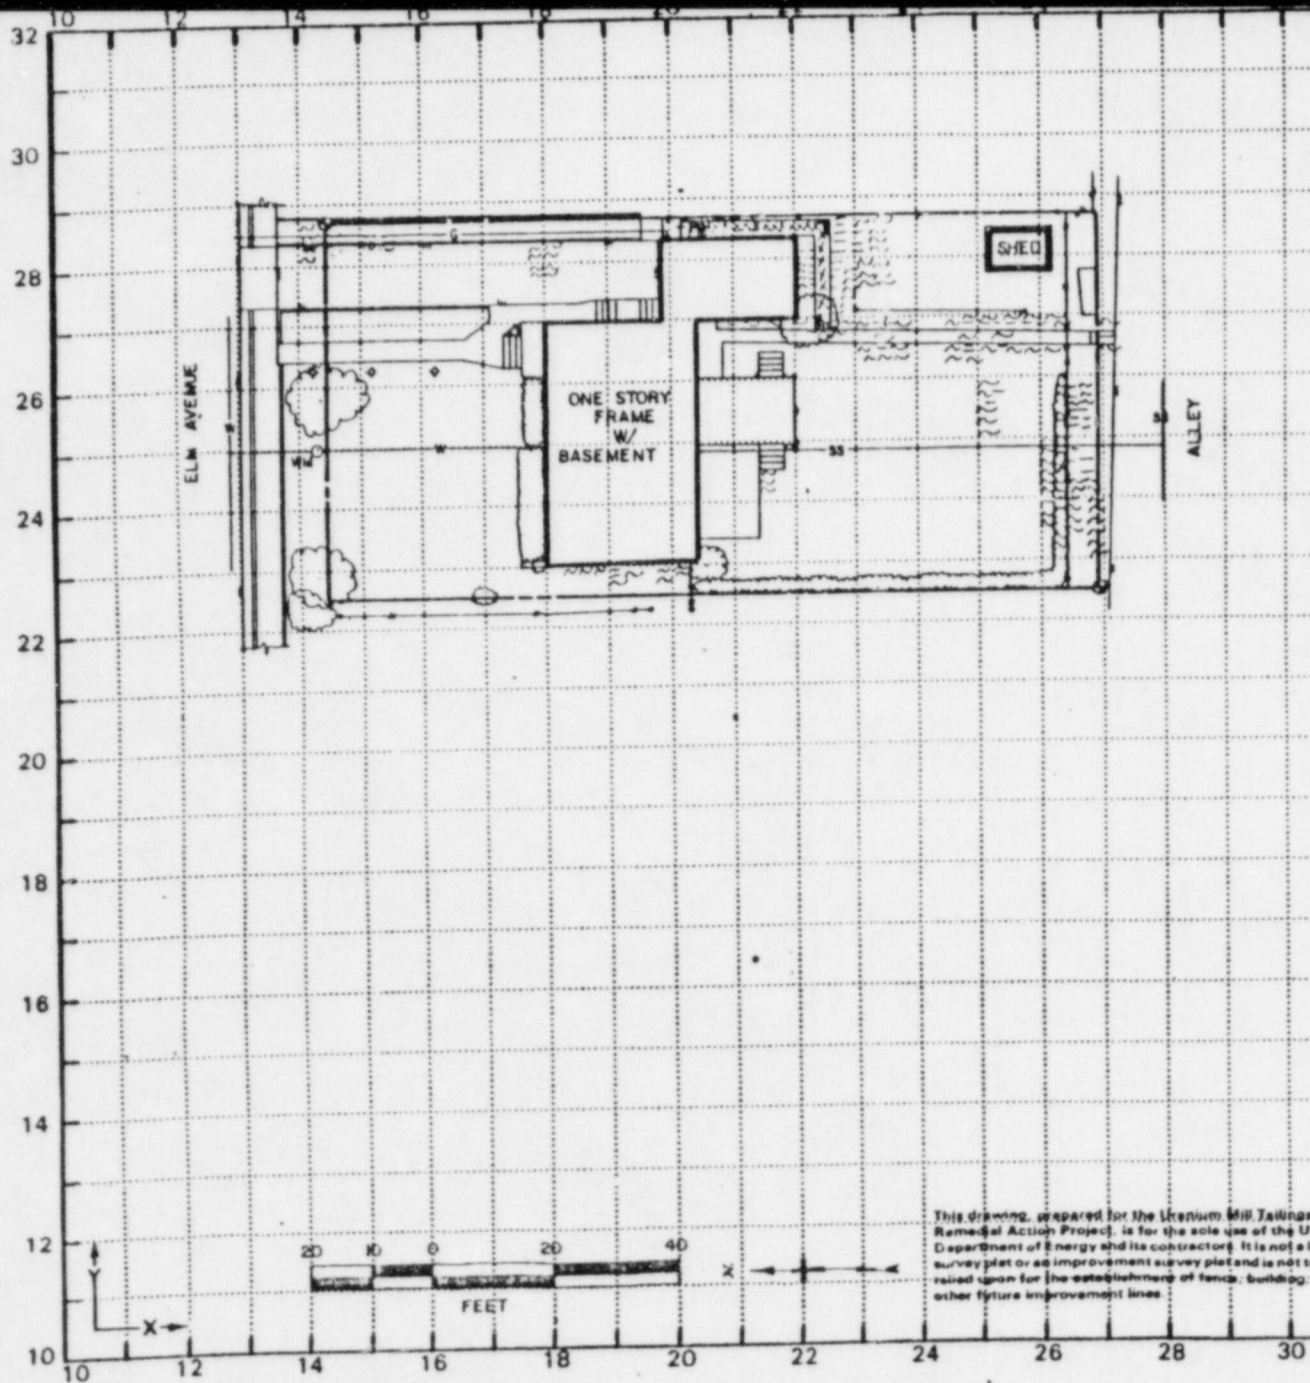
Exterior Gamma Survey map

Visual mill tailings were discovered beneath the brick walk, which surrounds the garage. This explains the slight elevation of readings in the garage.

Contamination was also discovered along side of the sidewalk, as well as beneath it. The sidewalk lies south of the primary structure.

Also, there were a few areas in the backyard, south of the primary structure, along the fence line, and an area along the west side of the house where contamination was discovered.
