# Rupture of Model 48Y UF<sub>6</sub> Cylinder and Release of Uranium Hexafluoride

Sequoyah Fuels Facility  
Gore, Oklahoma  
January 4, 1986

U.S. Nuclear Regulatory  
Commission

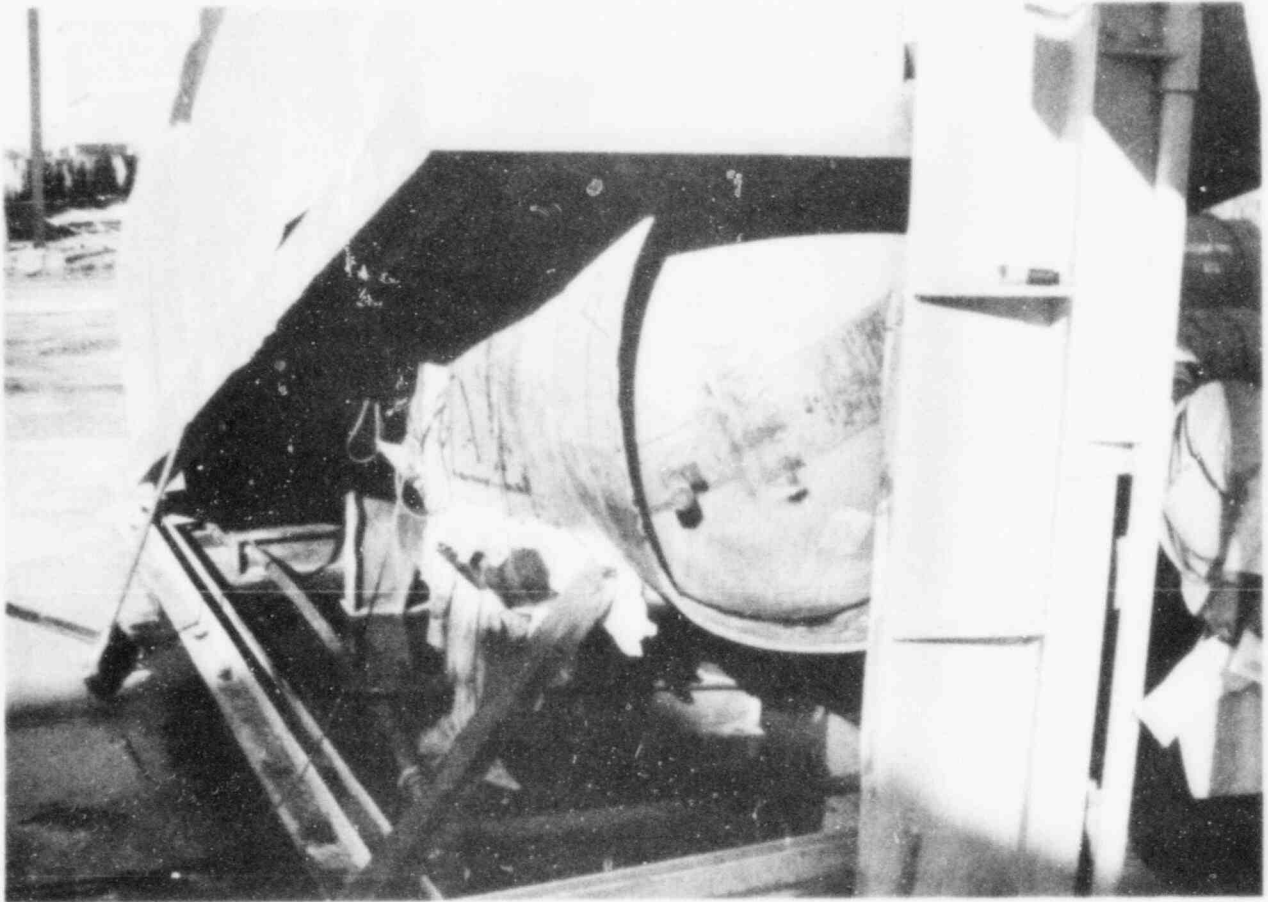
Figure 3.10 Ruptured cylinder

At approximately 11:30 a.m., the cylinder ruptures in the steam chest causing the cylinder to spin in its cradle. The 4-foot, lengthwise rupture which occurred along the top of the cylinder is oriented approximately 120 degrees from its

initial position after the cylinder comes to rest. The force of the explosion also ruptures the top of the steam chest enclosure. (See Figures 3.10 and 3.11.) Liquid  $UF_6$  flows from the rupture and rapidly reacts with moisture in the air to form uranyl fluoride ( $UO_2F_2$ ) and hydrofluoric acid (HF). The resulting vapor cloud is carried south by southeast by a wind gusting to 25 mph.

The ruptured cylinder, with its temporary rag plug in place, rests in the damaged steam chest. The fill valve, in the 8 o'clock position on the near end of the cylinder, was at 12 o'clock before the rupture occurred.

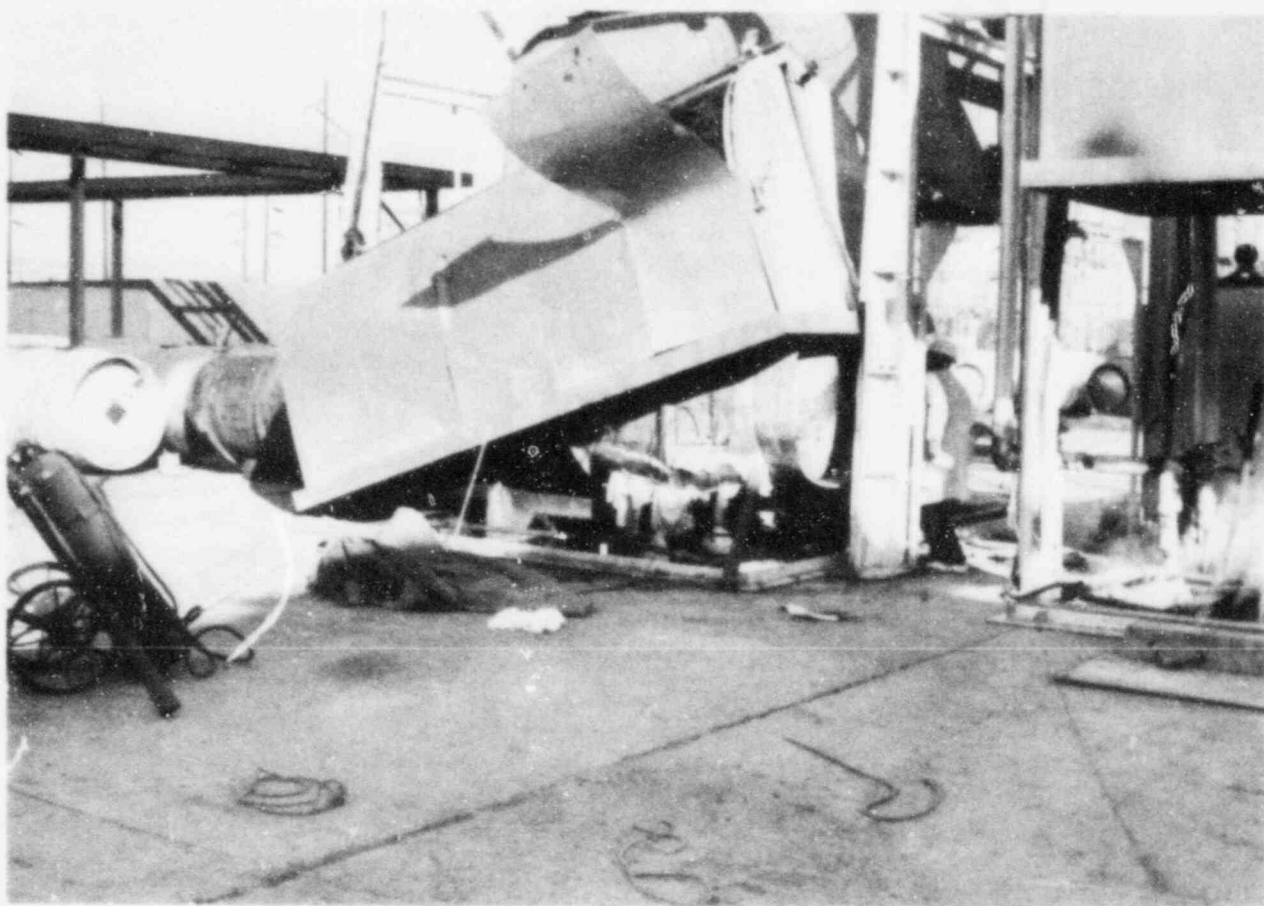
Figure 3.11 Damaged steam chest and cylinder

The force of the release caused damage to the steam chest cover.

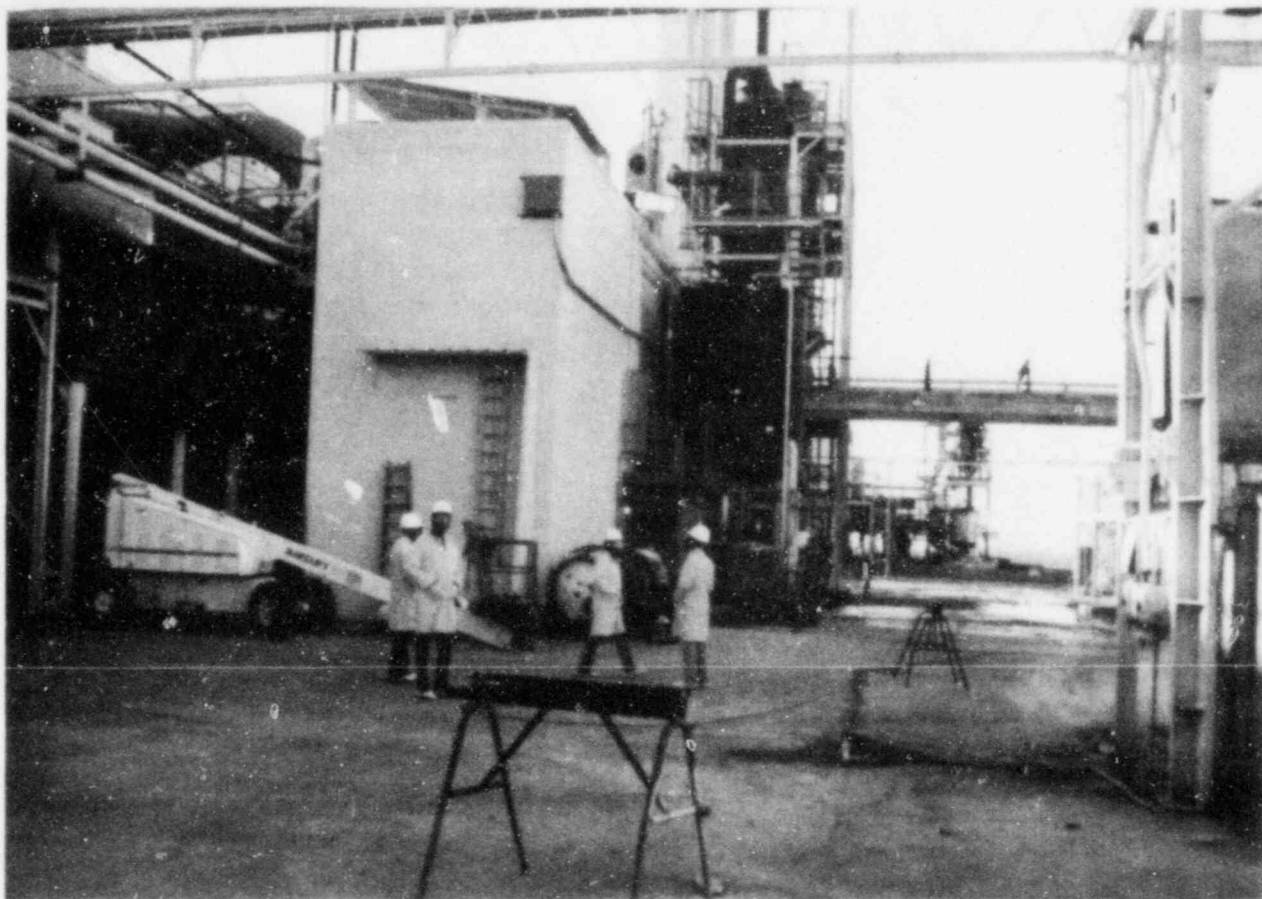
Figure 3.12 Scrubber building

The worker who was fatally injured was working on the upper level of the two-story white structure. He was engulfed by a cloud of vapors and gases consisting of hydrofluoric acid ( $\text{HF}$ ), uranyl fluoride ( $\text{UO}_2\text{F}_2$ ), and uranium hexafluoride ( $\text{UF}_6$ ). The nearest steam chest is barely visible at the right edge of the photograph.

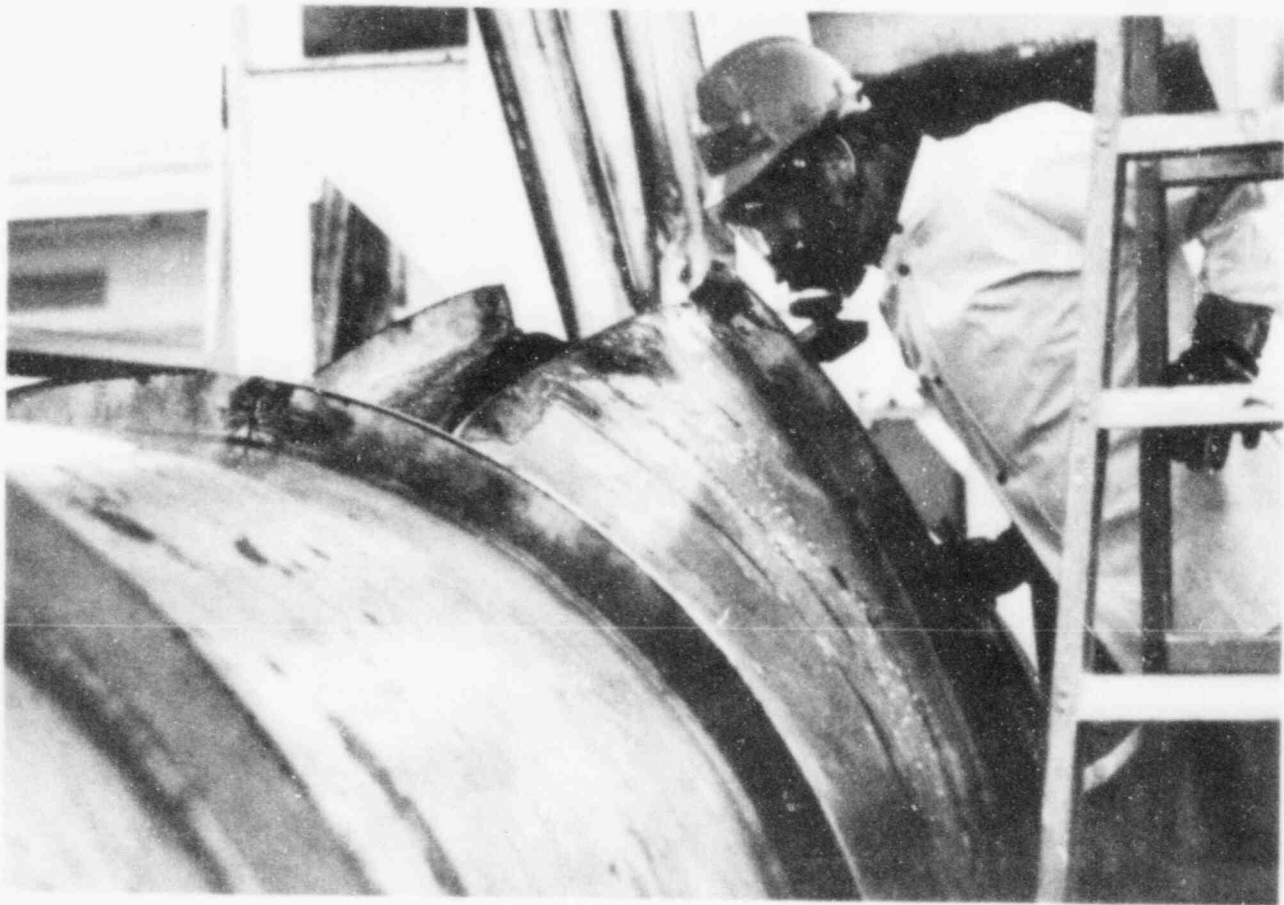
Figure 3.13 Damaged portion of the cylinder

The cylinder was ruptured for a distance of approximately 52 inches in the axial direction along a line passing through the location where the stiffening rings were butt welded closed. The crack resembled a long, narrow slit, approximately 8 inches wide at the widest point. The crack did not appear to be jagged or irregular. (See Figure 3.13.)

The rupture is shown in this picture, which was taken shortly after the temporary rag plug was removed. The cylinder has been rotated from its position immediately after the accident.

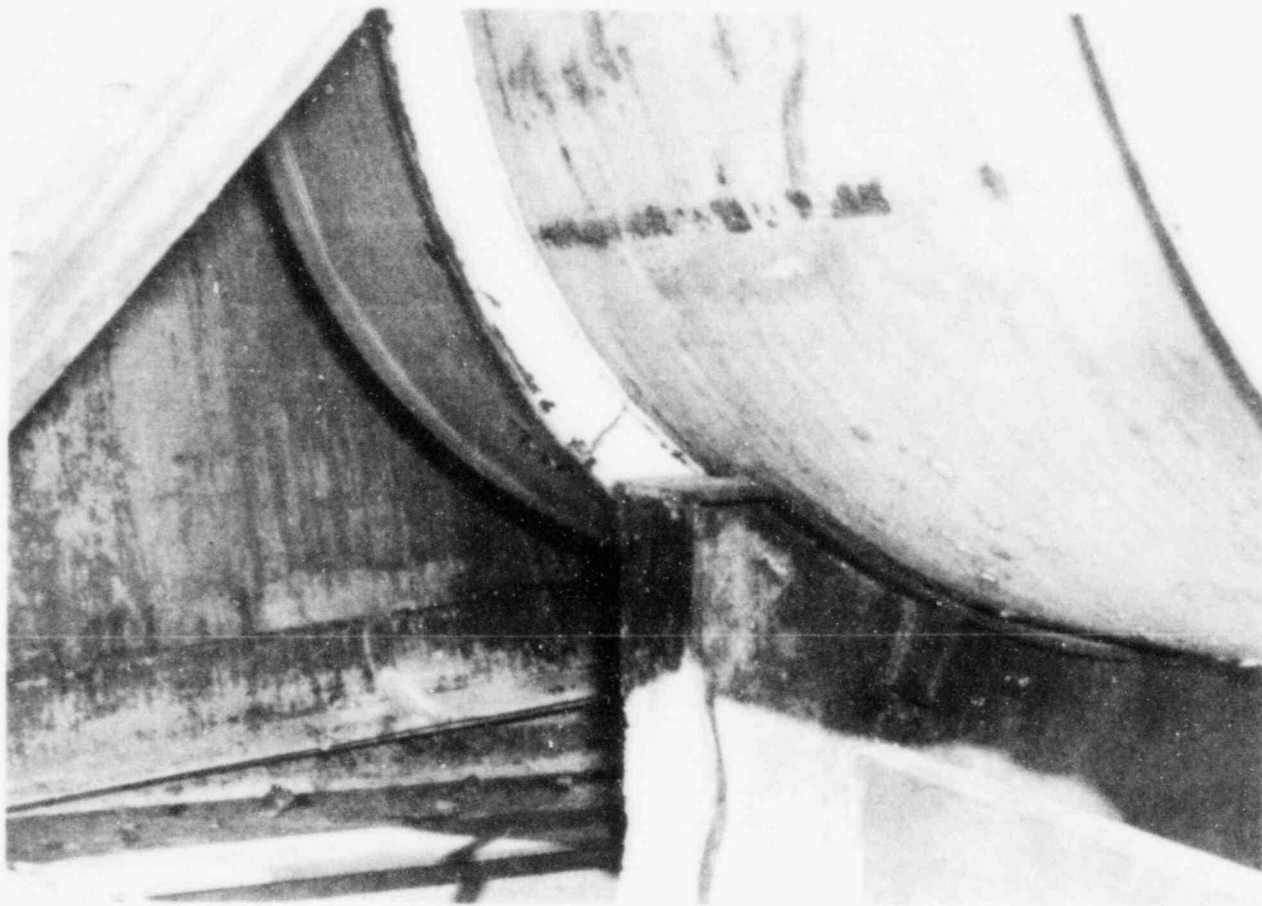
Figure 3.14 Separation of stiffener ring

The three circumferential stiffening rings were separated at the point where they were previously welded closed. The shell bulged radially outward with the maximum deformation appearing to be halfway between the stiffening rings. The cylindrical shell had undergone considerable plastic deformation in both the region of the rupture and in regions away from the rupture at the opposite end of the cylindrical shell. Figures 3.14 through 3.16 show this damage.

The stiffener ring farthest from the rupture clearly shows separation at the butt weld joining the ends of the ring.

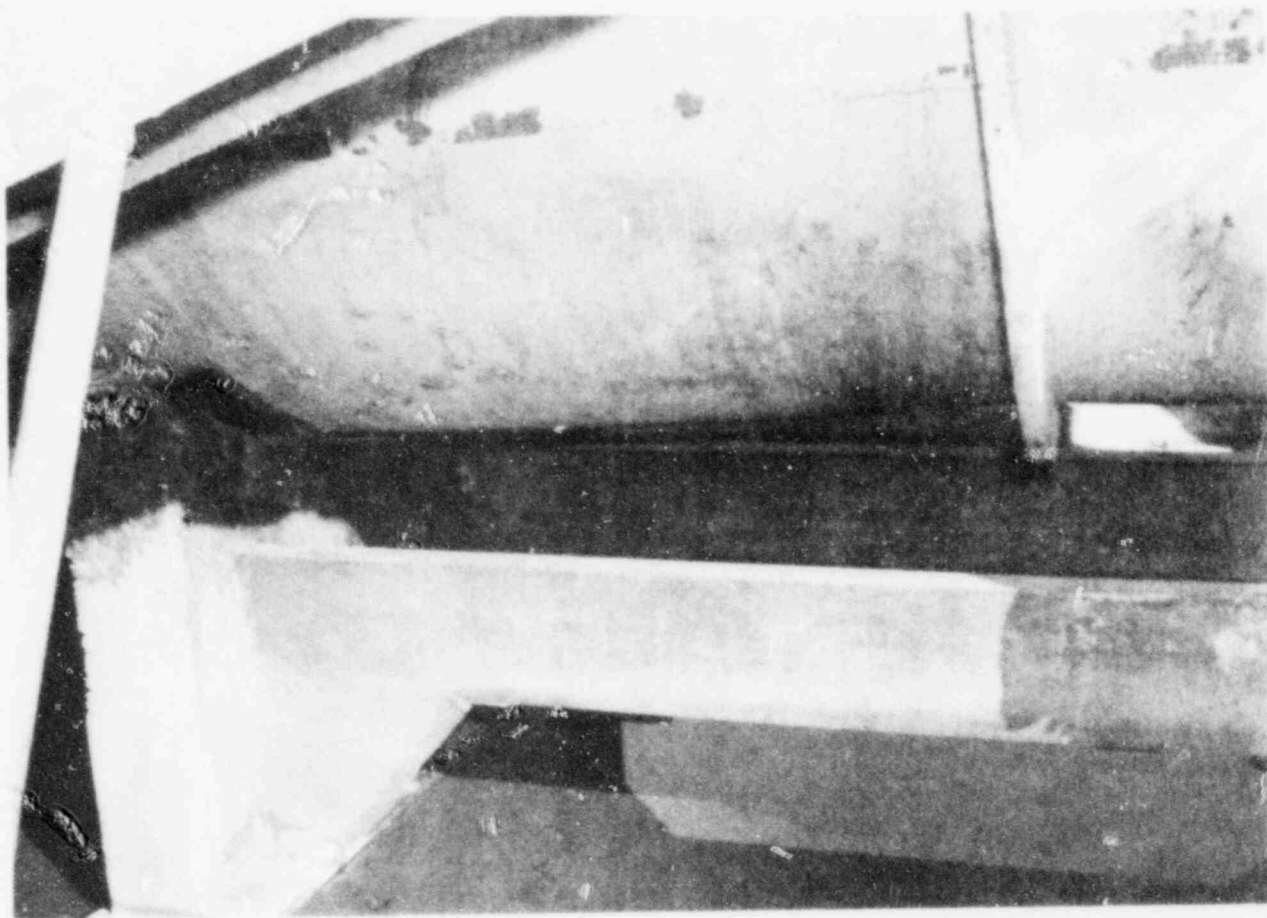
Figure 3.16 Deformation of cylinder wall

The plastic deformation of the shell before rupture indicates that the failure was ductile in nature rather than brittle. Brittle fracture is characterized by crack propagation driven by elastic strain energy. Because the material was strained well beyond its elastic limit, the failure mode was not brittle fracture. Also, if the shell had failed in a brittle manner at stress levels below yield, the loss of contents would have reduced the pressure so that general yielding of the shell would not have occurred in regions of the shell away from the rupture.

Bulging of the cylinder wall between the stiffener rings is clearly evident.

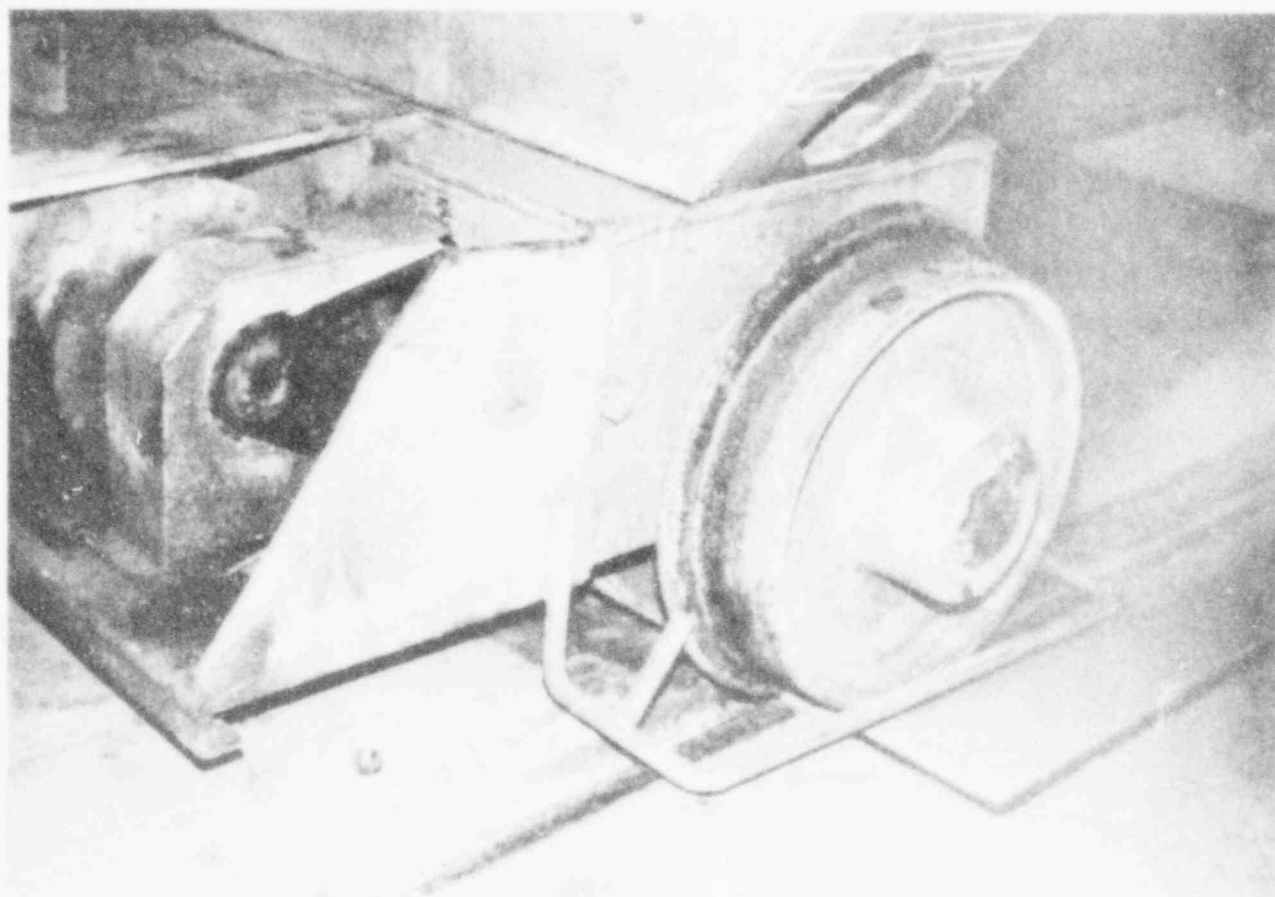
Figure 5.1 Cart wheel alignment

- (4) In the conduct of the scale testing and calibration, the investigators noted that the cart used to move cylinders on and off the scale platform apparently had been damaged in the past. As a result, the wheels at the east end of the cart were at an angle, confirming observations that only one of the wheels had hung up.

With a 14-ton cylinder placed in its optimum position on the cart and moved as close as possible to the drain station, the rear wheel is less than an inch from the edge of the scale platform.
