U. S. NUCLEAR REGULATORY COMMISSION  
REGION IV

Report No.: 40-8971/97-01

Licensee: U.S. Energy Corporation

Facility: Green Mountain Ion Exchange Facility

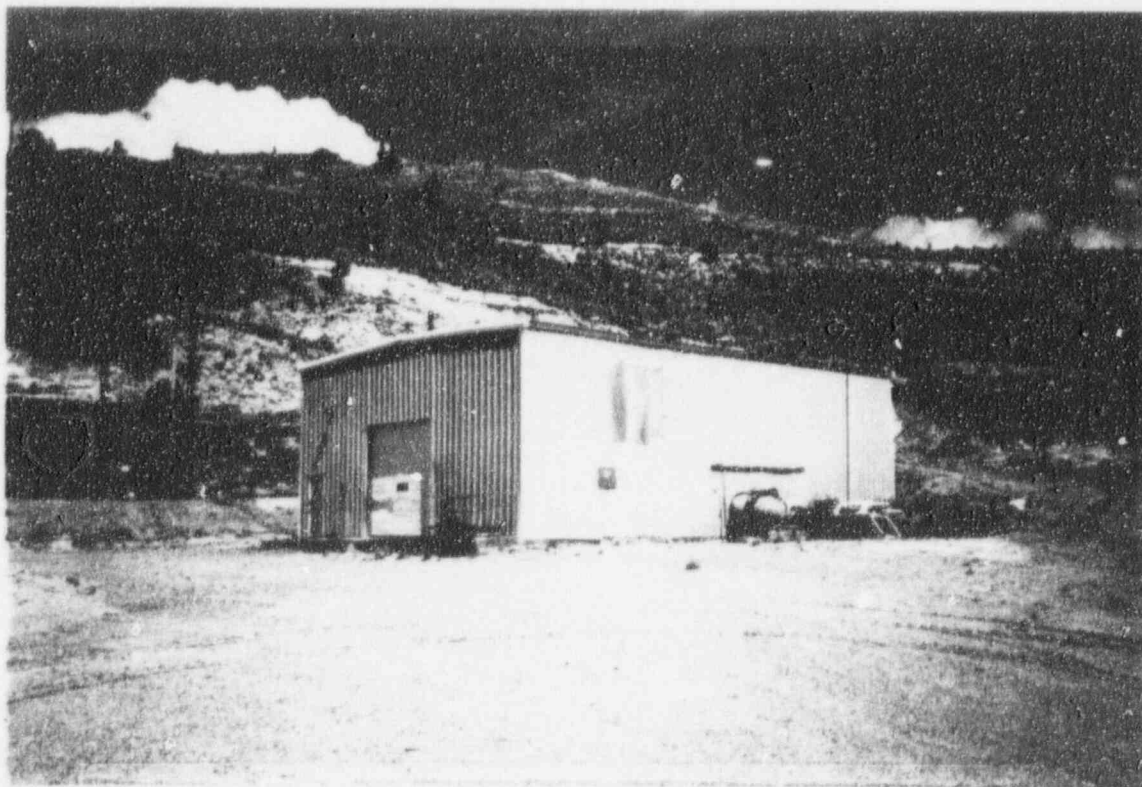
Photograph 1 - Green Mountain Ion Exchange Facility.

While the ion exchange columns themselves appeared to be in good condition, the mechanical components, such as pumps, and the building walls appeared to be deteriorating in both buildings. Also, piles of dirt and dust, as well as animal droppings, were found throughout the site. In summary, the site appeared to be in a state of disrepair although the licensee expressed confidence that the site could be restored to an operable status if the plant were to be restarted.

Ambient gamma exposure rate readings were obtained using a Ludlum Model 19 microrentgen meter. Elevated gamma readings were identified inside and around the ion exchange building; however, no radiation areas were identified on the site property.
