SUBJECT: REGION V INPUT TO ACRS REQUESTS ON PALO VERDE

### Review of Startup Experience for Palo Verde Unit 1

LOSS OF LOAD EVENT

PALO VERDE LOSS OF OFFSITE POWER  
OCTOBER 3, 1985 (J. T. BEARD, NRR)

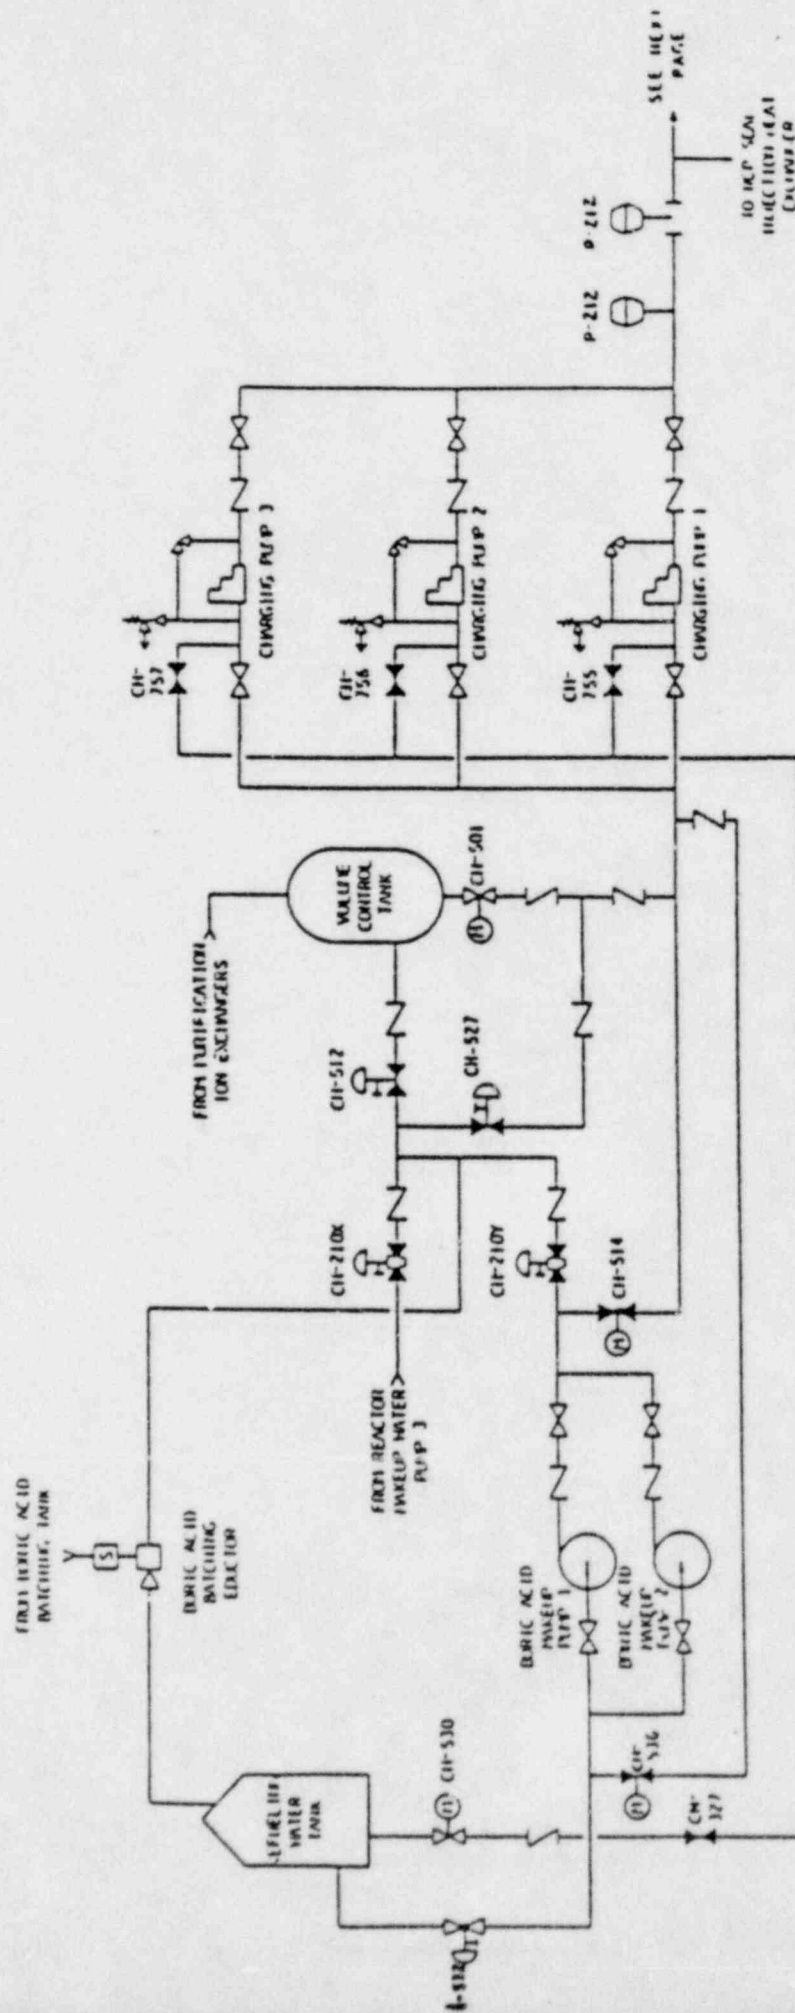
FIGURE 2.1-4  
SIMPLIFIED SCHEMATIC OF PALO VERDE CVCS SHOWING AUXILIARY  
SPRAY PORTION AND SOURCES OF BORATED WATER

- o AUXILIARY PRESSURIZER SPRAY SYSTEM BEGINS AT BRANCH FROM CHARGING SYSTEM AND ENDS AT PRESSURIZER SPRAY NOZZLES
- o MECHANICAL COMPONENTS CONSIST OF:
  - PIPING
  - TWO SOLENOID OPERATED VALVES (CH-203 & CH-205)
  - CHECK VALVE
- o SCHEMATIC OF AUXILIARY PRESSURIZER SPRAY SYSTEM AND SOURCES OF BORATED WATER (VIA CHARGING SYSTEM) SHOWN IN:
  - FIGURE 2.1-4 OF CEN-239, AND
  - FIGURES 5 & 6 OF APPENDIX B IN NUREG-1044

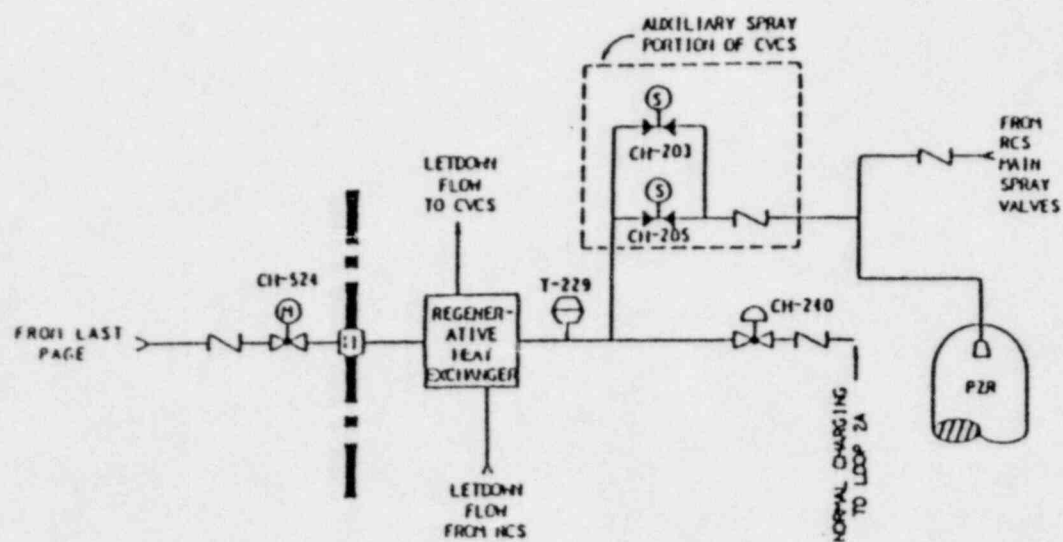
FIGURE 2.1-4 (CONT.)

SIMPLIFIED SCHEMATIC OF PALO VERDE CVCS SHOWING AUXILIARY  
PORTION AND SOURCES OF BORATED WATER
