Report of Construction Inspection

IE Inspection Report No. 050-330/77-02

Midland Nuclear Power Plant  
Unit 2  
Midland, MI

Inspection on February 28 and March 1, 1977, (Unit 2, 77-02): Special inspection concerning extensive bulge in the Unit 2 containment liner plate. One noncompliance item was identified relative to failure to report the bulge deficiency pursuant to the requirements of 10 CFR 50.55(e)(2).

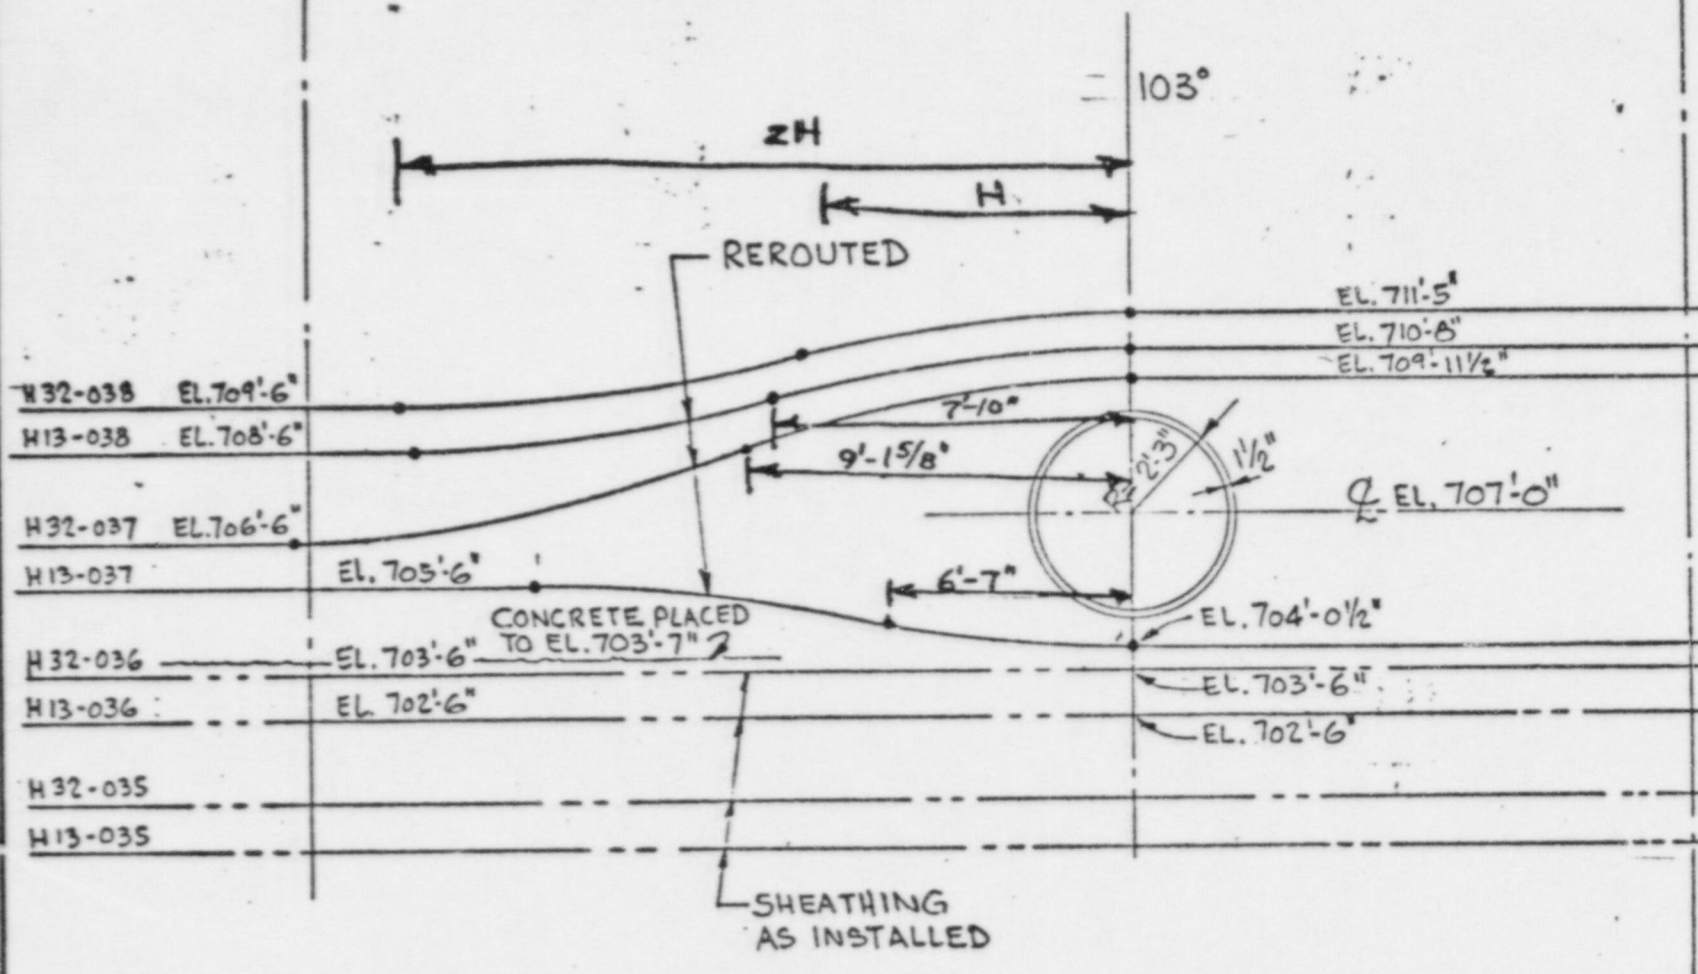
REVISD ALIGNMENT OF TENDONS  
AROUND MAIN STEAM PENETRATION

R. Shewmaker said that a problem had developed during the construction of the containment structure at the Midland 1 plant. Two tendons were misplaced and others had to be relocated to correct the deficiency. The NRC Staff agrees with the fix that was made. All of the modifications have been documented.

R. Shewmaker noted that this was a quality control breakdown which occurred when the chief surveyor was on vacation. The error was found before the next higher pour was made. (For diagrams of the error and the fix see Appendix XXIII.)

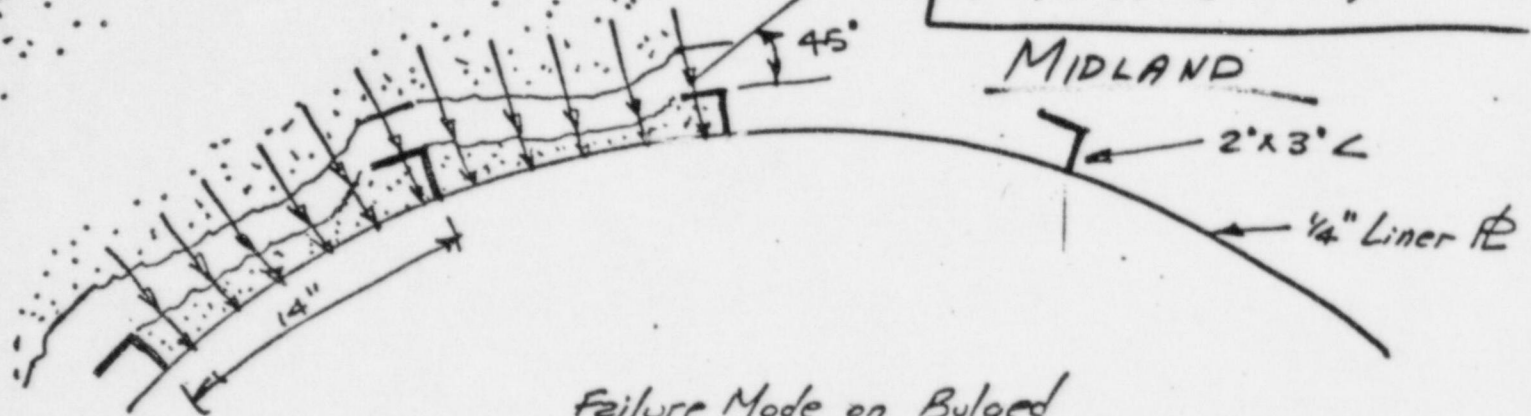
Failure Mode on Bulged  
Liner Plate  
N.T.S.

R. Shewmaker, NRC Staff, discussed proposed repairs to the liner plate of the containment building from the bulge reported at the 204th ACRS Meeting (see Appendix XXII). He noted that pipe penetrations and stiffening columns had arrested the extent of the bulge and there was no tearing of the metal. It is believed that freezing was the cause of the failure of a pipe used to supply concrete curing water. The section of the failed pipe was removed, as well as the bulged section of the liner. It is proposed to re-erect the liner plate with two-inch steel angles similar to the original construction. The concrete that was damaged will be removed and replaced with dry-pack concrete. Nelson studs will be placed between the angles. The three-inch void between the liner plate and the concrete wall will be filled with grout. The liner plate will be retested to develop the liner design criteria. NRC Staff believes that the proposed repairs are reasonable, but may require some additional rock anchors where the five-inch channels are not adequately embedded in concrete.
