ATTACHED DOCUMENT TITLE: DAVIS-BESSE COURSE OF ACTION (COA)

FINDINGS, CORRECTIVE
ACTIONS & GENERIC
IMPLICATIONS REPORTS
FROM SECTION C.1.1
PLAN NO. REV.
1A & 1B/1C 1

This report documents the troubleshooting and investigative actions performed to identify the root cause of the overspeed trips of the Auxiliary Feed Pump Turbines (AFPTs) at Davis-Besse on 6/9/85. Also presented in this report are the proposed corrective actions to eliminate the cause of the overspeed trips and a summary of the proposed confirmatory testing to ensure proper system operation.

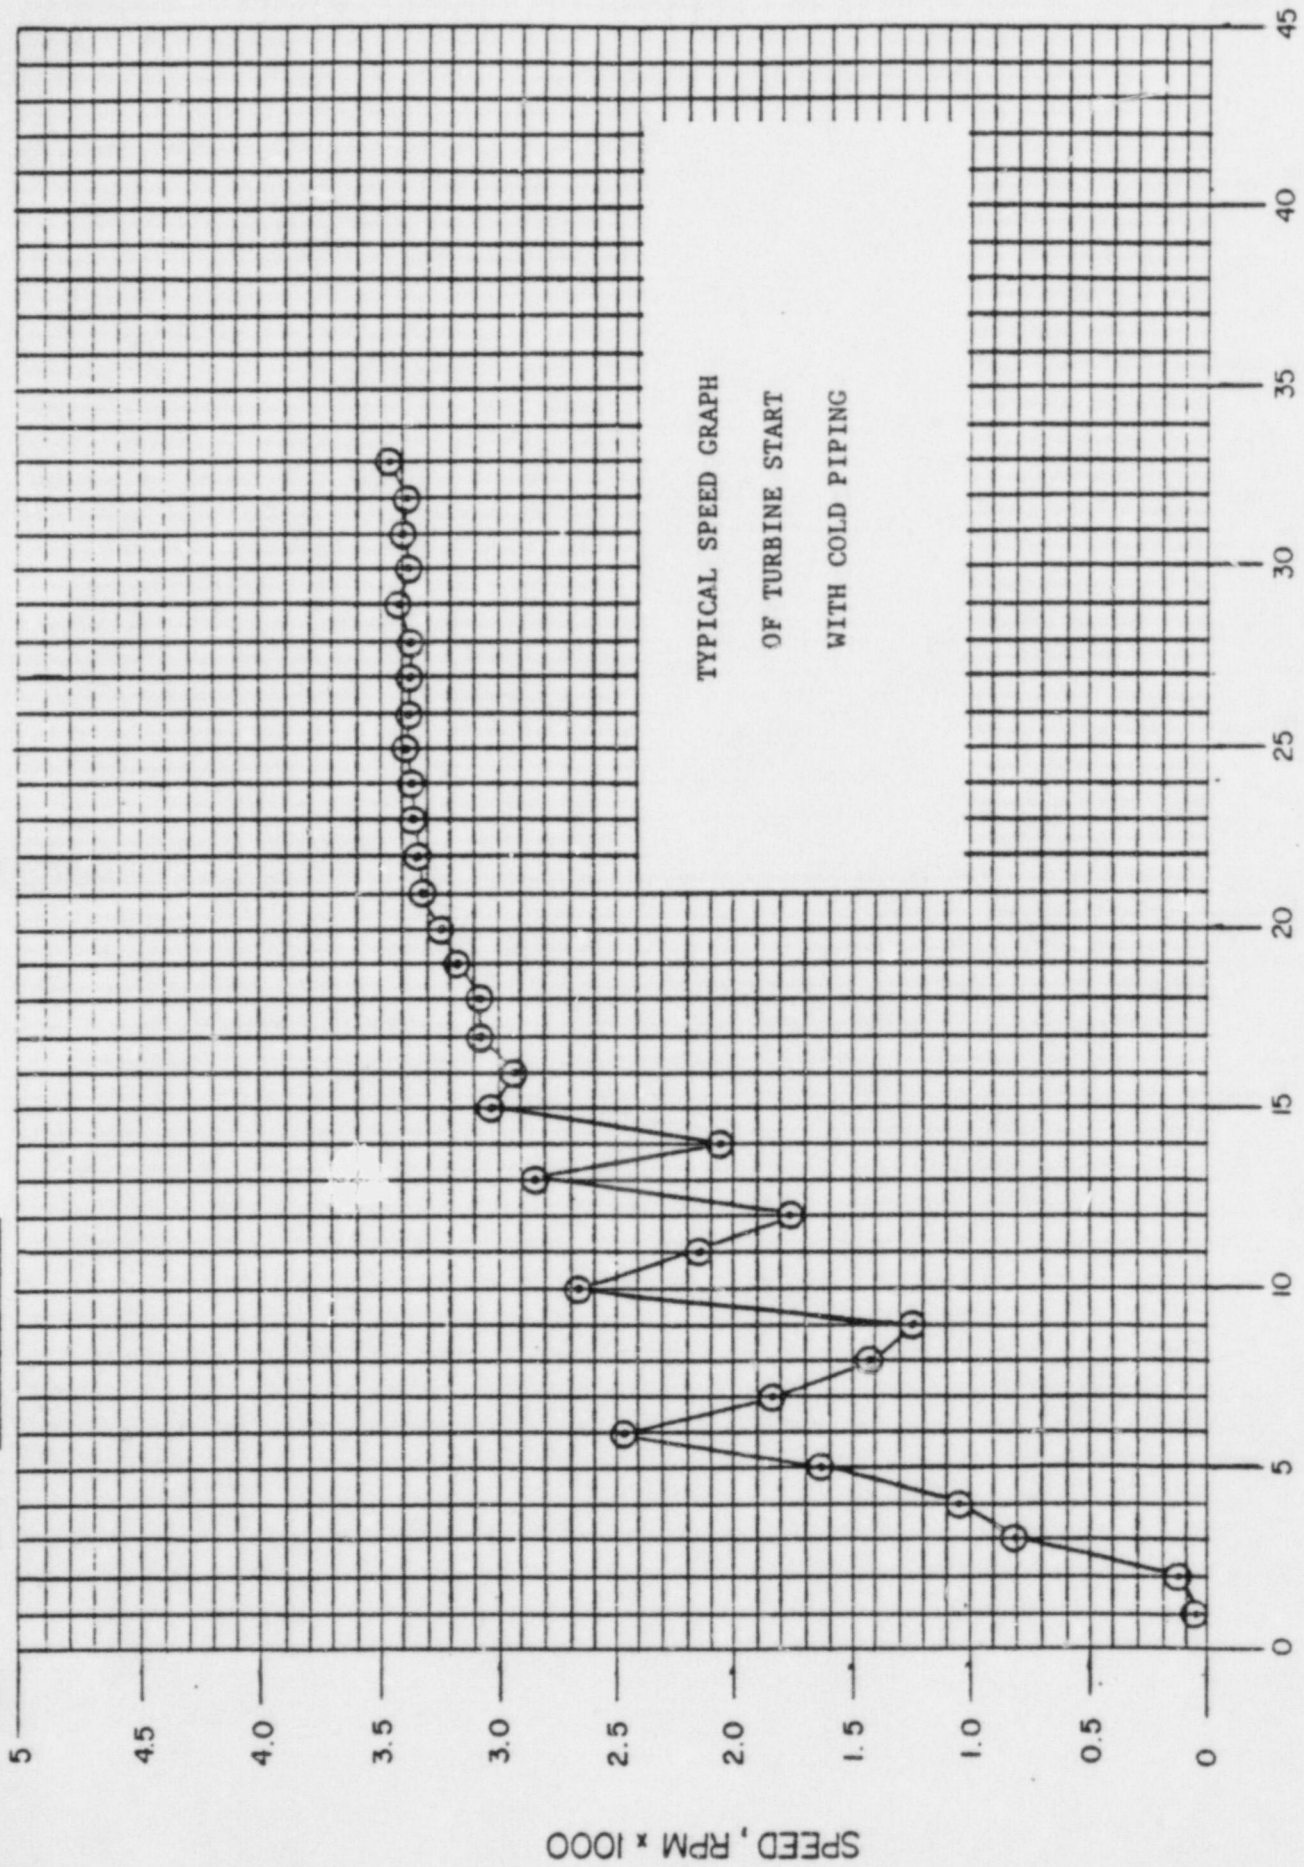
Figure 2

To further support the root cause of water causing the overspeed trips, a review of past AFPT quick starts was performed. This review involved analyzing the plots of turbine speed versus time during the starting transient. The review clearly showed a difference in stability of the turbines (especially AFP #1) when run on cold supply lines versus hot supply lines. When the turbines are started with cold steam supply lines, the turbine speed is very erratic during acceleration to rated speed. However, when the turbines are started with hot steam supply lines, the speed graphs are very smooth with a constant acceleration to rated speed. (See Figures 2 and 3 for typical AFPT speed graphs of cold versus hot lines.)

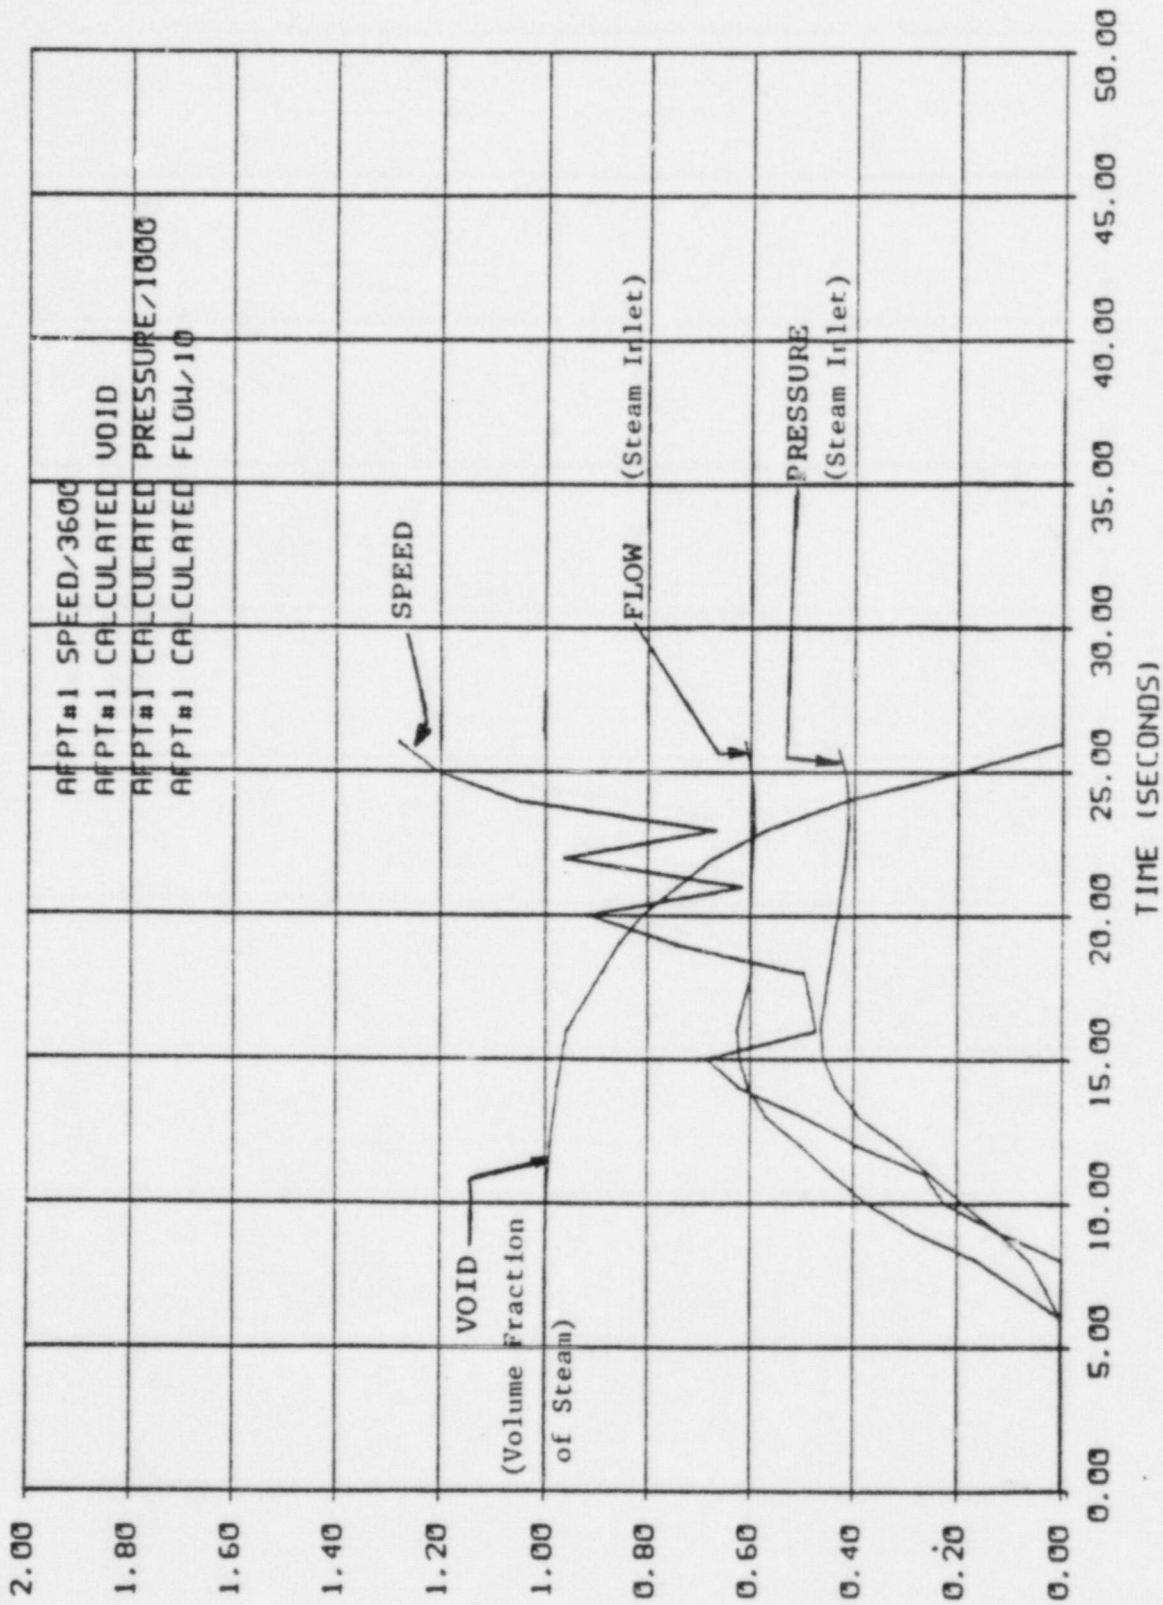
Figure 4

This transient analysis substantiates the fact that large amounts of water can be generated when steam is initiated into the long cold piping. In addition, it shows that the condensate can be expected to reach the turbines in approximately the time frame required to support the observed overspeed trips of the AFPTs (25-30 seconds).

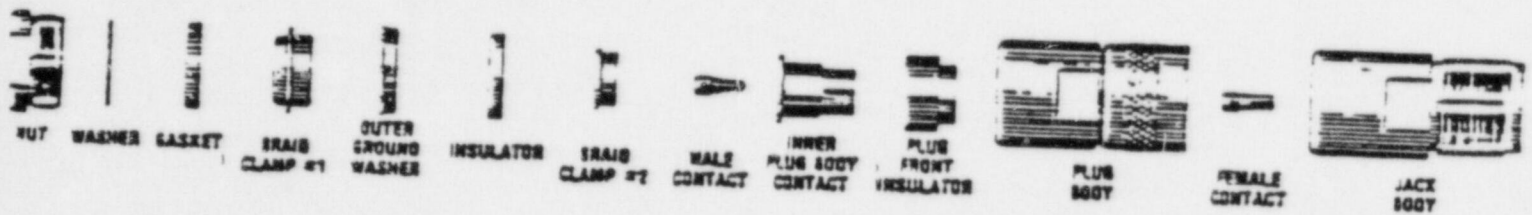
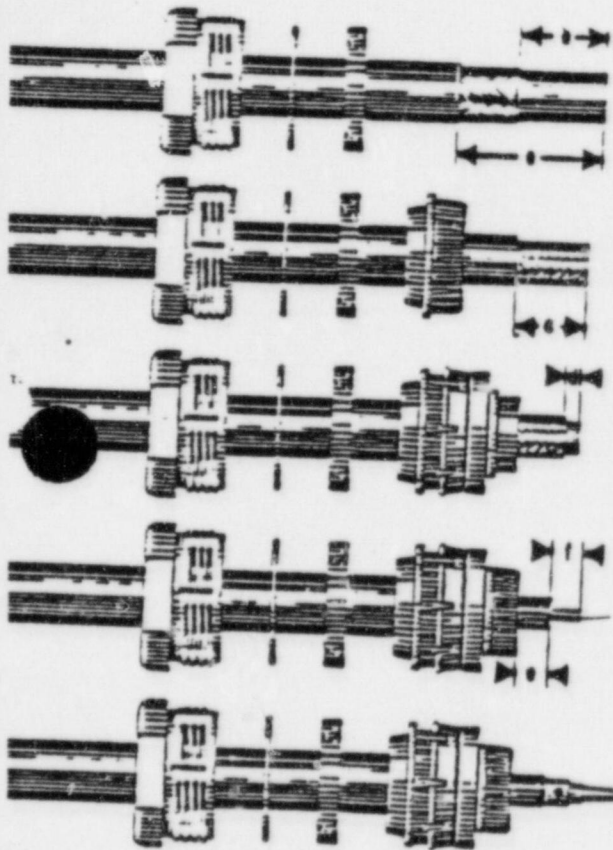
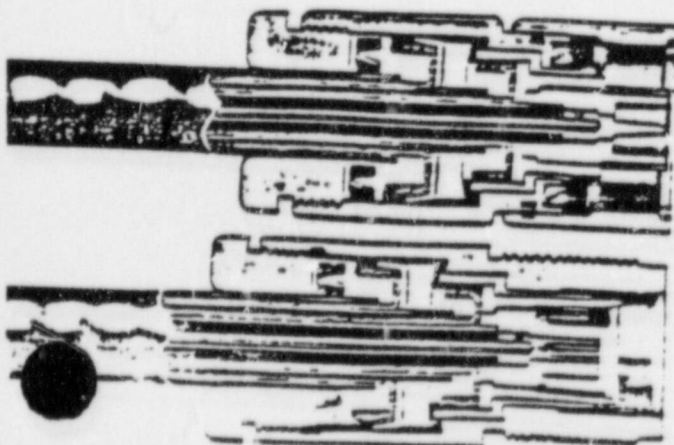
Fig. 2

1. RPS Cabinet (Cabinet 1) (5755F) has a loose connection to the station ground bus. Tightening of this connection has been completed. 2
2. The center pin on the preamp detector cable connector was pushed in approximately $\frac{1}{4}$ " and was off center. This connector has been replaced using installation instructions written in the Maintenance Work Order. Figure 2 shows a typical connector assembly.

1. A direct cause of elevated count rate on NI-1 was determined by Westinghouse to be improper installation of the Triax cable jack which mates with the detector cable
