Boston Edison

Pilgrim Nuclear Power Station
Rocky Hill Road
Plymouth, Massachusetts 02360

Enclosure: LER 97-007-00

Safeguards Buses De-Energized and Losses of Off-Site Power During Severe Storm While Shut Down

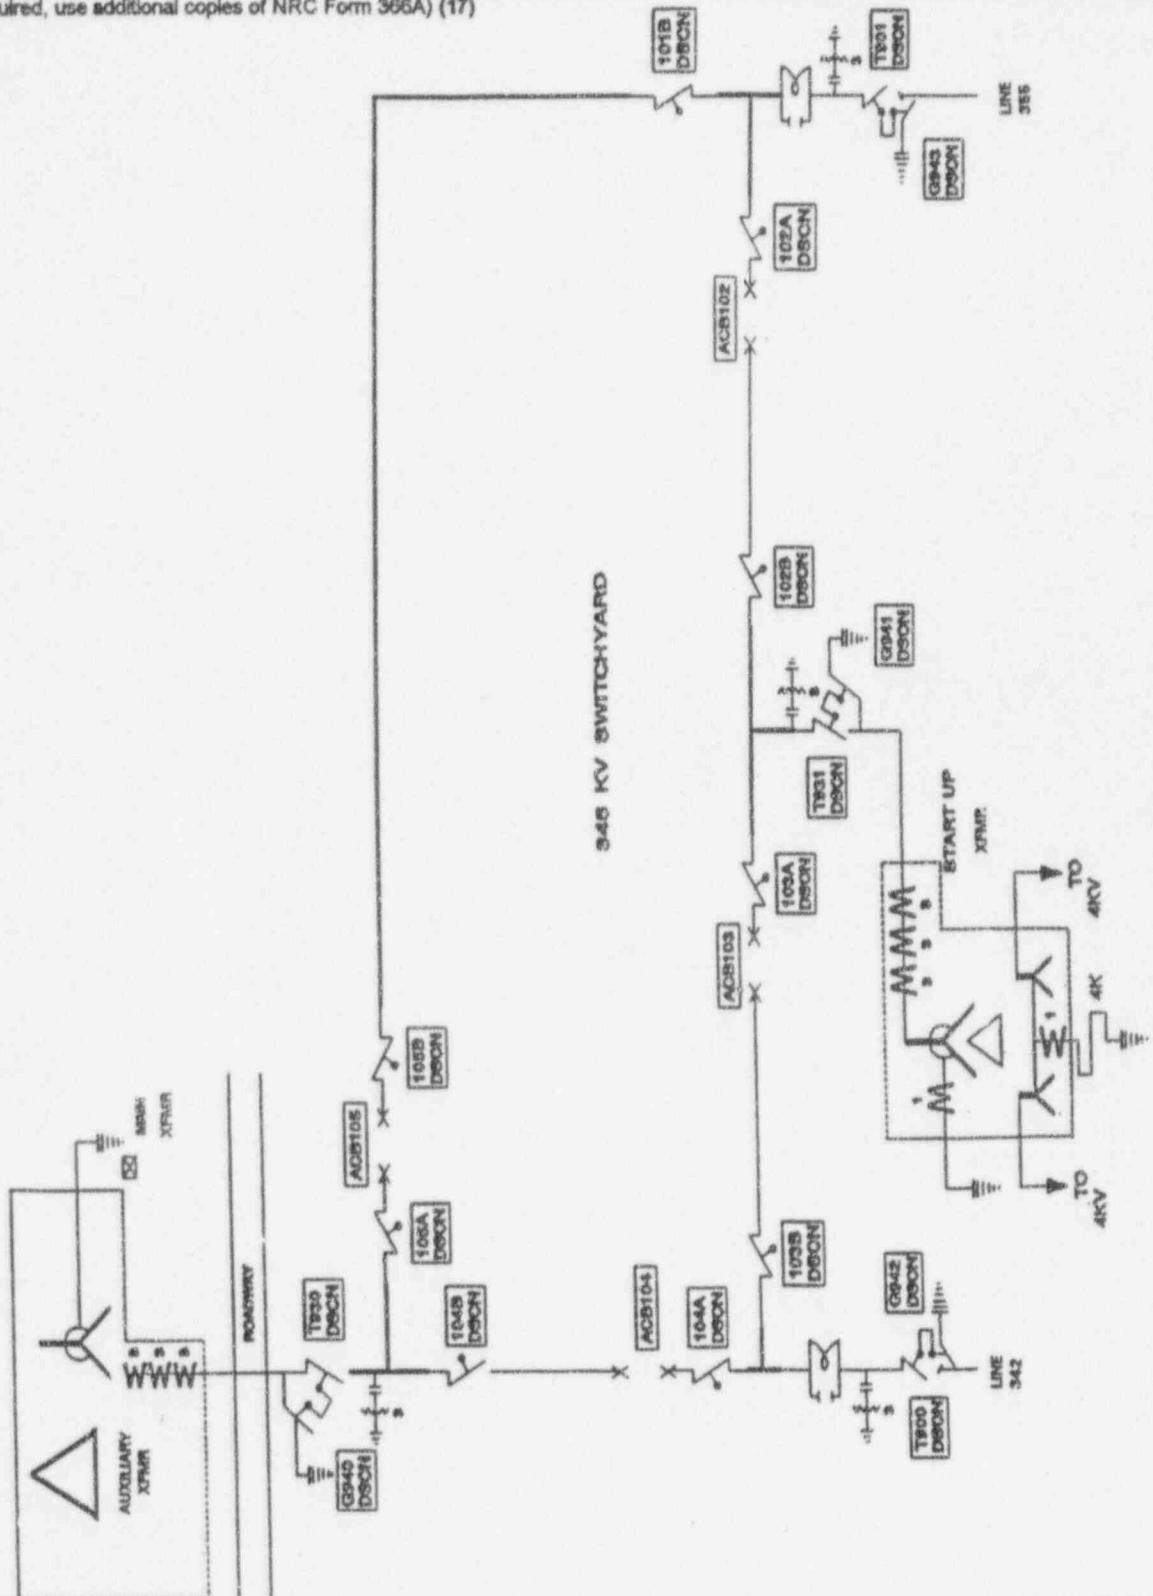
ONE LINE DIAGRAM - 345 KV SWITCHYARD

- The preferred source of off-site power, 345 Kv transmission lines 342 and 355, was energized. The 345 Kv switchyard air circuit breakers ACBs 102, 103, 104 and 105 were closed. The startup transformer (SUT) was energized from lines 342 (via ACB-103) and 355 (via ACB-102). A new main transformer had been moved onto its platform but was neither electrically nor mechanically connected, and the unit auxiliary transformer was not available because of the main transformer status. Located at the end of this report is a simplified single line drawing of the 345 Kv switchyard.
