**Southern Nuclear  
Operating Company, Inc.**  
40 Inverness Parkway  
Post Office Box 1295  
Birmingham, Alabama 35201  
Tel 205.992.7279  
Fax 205.992.0341

May 7, 1997

HL-5389

**Edwin I. Hatch Nuclear Plant - Unit 2  
Supplemental Information Regarding the  
Inservice Inspection of Feedwater Sparger**

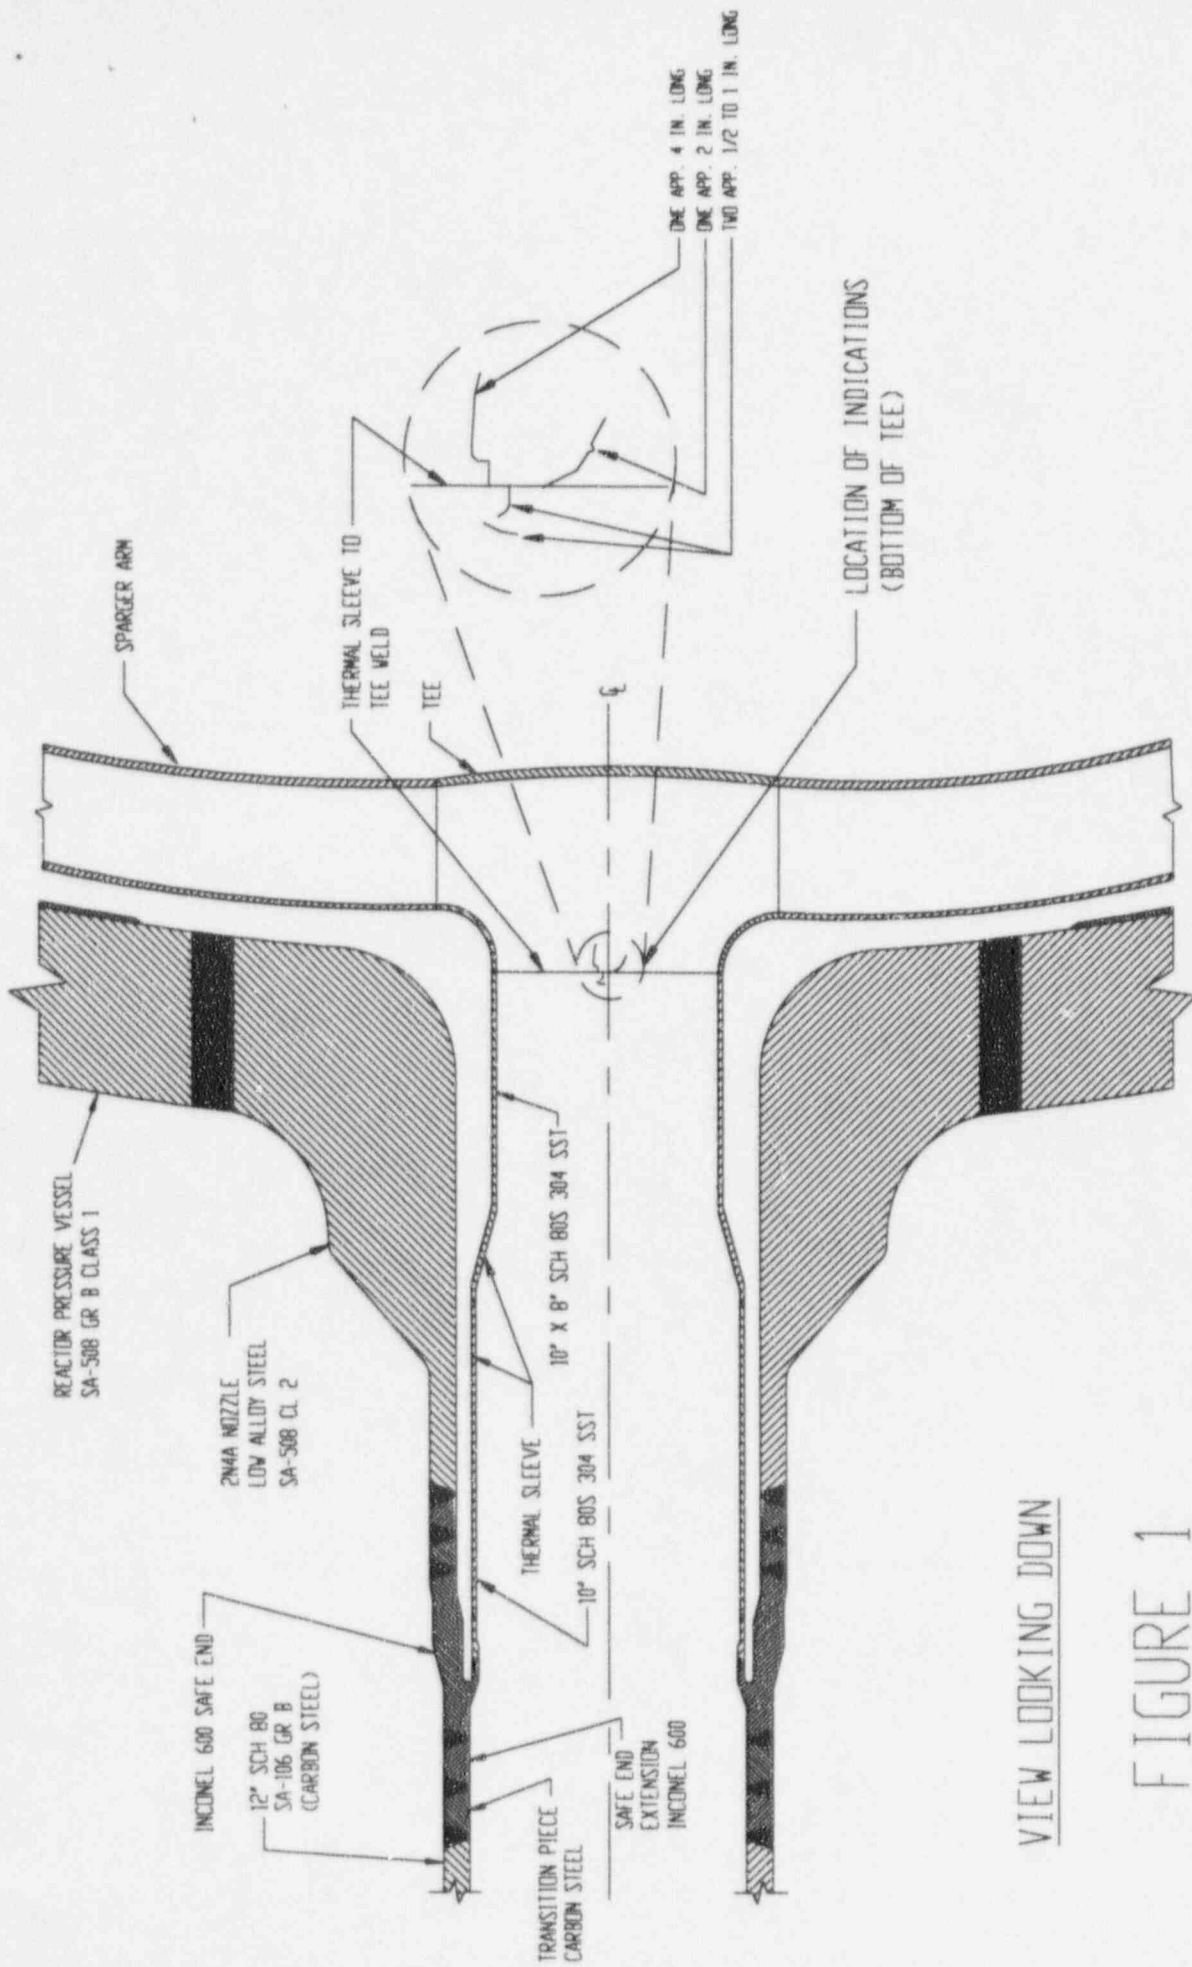
FIGURE 1

In response, Figure 1 provides additional details for the location of the indications on the 'A' sparger thermal sleeve. The indications are located on the bottom of the pipe and are predominately axial in orientation. A review of the examinations shows that the indications are characterized as four primary indications with minor branching. One indication is approximately four inches long and appears to traverse the sleeve to the tee weld. Another indication is approximately two inches long within the sparger tee next to the tee weld. The two remaining indications are approximately one and one-half inches long within the thermal sleeve next to the tee weld.

The predominately axial orientation of the indications, along with very low pressure and forces transmitted to the area of the indications, supports the determination that fatigue is the likely mechanism of the cracking. The relatively straight segments of the indications going through the tee weld are not characteristic of intergranular stress corrosion cracking (IGSCC). Additionally, the cracking at the observed locations would be expected to be circumferentially oriented rather than axial for causes other than fatigue.

In response to the NRC staff's comments relative to the potential for loose parts, SNC's evaluation that the likelihood of the indications on the sparger thermal sleeve and on the tack welds on the two nuts on the end bracket to result in loose parts is extremely remote. The indication on the end bracket is located on the tack weld of the nut to the end bracket for each of the two bolt locations. However, there are additional tack welds on the nut to the end of the bolt. These tack welds were visually inspected and showed no indications. Further, the end plate is welded to the bracket and eliminates any structural need for the bolts. The bolts were originally installed as a fit-up aid during installation of the sparger and are not required for sparger support. Additionally, the end bracket is connected to the reactor pressure vessel (RPV) and transmits the structural loads to the (RPV). Visual examinations of the end bracket connection welds to the RPV were performed and no indications were identified. Also, the sparger thermal sleeve to tee weld was conservatively assumed to be cracked through wall for 360 degrees and consequently providing no support for the sparger. An evaluation of this conservative assumption shows that the sparger supports will adequately support the sparger. Based on the above, the potential for the described indications to result in loose parts is considered as extremely remote.

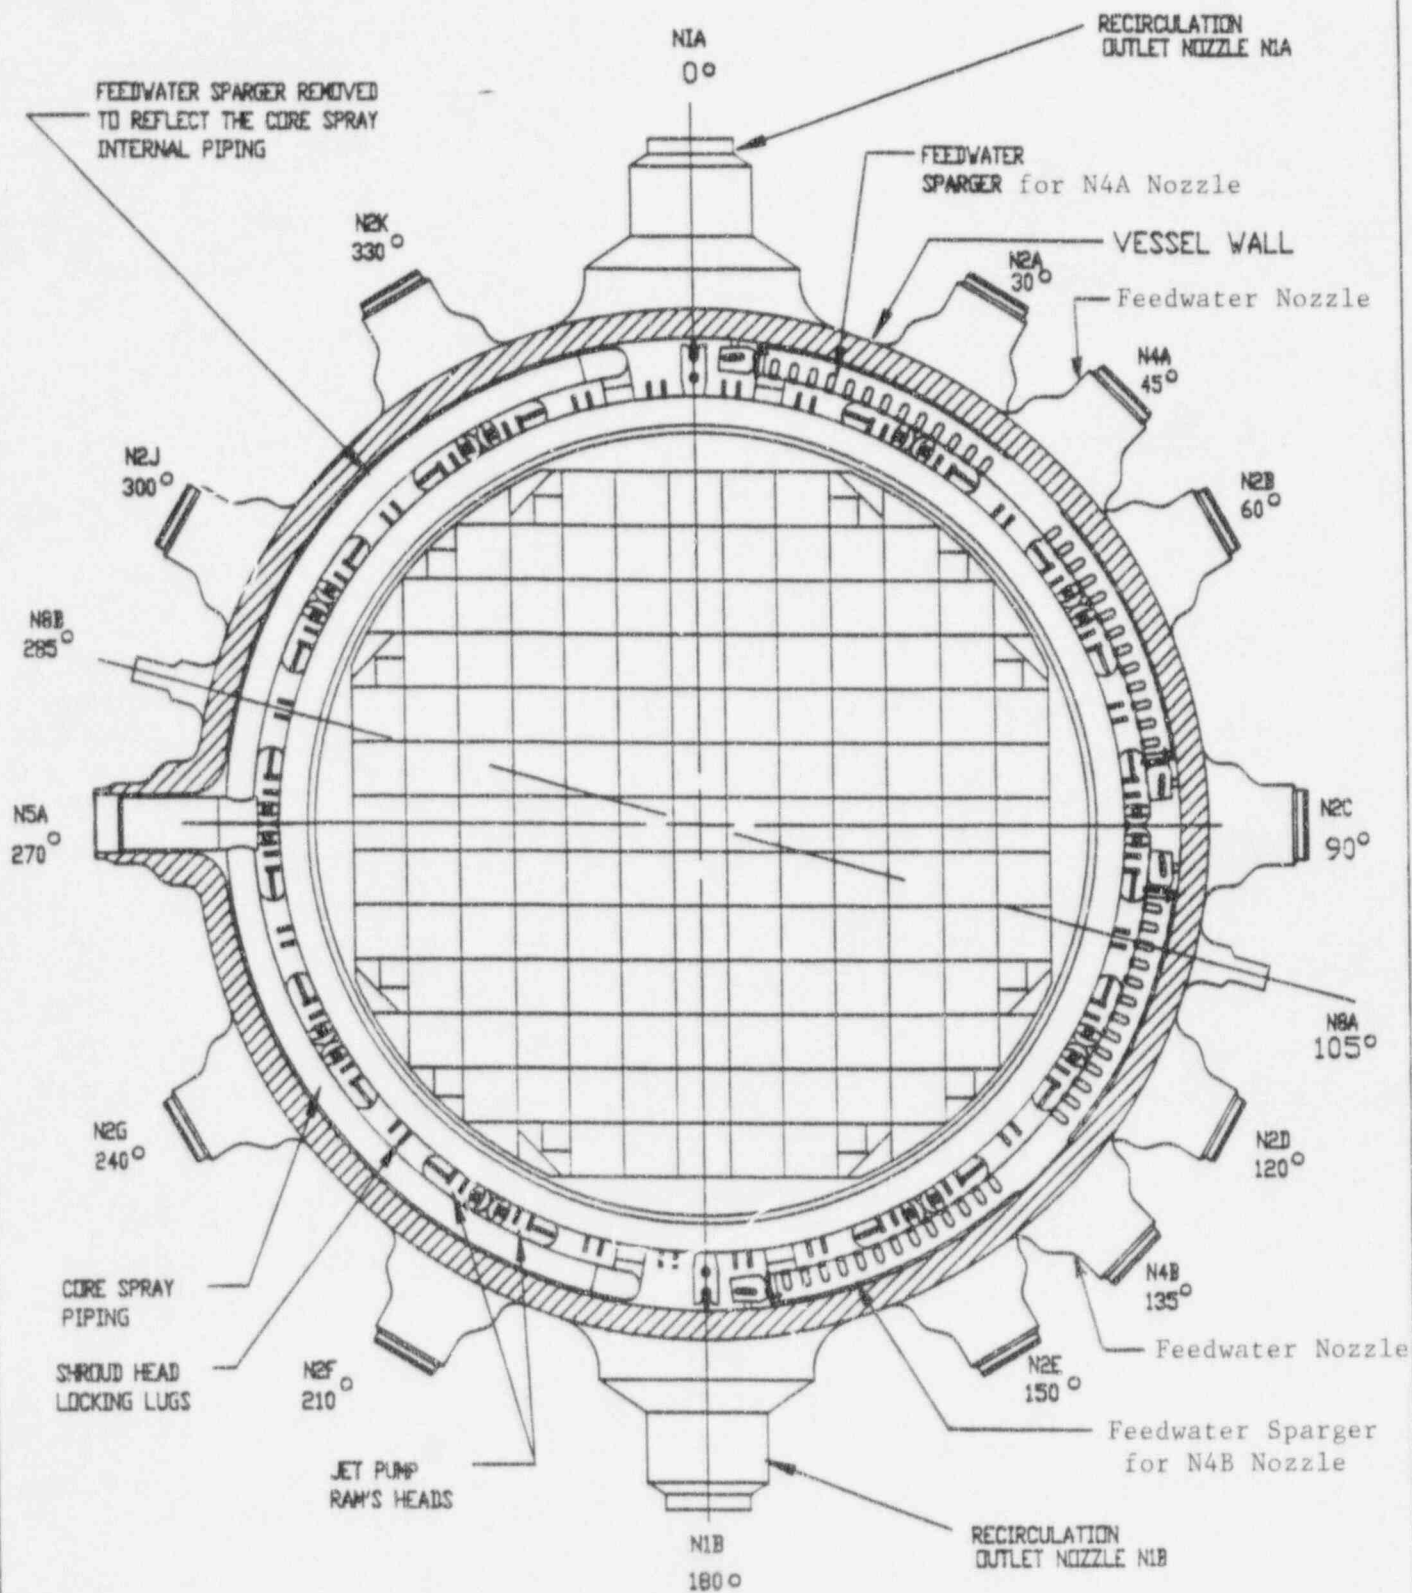
Figure 2

Figures 2 and 3 provide additional details of the orientation of the feedwater spargers. Each of the four feedwater nozzles (N4A through N4D) are equipped with a separate sparger.
