B. AHLUWALIA, PH.D.
RADIOLOGICAL PHYSICIST

REPORT OF TELETHERAPY TESTS AND SURVEYS

Licensee St. Joseph Regional Medical Center of North Oklahoma, Inc.
Address 14th and Hartford, P. O. Box 1270, Ponca City, Oklahoma 74602
License # 35-14046-01

FIVE YEAR INSPECTION & PREVENTATIVE MAINTENANCE REPORT

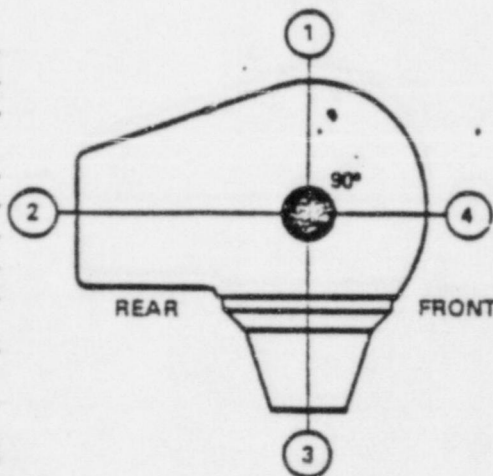
View A-Vertical
from left side

Position No.	Radiation Level (mr/hr)
View A	1 <u>2.8</u>
	2 <u>0.4</u>
	3 <u>6.8</u>
	4 <u>1.4</u>
View B	5 <u>1.2</u>
	6 <u>1.6</u>
	7 <u>2.2</u>
	8 <u>1.3</u>
View C	9 <u>0.5</u>
	10 <u>0.5</u>
View D	11 <u>1.2</u>
	12 <u>1.8</u>
	13 <u>1.2</u>
	14 <u>1.3</u>
Average value	<u>1.73</u>
Maximum value	<u>6.8</u>

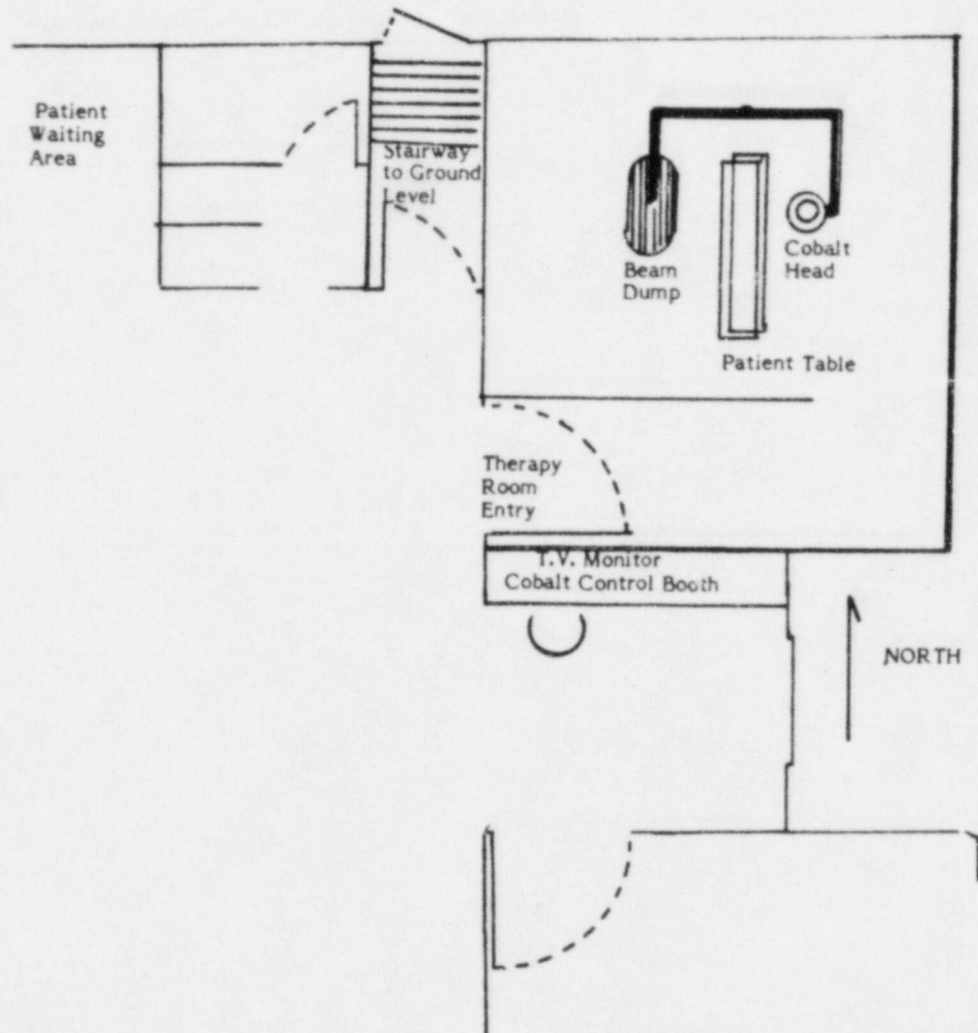
PLAN OF RADIATION THERAPY AREA
(Not to scale)

* Position (keyed to sketches)	** Maximum Radiation Level (mR/hr)	Restricted Area?	Beam Orienta- tion	Maximum Field Size at a Specified Distance	Beam Catcher Used?	Phantom in Beam?	Beam Calibration		
							Distance	Field Size	Ra /
Roof	0.04, 0.1	No	0, 90	30 x 30	Yes	Water Phantom	80.0 cm	Output in Roentgen per min. i) for 10x10 cm field size 164.1 ii) for 25x25 cm field size 177.23	
Roof	0.5, 1.8	No	145, 180 Degrees						
Roof	0.1	No	270	"	"	"			
Therapy Room Door	0.05	Yes	0, 90, 145 180, 270	"	"	"			
Stairway	0.05, 1.5	No	0, 90	"	"	"			
Stairway	0.3, 0.07	No	145, 180 & 270	"	"	"			
Ground Level SE of Therapy	0.04	No	All Above	"	"	"			
Control Booth	0.02 0.03	Yes Yes	0, 90, 270 145, 180	"	"	"			
Storage Area Under Therapy	0.03 0.04	No No	0 90, 145 180 & 270 Degrees	"	"	"			
Instrument used: Victoreen Model Thyac III, Probe Model 469, Sr# 4313M							RHM 6805.6	5726 Curies
