Department of Energy
Albuquerque Operations Office
P.O. Box 5400
Albuquerque, New Mexico 87185-5400

May 5, 1997

**SOUTH CLIVE SITE
URANIUM MILL TAILINGS REMEDIAL ACTION
COMPLETION REPORT**

ENGINEERED REPAIR WORK OF SOUTH CLIVE DISPOSAL CELL

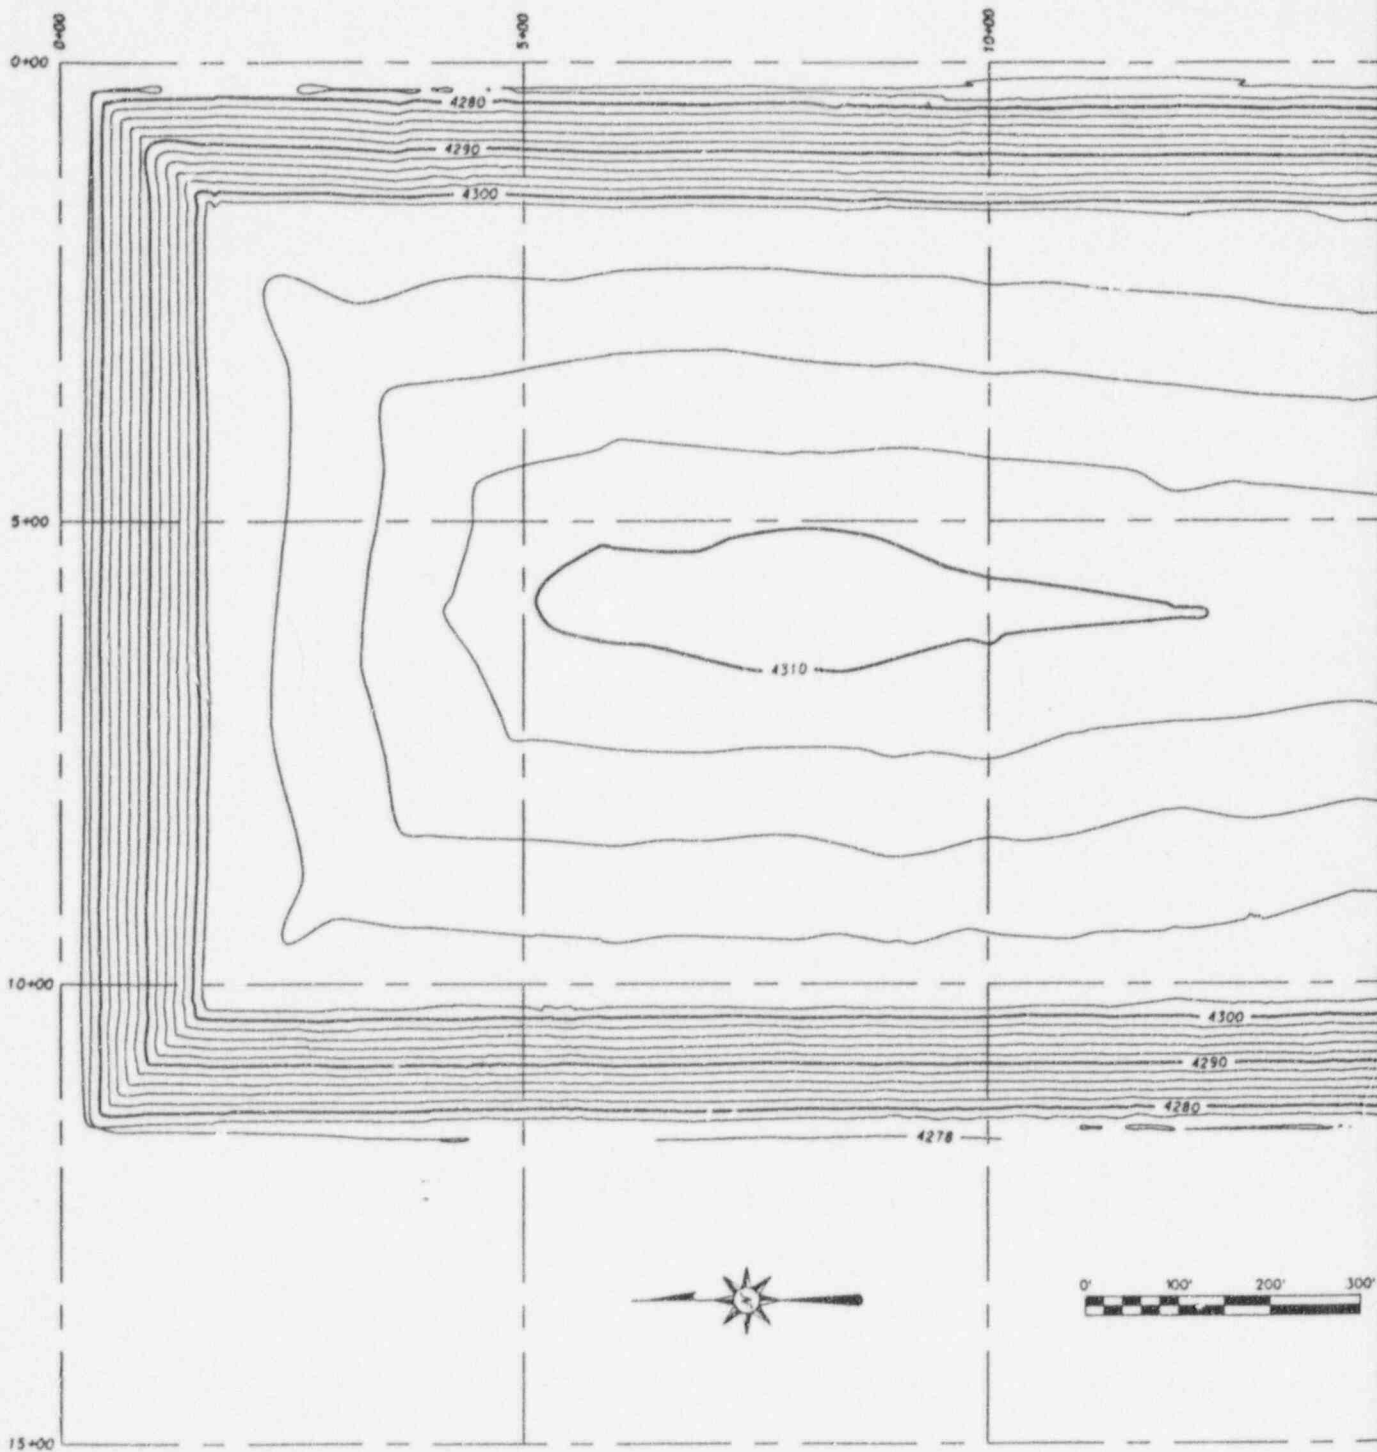
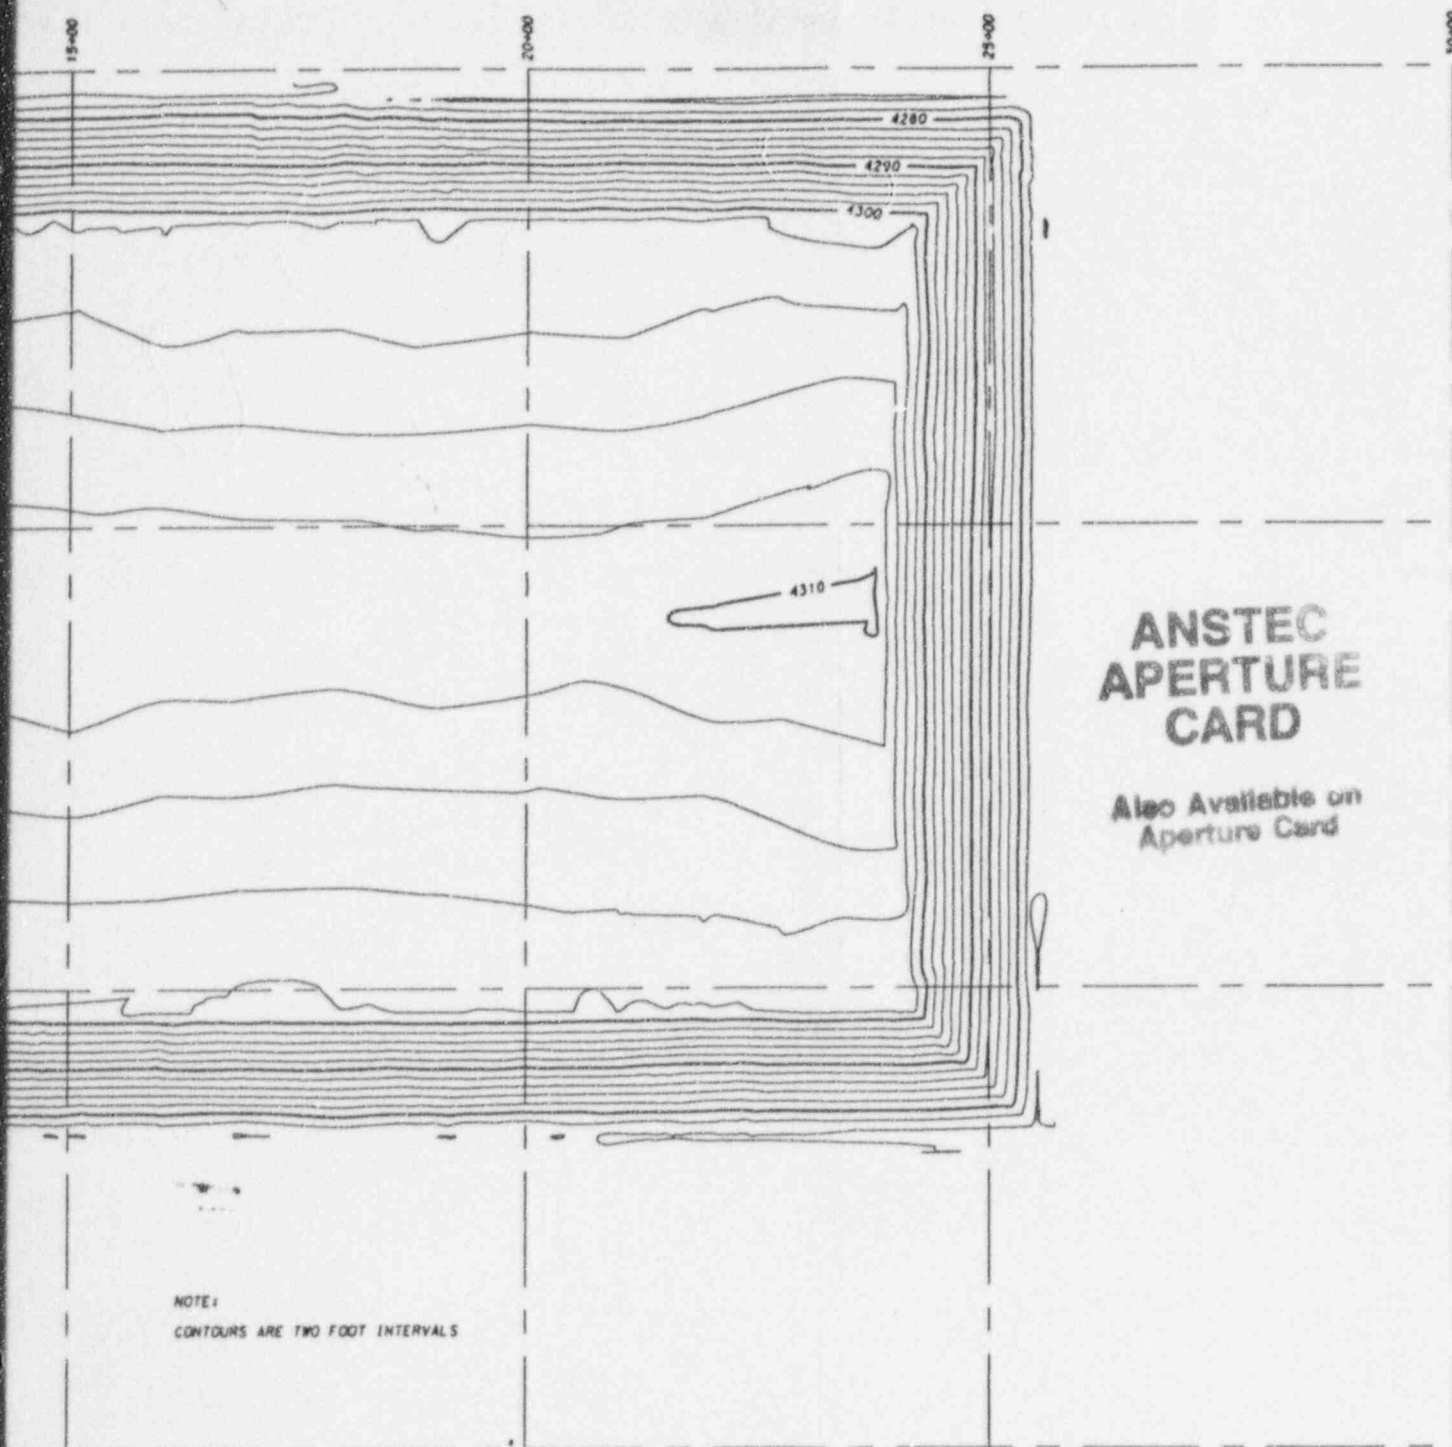
Figure 5 is the final as-built drawing and represents the condition of the cell following rework which was performed from November 1996 through March 1997. (Reference Appendices K and L.)

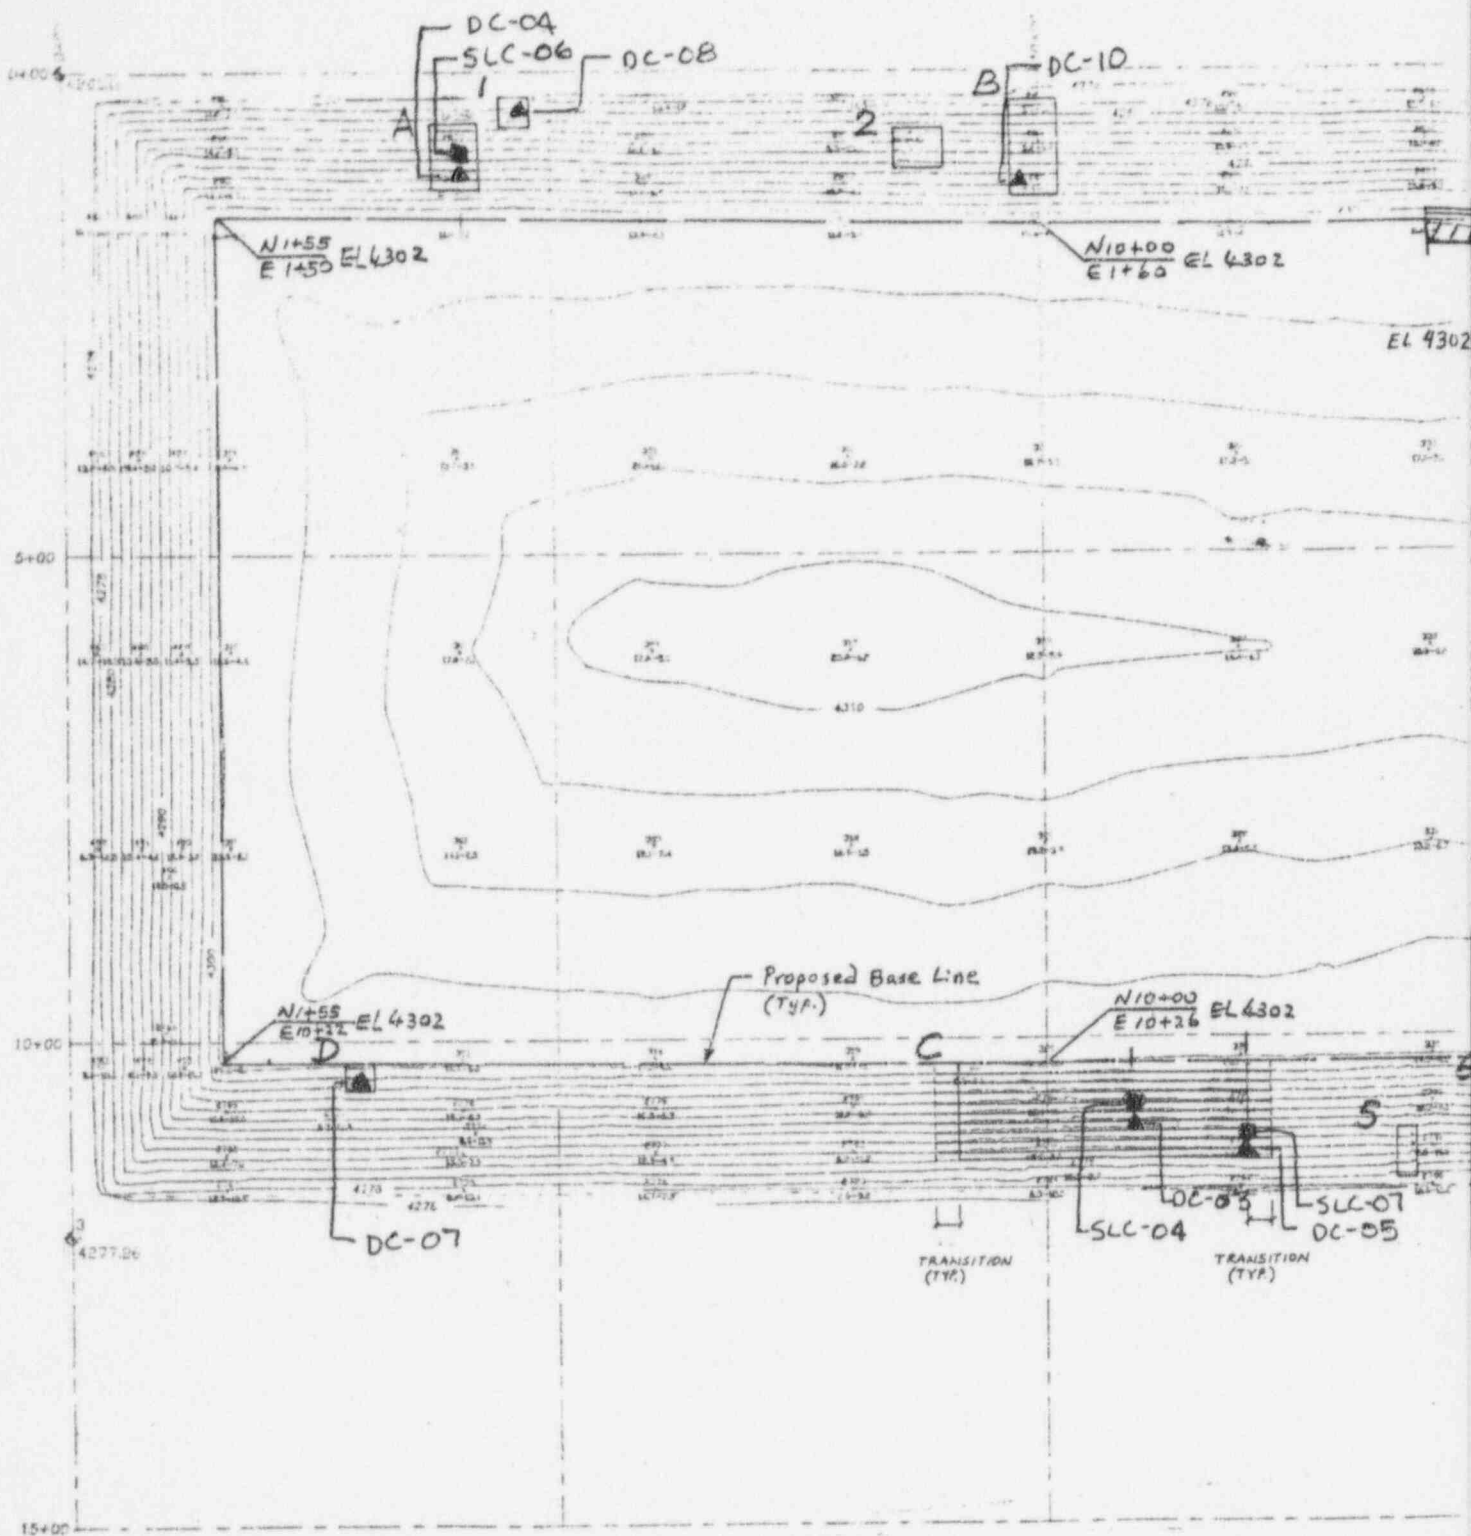
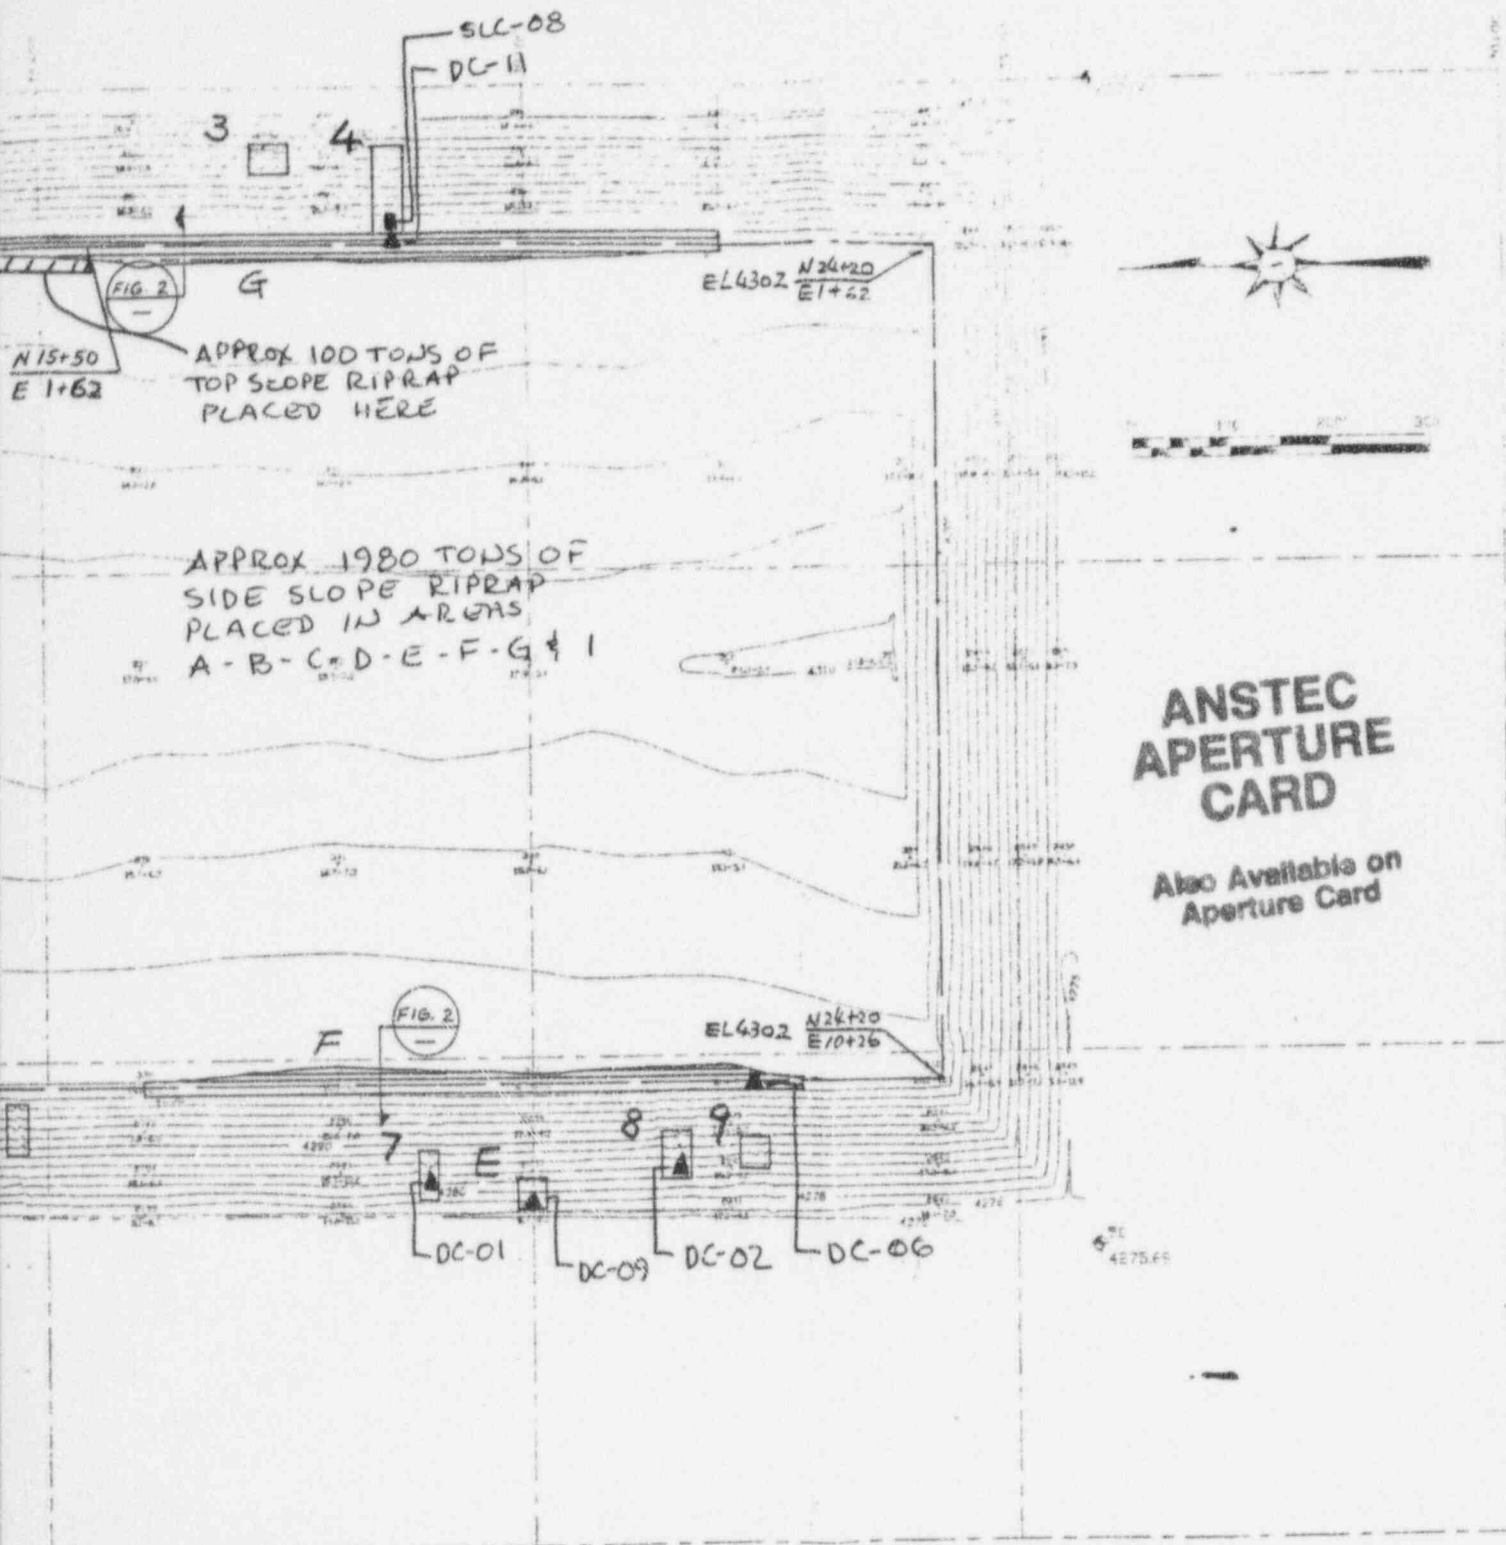
EXHIBIT 4

Exhibit 4 shows the detailed locations where riprap repair and in-place testing was performed.

In Exhibit 4, the as-built drawing depicts the various repair or re-graded areas. These are designated Areas A through I, and are the locations in which depth checks and gradations were performed. All of the disposal cell repair work was performed in accordance with recommendations and technical requirements in the Engineering Assessment (Appendix K).

2. Small areas on the cell of segregated fine particle size riprap material were removed, and were replaced with new riprap material meeting technical design requirements for quality, particle size, and layer thickness.
