SOUTHERN CALIFORNIA

Subject: Docket No. 50-362  
30 Day Report  
Licensee Event Report No. 97-001  
San Onofre Nuclear Generating Station, Unit 3

LICENSEE EVENT REPORT (LER)																
Facility Name (1) SAN ONOFRE NUCLEAR GENERATING STATION, UNIT 2										Docket Number (2) 0   5   0   0   0   3   6   2			Page (3) 1 of 0   5			
Title (4) Reactor Coolant System Leakage - Instrument Thermowell Nozzles																
EVENT DATE (5)			LER NUMBER (6)				REPORT DATE (7)			OTHER FACILITIES INVOLVED (8)						
Month	Day	Year	Year	///	Sequential Number	///	Revision Number	Month	Day	Year	Facility Names		Docket Number(s)			
0   4	1   2	9   7	9   7	---	0   0   1	---	0   0	0   5	0   9	9   7	None					
OPERATING MODE (9) 2			THIS REPORT IS SUBMITTED PURSUANT TO THE REQUIREMENTS OF 10CFR (Check one or more of the following) (11)													
POWER LEVEL (10) 0   0   0			20.402(b)				20.405(c)				50.73(a)(2)(iv)				73.71(b)

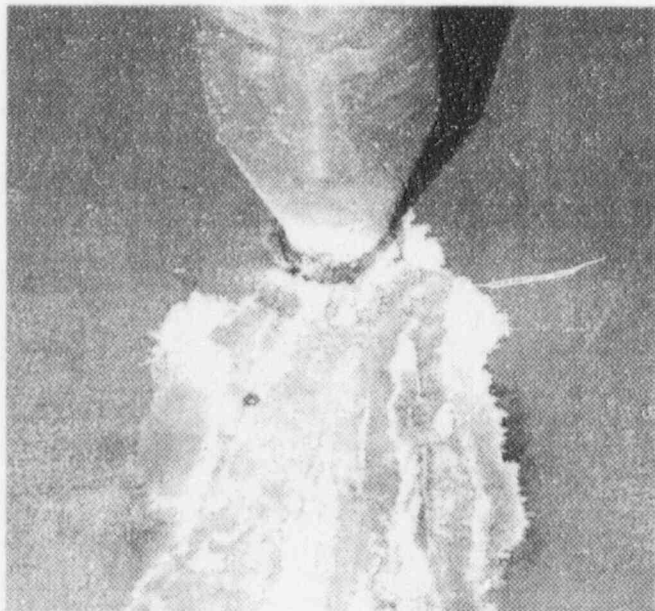
Figure 1  
Hot Leg Loop 2 Narrow Range Temperature

Based on evaluation of the leak size, leak location, deposition of boric acid crystals, and previous experience with Inconel 600 nozzle leakage, Edison suspects the leakage is from a crack through the nozzle in the heat affected zone (HAZ) of the partial penetration weld on each of the instrument nozzles. Historically, Edison has determined that similar cracks were caused by Primary Water Stress Corrosion Cracking (PWSCC) of alloy 600 type materials. Therefore, cracking of Inconel 600 material is well known, and is believed to be the root cause of the leaks.

Edison will replace the outer half of the Inconel 600 material of the original nozzles with Inconel 690. Required welding will be completed in accordance with the ASME III, Class 1 welding guidelines. [Note: This repair is similar to that reported in LER 2-97-004; see additional information section below.]

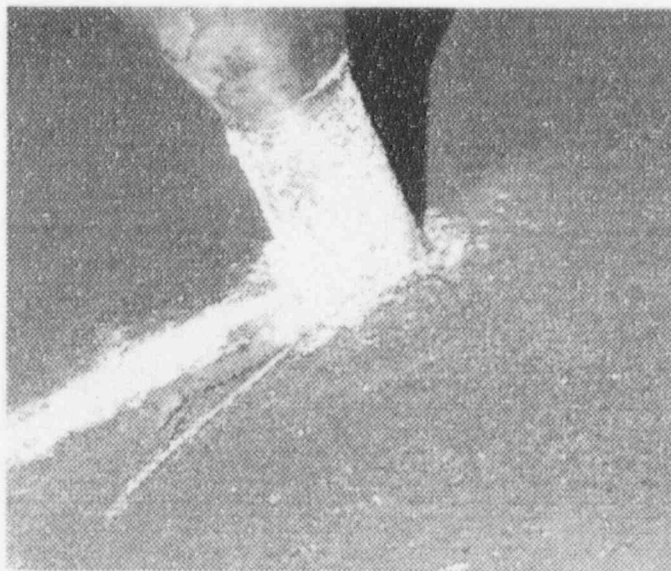
Figure 3  
Steam Generator Channel C Differential Pressure

Four of these nozzles (temperature measurement) were originally designed and installed as a one piece nozzle made of Inconel 600 welded with a J-Groove weld on the inside of the RCS piping (see Figures 1-5). The pressure measurement nozzle differs from the temperature nozzles in that it has a SA-182, F316 stainless steel socket butt welded to the Inconel 600 nozzle shank.
