## LICENSEE EVENT REPORT (LER)

Millstone Nuclear Power Station Unit 2

Leakage Through Letdown Valves 2-CH-089 and 2-CH-515

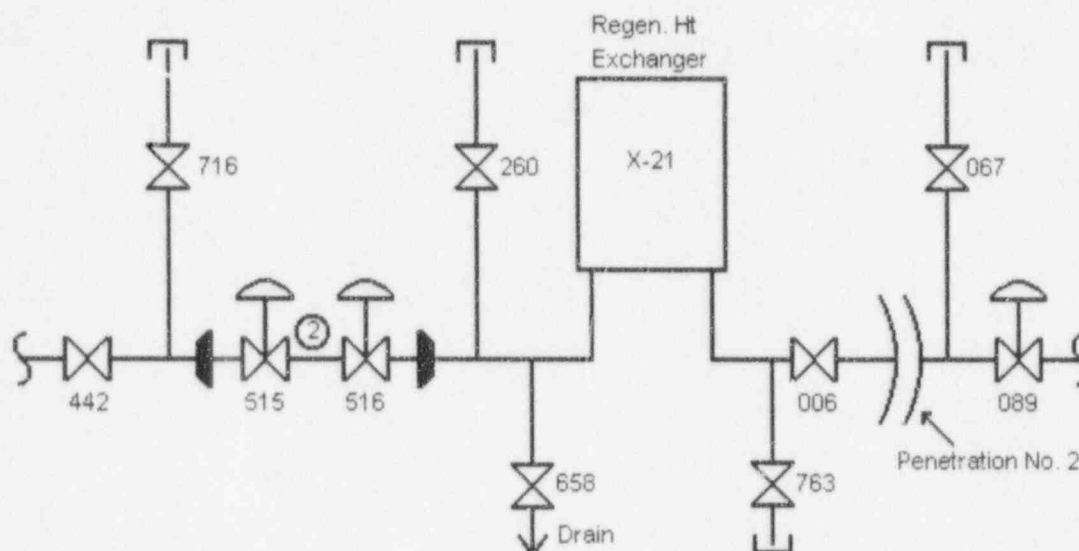
FIGURE 1

The Letdown flow path, shown in Figure 1, contains three Fisher air-operated globe valves, 2-CH-089, 2-CH-515 and 2-CH-516 which provide Containment isolation and/or Letdown isolation following receipt of a Safety Injection Actuation Signal (SIAS) or Containment Isolation Actuation Signal (CIAS). Isolation of the Letdown line achieves two safety functions, Reactor Coolant System (RCS) inventory control and prevention of an uncontrolled release of radioactive material. On August 30, 1993, with the Unit in Mode 1 at 100% power, a final engineering analysis performed to assess the consequences of leakage through 2-CH-089 and 2-CH-515, concluded that for this particular scenario, a double-ended letdown line break downstream of 2-CH-089 with failure of 2-CH-516 to close would result in some leakage from the RCS to an area outside of Containment and was thus reportable. (It is noted that a preliminary engineering analysis had previously concluded on July 23, 1993, that the leakage was not reportable.) These two valves, 2-CH-089 and 2-CH-515, would not have been able to perform part of their intended function, Letdown isolation at full system pressure.

A fire in Fire Area R-1 is assumed to generate spurious control signals that prevent closure of two of the three letdown valves, 2-CH-515 and 2-CH-516, coincident with loss of charging capability for 4 hours. The reported leakage of 20 to 30 gallons per minute would have exceeded the assumed RCS leakage rate of 15 gpm, if valve 2-CH-089 had been relied upon to isolate the RCS letdown line.

1. Appropriate procedures shall be revised prior to entry into Mode 4 from the current outage to ensure that proper valve control parameters (bench set, air regulator, and stroke length) are specified and verified after any maintenance activities are performed that could affect dual function valve closing forces. (This commitment was previously sent to the NRC in LER 336/97-011-00, NNECO Commitment No. B16372-01.)
2. The affected valves will be adjusted to ensure they properly close against containment design pressure and NOSP, and they will be tested to ensure Appendix J, Type C leakage rate testing criteria are met. These activities will be performed prior to entry into Mode 4 from the current outage. (This commitment was previously sent to the NRC in LER 336/97-011-00, NNECO Commitment No. B16372-02.)
