UNITED STATES
NUCLEAR REGULATORY COMMISSION
REGION II
101 MARIETTA STREET, N.W., SUITE 2900
ATLANTA, GEORGIA 30323-0199

March 27, 1996

Florida Power Corporation
Crystal River Energy Complex
Mr. P. M. Beard, Jr. (SA2A)
Sr. VP, Nuclear Operations
ATTN: Mgr., Nuclear Licensing
15760 West Power Line Street
Crystal River, FL 34428-6708

SUBJECT: PLANT PERFORMANCE REVIEW (PPR) - CRYSTAL RIVER 3

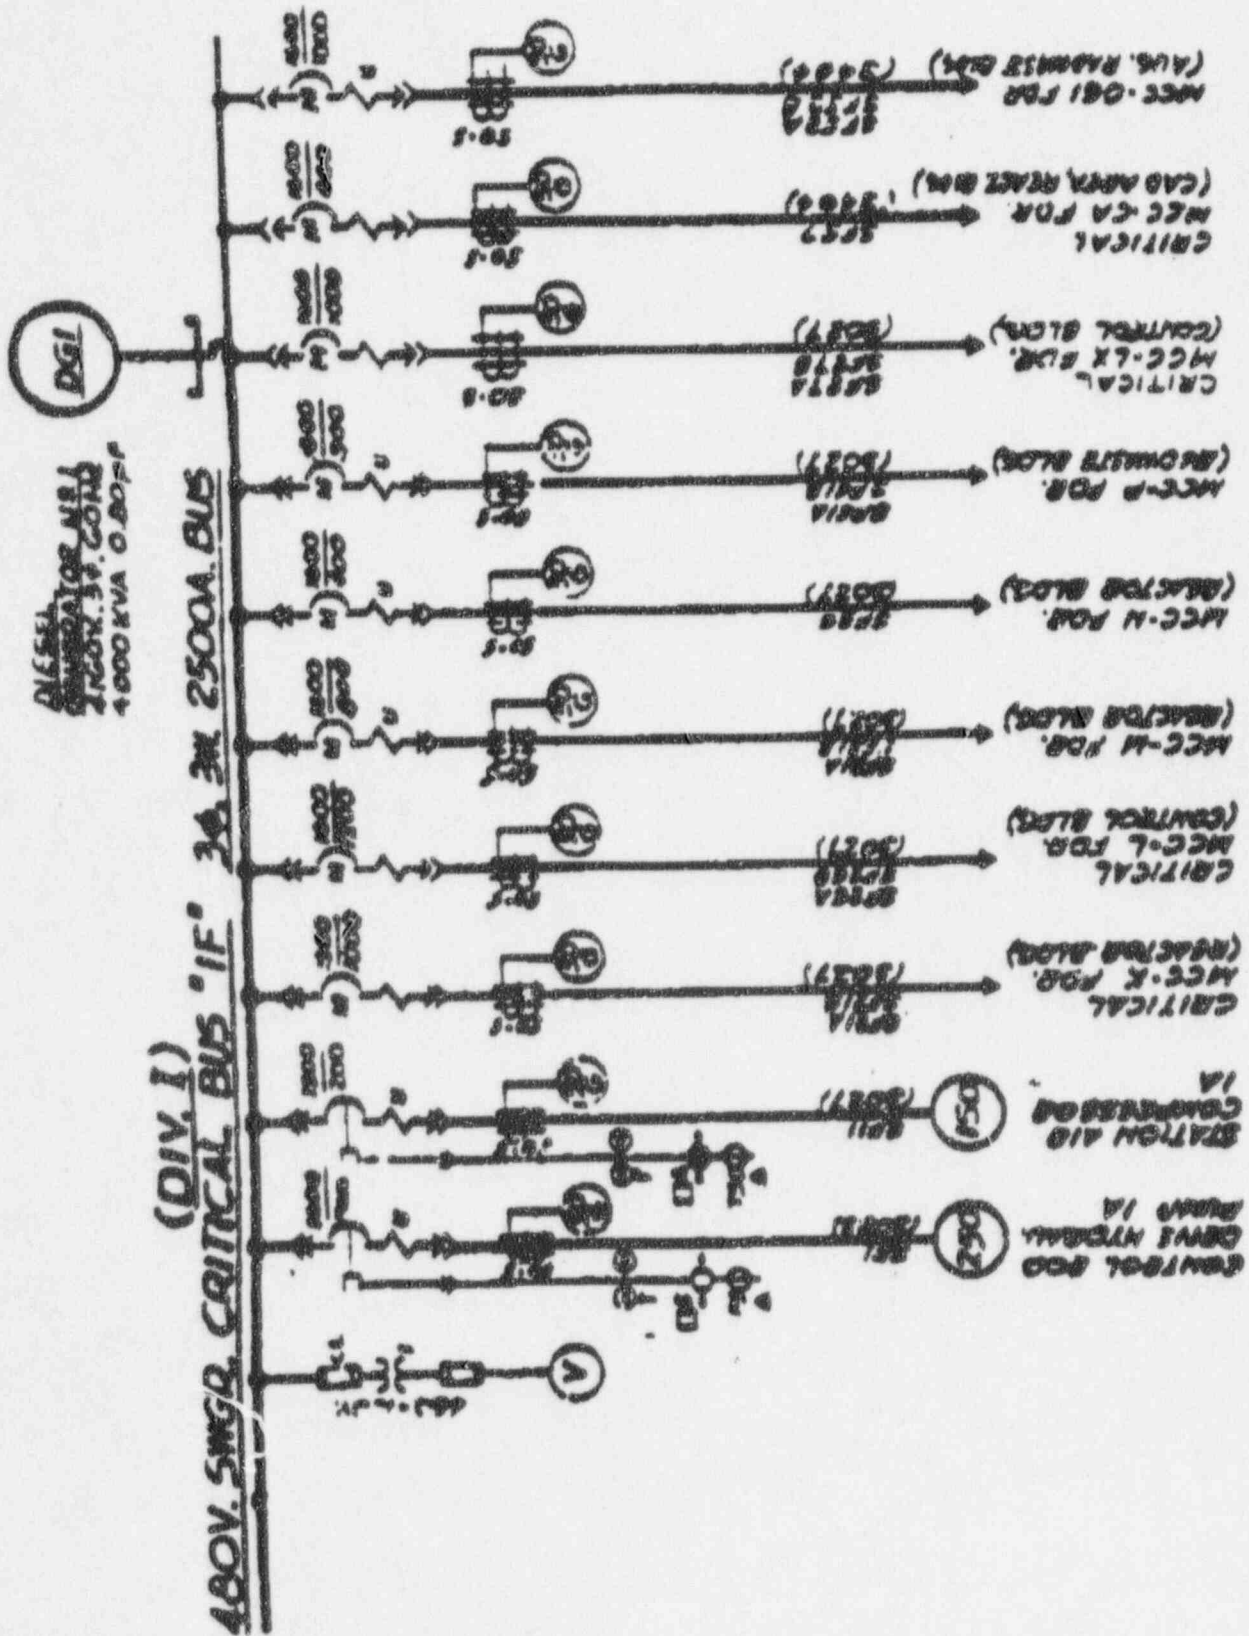
FIGURE 1 - COOPER DIVISION 1480 VAC CRITICAL BUS "1F"

- LICENSEE AND A VENDOR REPRESENTATIVE INSPECTED ALL SIMILAR UNIT 2 BREAKERS. SWITCHES WERE FOUND WITH SCRATCHES OR "MOLD MARKS" BUT NONE OF THE CONDITIONS WERE JUDGED SIGNIFICANT. NONE OF THE CUTOFF SWITCHES WERE FOUND WITH LOOSE SCREWS.
