U.S. NUCLEAR REGULATORY COMMISSION
REGION IV

Report No.: 40-6659/97-01

Licensee: Petrotomics Company

Facility: Former Shirley Basin Uranium Mill

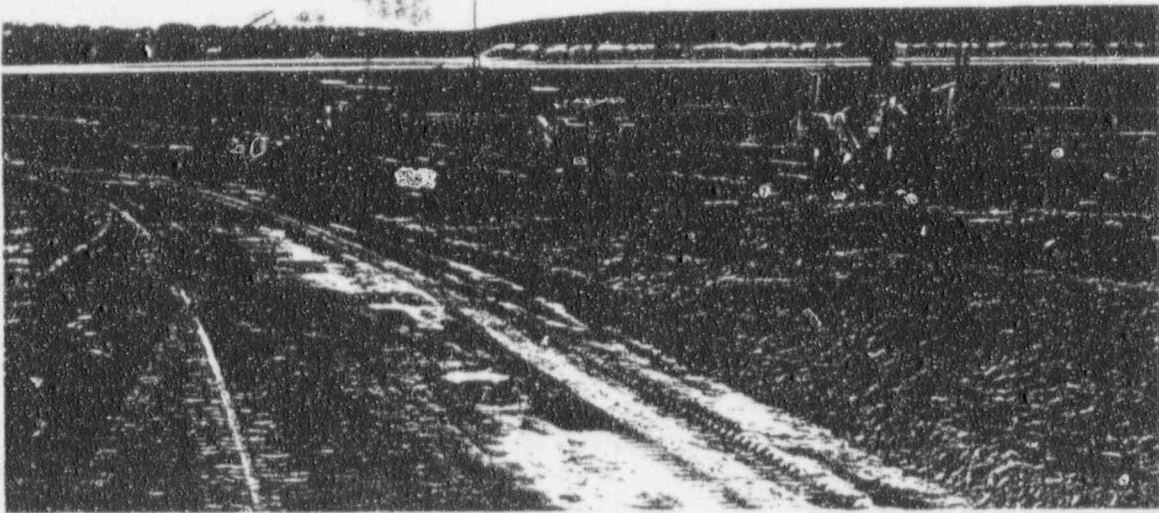
Photo 1 Collection of clay from borrow area for installation on tailings pile.

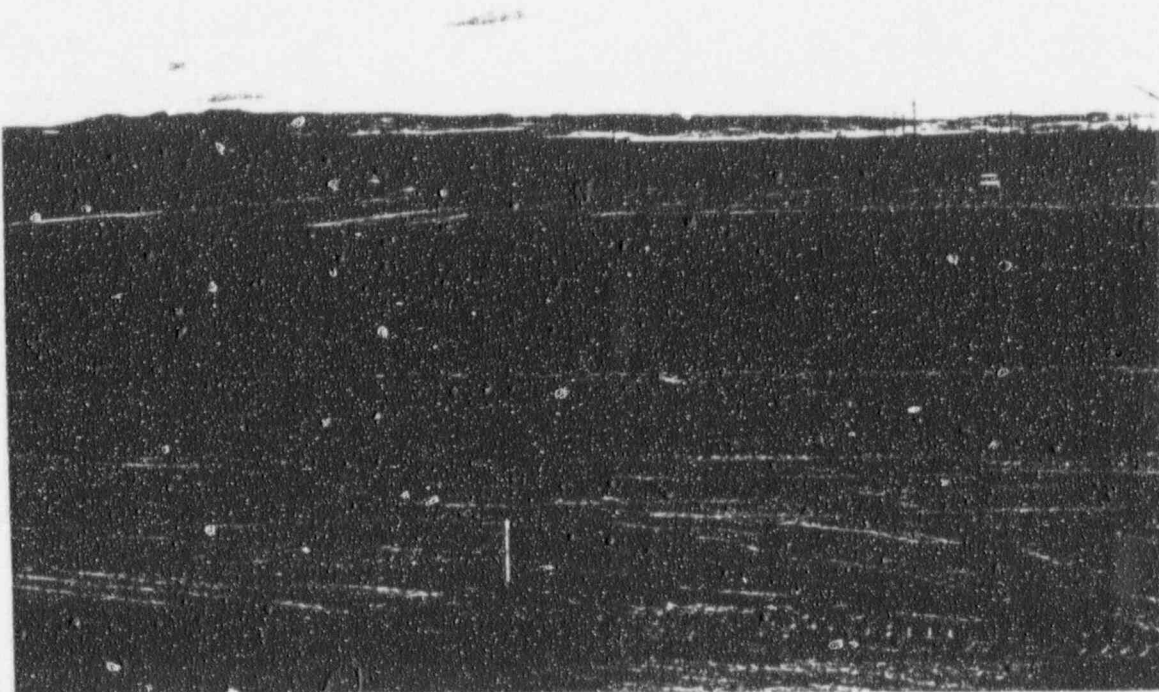
However, one settlement monitor (No. 6, which was located in the western portion of the tailings impoundment) has not reached the 90 percent settlement point. The licensee previously installed additional soil on top of this area (a process called surcharging) to assist in the settlement process. If the area fails to settle in a timely manner, the licensee cannot install the final radon barrier over this portion of the tailings pile during the 1997 construction season. Consequently, the licensee will not be able to meet the October 31, 1997, deadline that is stipulated in License Condition 50.A(3). The licensee plans to continue discussions with the NRC involving their options related to the settlement of the tailings pile around settlement monitor No. 6.

Photo 2 Surcharged area around Settlement Monitor No 6; reclamation of tailings in progress in background.

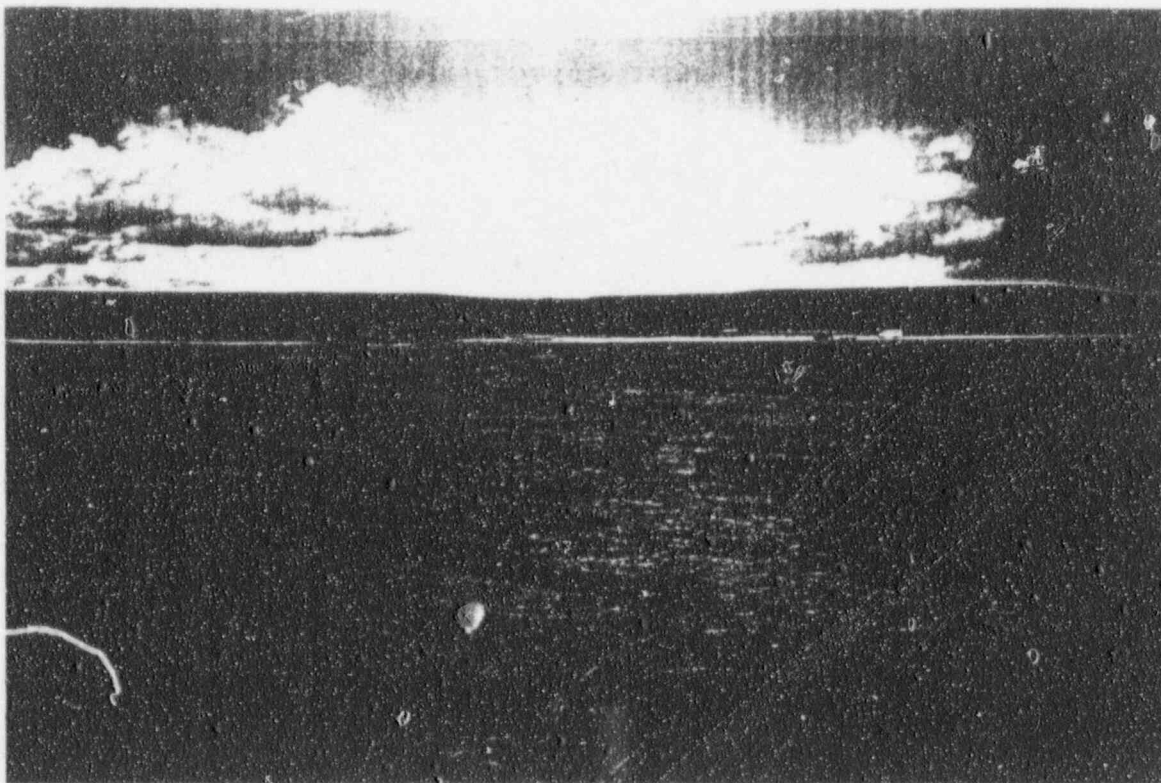
Photo 3 Area of tailings impoundment recently seeded for vegetation growth.

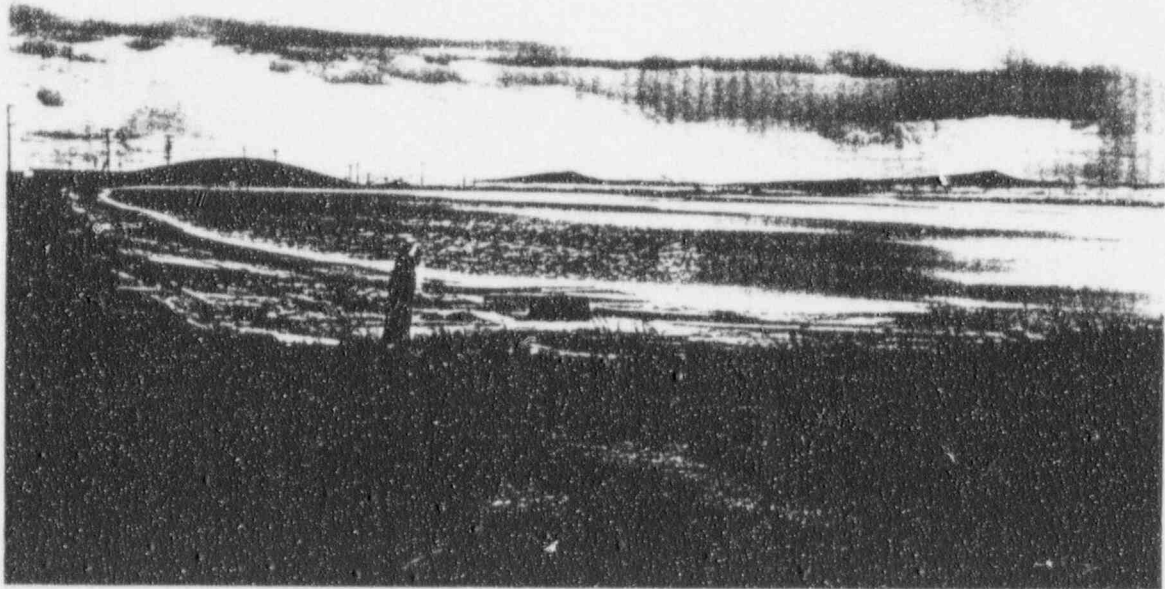
Photo 5 Stage I evaporation pond; enhanced evaporation system in service on right.

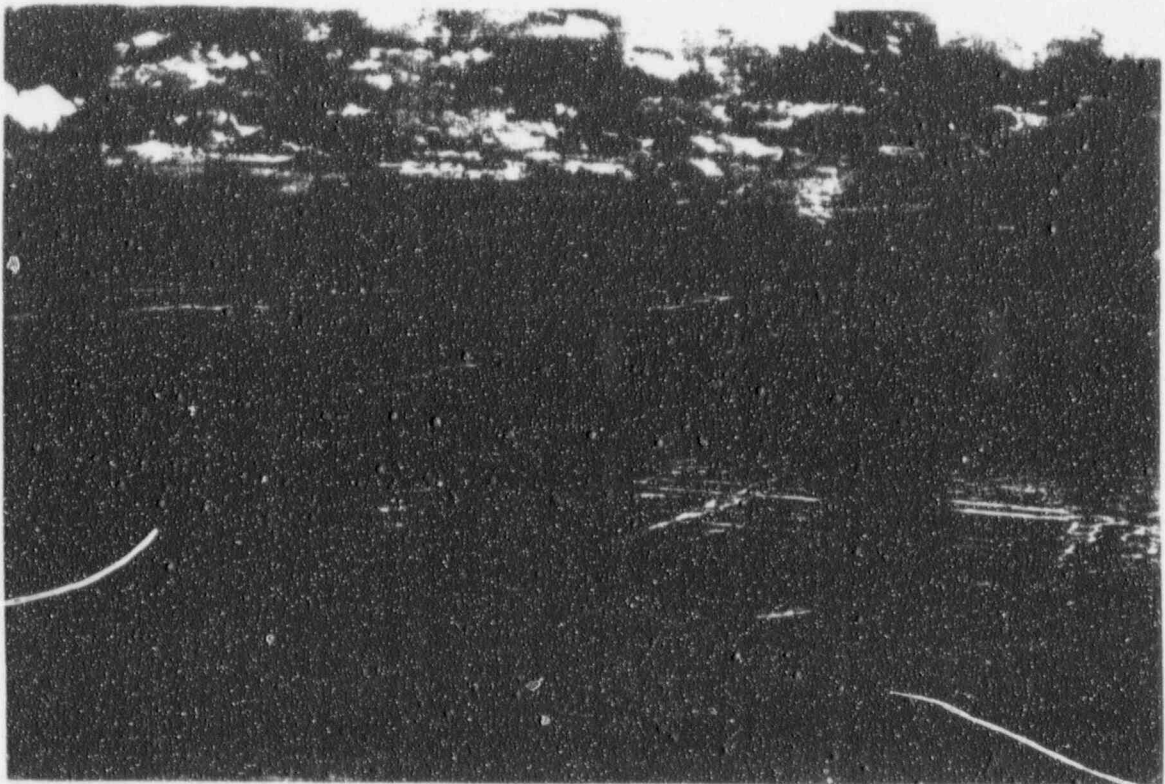
Photo 6 Enhanced evaporation system in service at Stage I pond

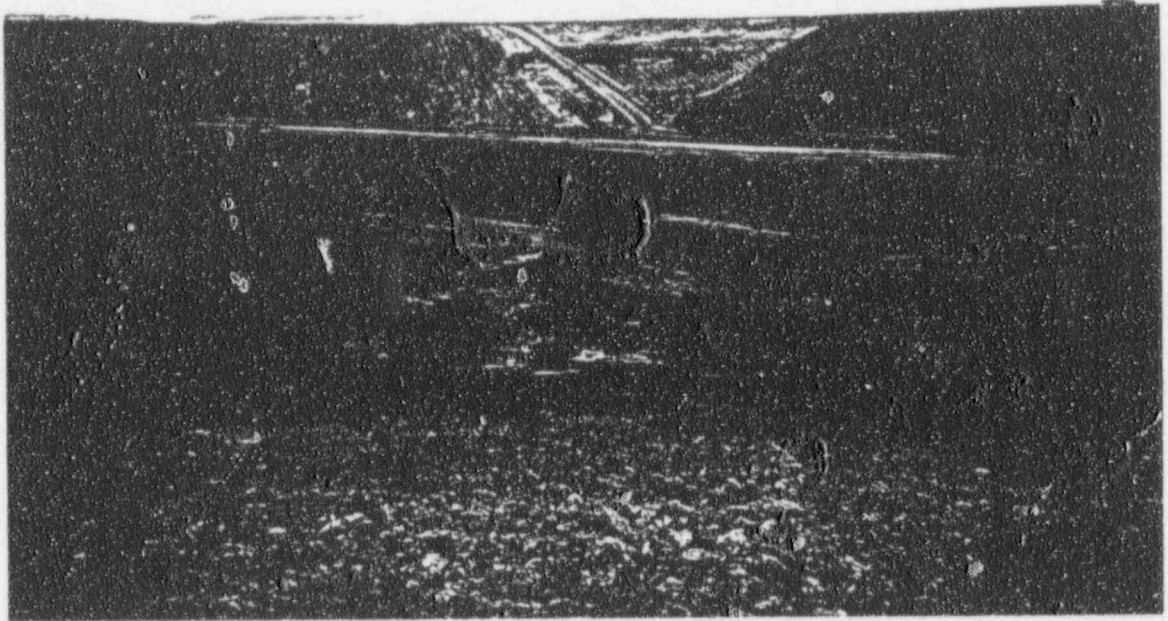
Besides construction work of the radon barrier, the licensee also was performing repair work on their former mine, Pit 4. Pit 4, an open pit mine located near the tailings pile, was drained during August-September 1996. The water, totalling roughly 43 million gallons, was temporarily relocated to the east drainage basin (formerly the mill's freshwater pond) adjacent to the tailings pile. Following the dewatering of Pit 4, the eastern slope of the pit was reworked to repair damage caused by the failure of the slope. Repair of Pit 4 began in August 1996 in accordance with a State-approved reclamation plan. The Pit 4 repair work was expected to be completed in early-June 1997. The water in the east drainage basin was being utilized in the tailings reclamation work. The licensee plans to evaporate any remaining fluid in the east drainage basin by next year.

Photo 7 Former Pit 4 mine being reworked in accordance with state-approved reclamation plan.

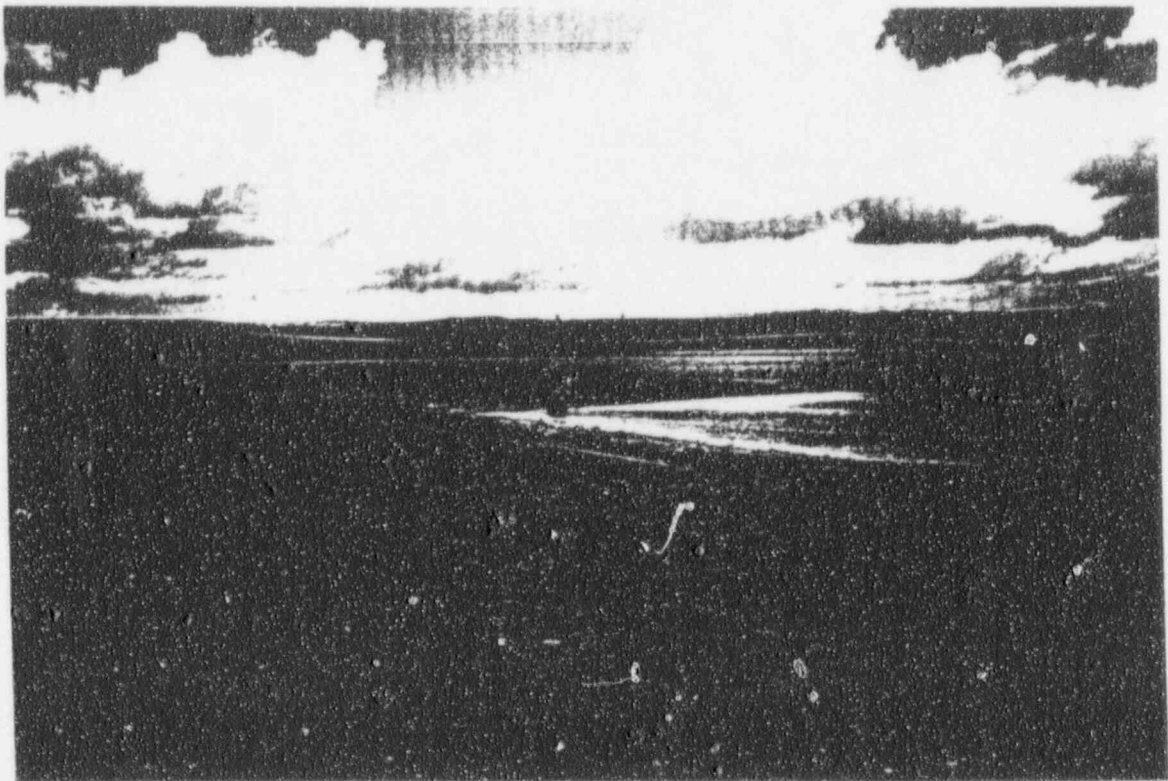
Photo 8 East Drainage Basin location where Pit 4 water was pumped in 1996; water truck collection point can be seen.
