Subject: LICENSEE EVENT REPORT (LER) 96-019-01

CRYSTAL RIVER UNIT 3

Classification of Transfer Switch Causes Potential for Loss of Power to ES Status Lights

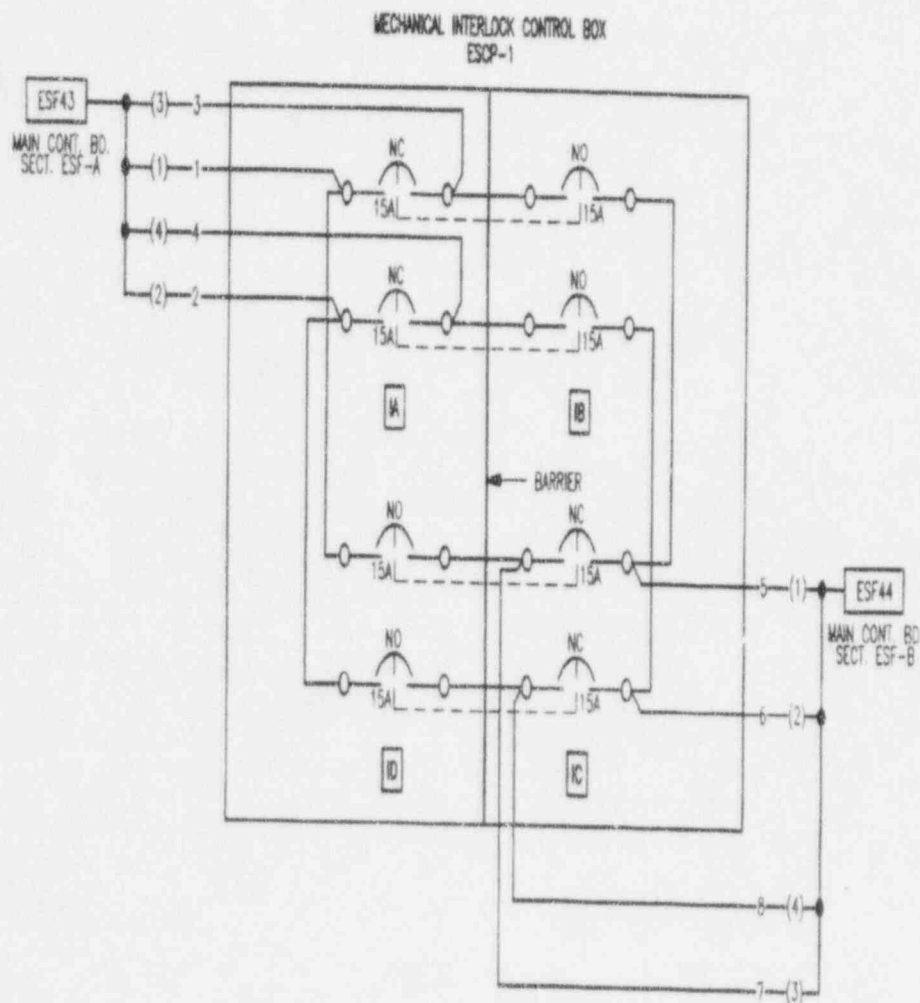
Figure 1

The primary concern is that a non-safety related/non-qualified component is installed in a safety related system. Power to ESCP-1 is fed from 120 volt vital bus distribution panels [EF,UJX] VBDP-3 and VBDP-4. The function of ESCP-1 is to ensure continuity of power from the vital bus distribution panels to their respective ES indicating light matrices and, as required, provide continuity of power to the light matrices from one power distribution panel. ESCP-1 is a passive device that performs no automatic safety function.

ESCP-1 is located behind the ES section of the MCB and consists of four manual bus transfer switches used to select the source of power to the ES status boards. See Figure 1. A failure or multiple failures of the non-safety normally closed (NC) switches could cause a loss of "A" or "B" status indication thus preventing the function from being fulfilled. There is no credible failure of a normally open non-safety switch that would cross connect the vital busses. Note that these switches are for the ES status boards on the MCB only and do not provide an alternate power source for the ES actuation channels. Further, if a loss of ES status lights were to occur, the operator would have available redundant ES status lights were to occur, the operator would have available redundant ES equipment indication via the indicating lights on the MCB for each pump and valve.

The existence of procedural controls to prevent cross connection of the vital busses was immediately confirmed. Subsequently, the normally open switches on ESCP-1 were tagged open by administrative clearance.

As indicated in FPC letter to the NRC, 3F1296-20, dated December 19, 1996, ESCP-1 will be upgraded to safety related. The modification to upgrade ESCP-1 is identified as a FPC Restart Issue, D-21. This modification is currently scheduled for installation by the end of July, 1997.
