PRECURSOR DESCRIPTION AND DATA

NSIC Accession Number: 159134

Title: Loss of Offsite Power at Arkansas Nuclear 1

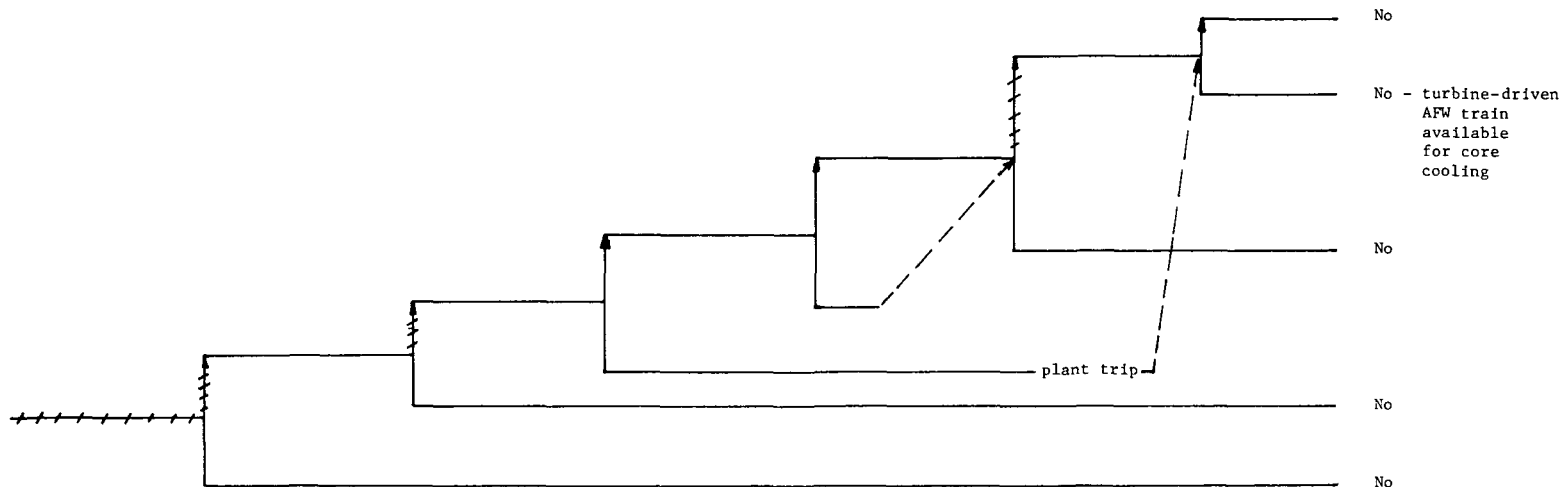
Reactor at 100% power and loss of 500-kV line due to ground fault (one 500-kV previously out of service)	Loss of second 500-kV line due to overload	Loss of 161-kV line due to overload	Manual reactor runback and subsequent reactor trip	Auxiliary loads transferred to startup transformer #1 (which was already experiencing low output voltage)	Faulted relay results in SU transformer #1 lockout (loss of voltage on all auxiliary buses)	Diesel generators start and provide power to safety-related loads
--	--	-------------------------------------	--	---	---	---

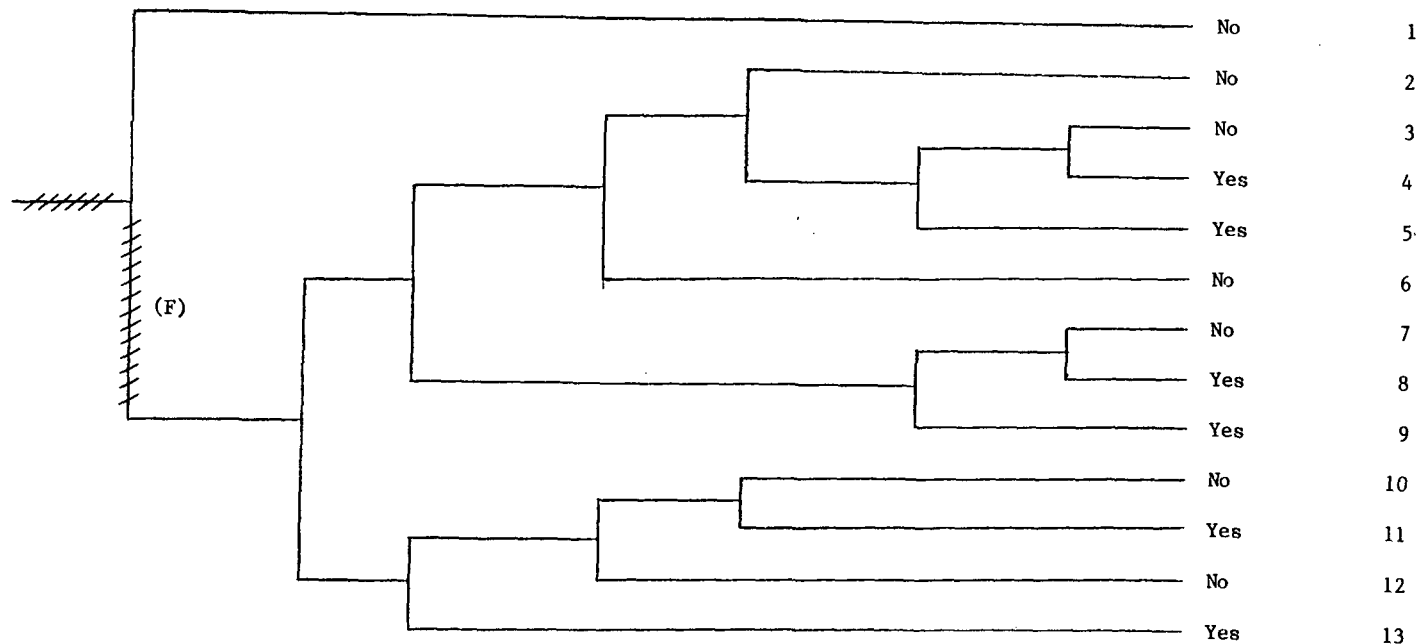
NSIC 159134 - Sequence of Interest for Loss of Offsite Power at Arkansas Nuclear - Unit 1

Loss of Offsite Power	Turbine Generator Runs Back and Assumes House Loads	Emergency Power	Auxiliary Feedwater and Secondary Heat Removal	PORV Demanded	PORV or PORV Isolation Valve Closure	High Pressure Injection	Long Term Core Cooling	Potential Severe Core Damage	Sequence No.
-----------------------	---	-----------------	--	---------------	--------------------------------------	-------------------------	------------------------	------------------------------	--------------
