PRECURSOR DESCRIPTION AND DATA

NSIC Accession Number: 158279

Title: Degraded Emergency Feedwater System During a Loss of Offsite Power at Arkansas Unit 2

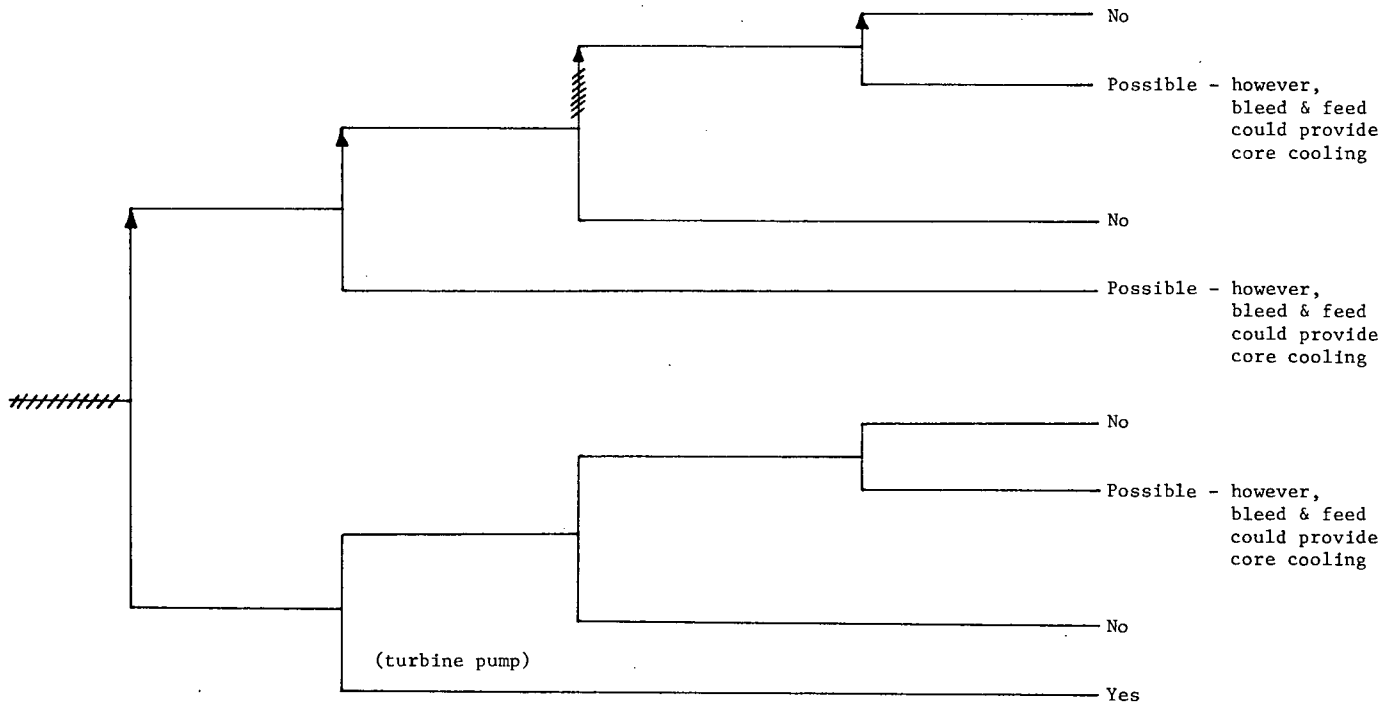
4. Approximately 15 min after the LOOP, emergency feedwater flow became erratic with flow rate oscillating between 80% and 100% of rated flow due to cavitation. This was caused by flashing of the startup and blowdown demineralizer effluent.

Loss of offsite power	Diesel generators supply power to safety-related loads	Emergency feedwater provided to steam generators	Emergency feedwater pumps cavitate due to mixing of hot startup and blow-down demineralizer effluent with CST flow	Demineralizer effluent isolated and EFW pumps vented	Potential Severe Core Damage
-----------------------	--	--	--	--	------------------------------

NSIC 158279 - Actual Occurrence for Degraded Emergency Feedwater System During a Loss of Offsite Power at Arkansas Unit 2

5. The startup and blowdown demineralizer effluent was isolated from the EFW pump suction and both EFW pumps were alternately stopped, vented, and restarted.

Offsite power was restored via startup transformers ST-2 and ST-3. The EFW system operating procedures were revised to require isolation of the startup and blowdown effluent prior to exceeding 5% power.

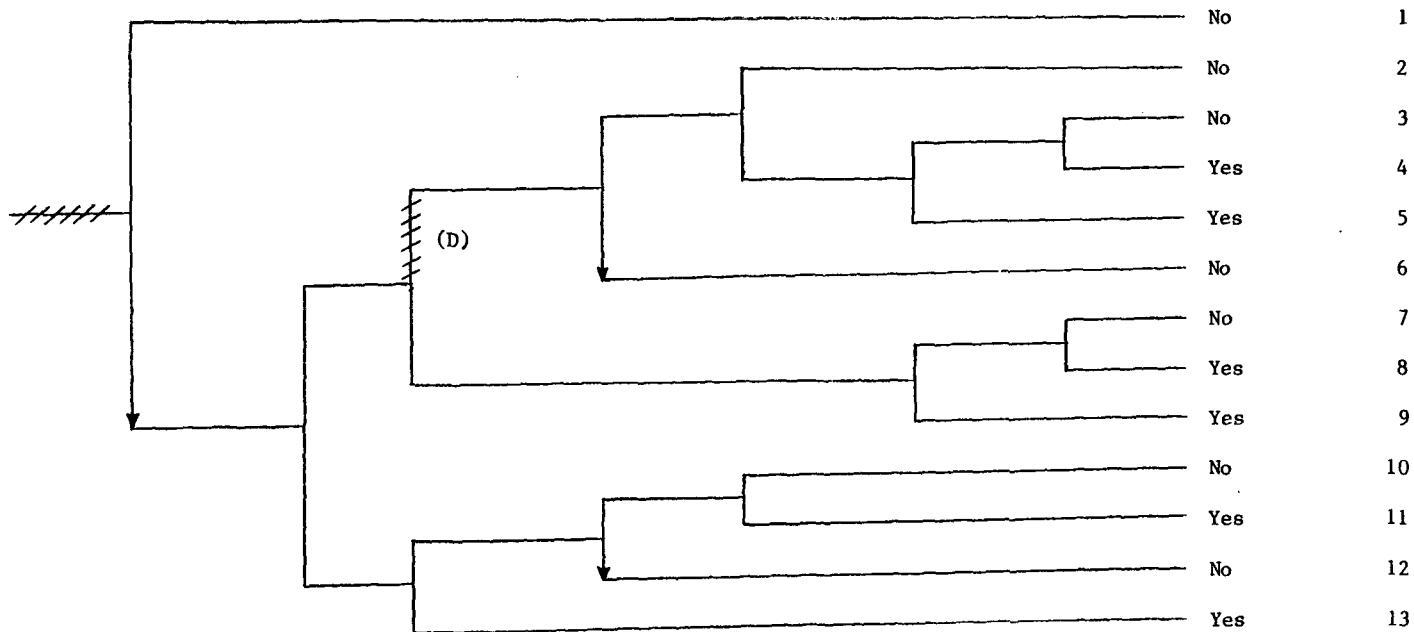
Loss of Offsite Power	Turbine Generator Runs Back and Assumes House Loads	Emergency Power	Auxiliary Feedwater and Secondary Heat Removal	PORV Demanded	PORV or PORV Isolation Valve Closure	High Pressure Injection	Long Term Core Cooling	Potential Severe Core Damage	Sequence No.
-----------------------	---	-----------------	--	---------------	--------------------------------------	-------------------------	------------------------	------------------------------	--------------

NSIC 158279 - Sequence of Interest for Degraded Emergency Feedwater System During a Loss of Offsite Power at Arkansas Unit 2
