PRECURSOR DESCRIPTION AND DATA

NSIC Accession Number: 166082

Title: Loss of RCIC and HPCI Systems at Brunswick 2

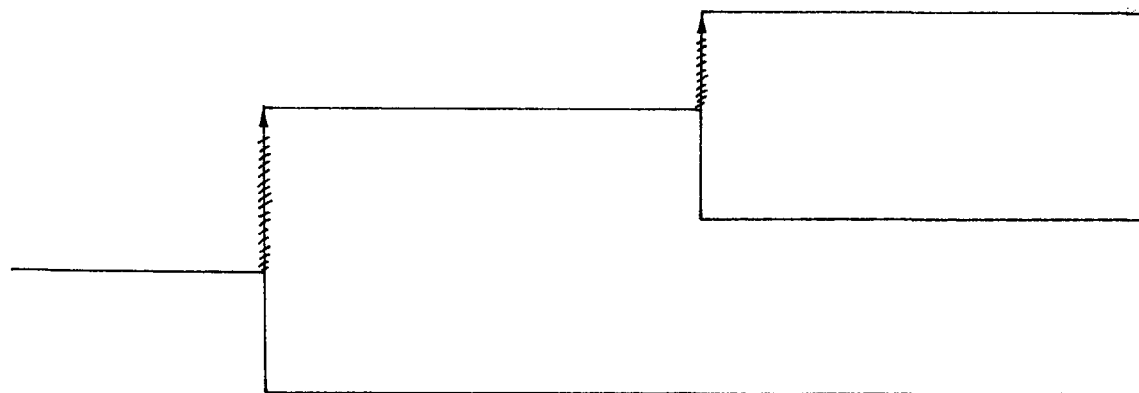
HPCI test is under way with reactor at 37% power	HPCI injection valve fails to open due to burned motor windings, resulting in HPCI inoperability	RCIC found inoperative due to failed resistor in turbine governor
--	--	---

Potential
Severe
Core
Damage

No - no requirement
for HPCI, RCIC
