Accident Sequence Precursor Program Event Analysis

LER No: 455/88-008
 Event Description: Loss of feedwater and one train of auxiliary feedwater tripped
 Date of Event: July 14, 1988
 Plant: Byron Unit 2

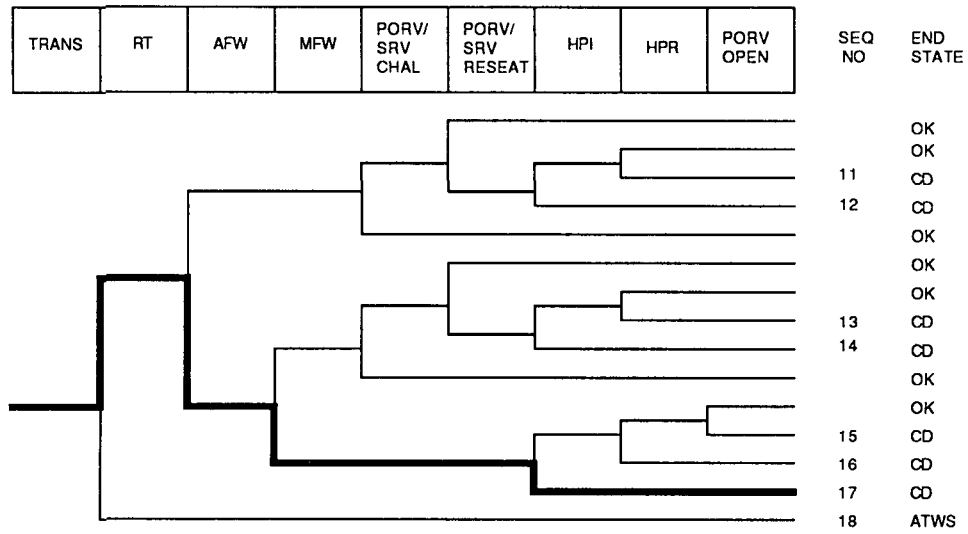
Dominant Core Damage Sequence for LER 455/88-008

The conditional probability of severe core damage estimated for this event is 4.0×10^{-5} . The dominant sequences to core damage involve failure of auxiliary feedwater ($p = 5.2 \times 10^{-3}$), failure to recover main feedwater ($p = 0.34$), and failure of feed and bleed capability ($p = 0.02$, including operator failure). The dominant sequence for this event is highlighted on the following event tree.
