## PRECURSOR DESCRIPTION AND DATA

NSIC Accession Number: 160846

Title: Loss of 24 Volt dc Nonnuclear Instrument Power Supply  
at Crystal River 3

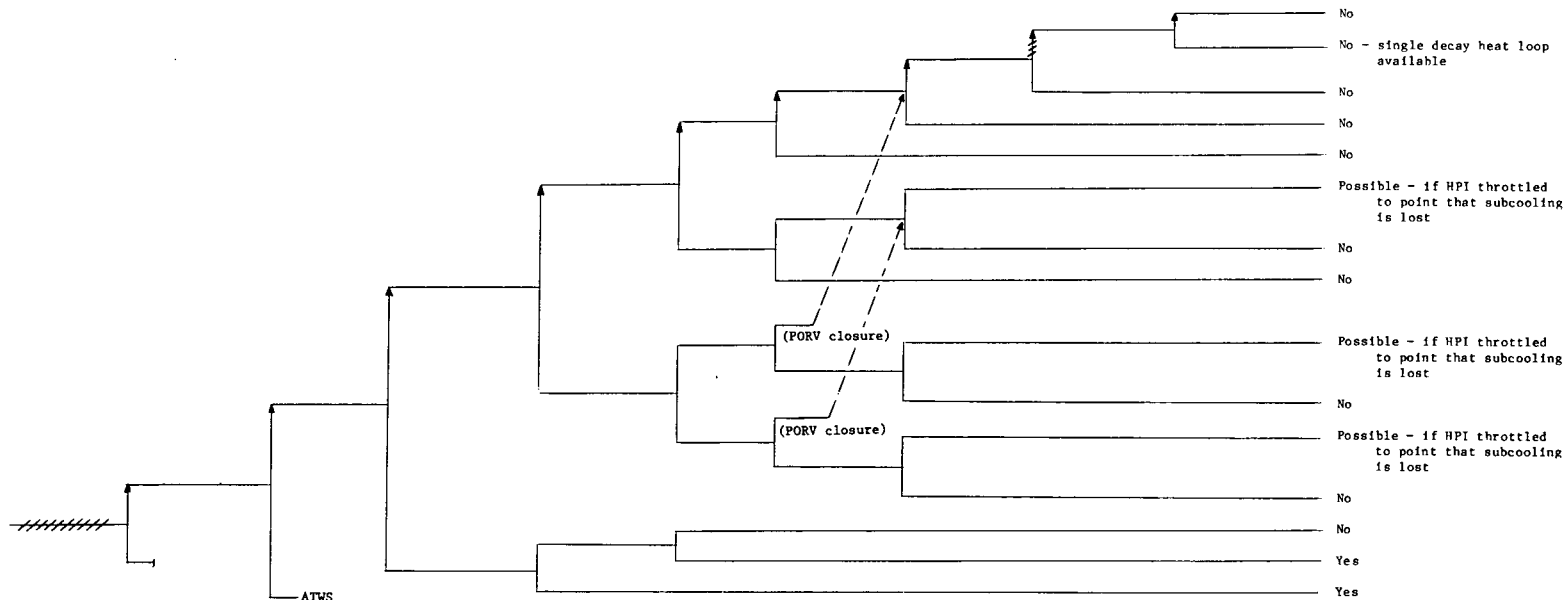
NSIC 160846 - Actual Occurrence for Loss of 24-V Nonnuclear Instrument Power Supply at Crystal River 3

Reactor at power and loss of NNI train X power supply due to failed voltage buffer cord	Consequent erroneous signals to ICS resulting in increased power demand, feed-water runback, and opened PORV	Reactor trip due to high RCS pressure	Safety injection initiated due to decreasing RCS pressure	Operator closes block valve and isolates open PORV	Operator manually initiates emergency feedwater	Power restored to NNI train X	HPI throttled to minimize discharge of containment	Decay heat closed cycle cooling pumps DCP-1A unavailable due to failed motor coupling	Shutdown delayed while pump DCP-1A is repaired	Potential Severe Core Damage
---	--	---------------------------------------	---	--	---	-------------------------------	--	---	--	------------------------------

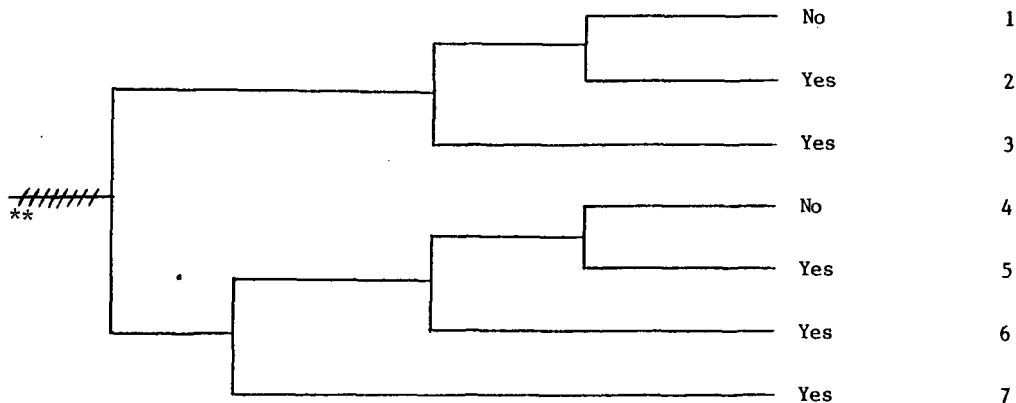
NSIC 160846 - Sequence of Interest for Loss of 24-V dc Nonnuclear Instrumentation Power Supply at Crystal River 3

Small LOCA*	Reactor Trip	Auxiliary Feedwater and Secondary Heat Removal	High Pressure Injection	Low Pressure Recirculation and LPR/HPI Cross-Connect	Potential Severe Core Damage	Sequence No.
----------------	-----------------	---	-------------------------------	---	---------------------------------------	-----------------

\*due to loss of NNI-X power supply

\*\*continued small LOCA requires operator error in not closing PORV block valve
