PRECURSOR DESCRIPTION AND DATA

NSIC Accession Number: 167624

Title: Loss of Offsite Power and Failure of a Diesel Generator to Start at Crystal River 3

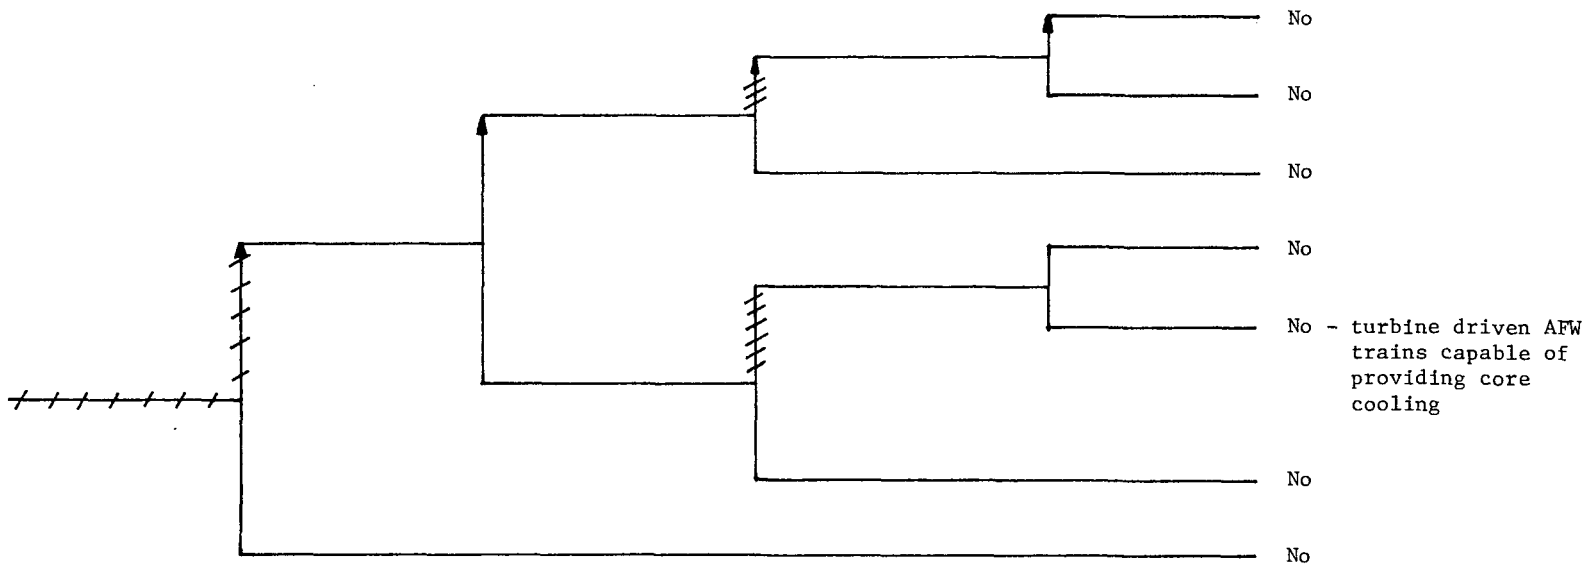
Reactor at 100% power and lightning strike on 230-kV feeder	Failure of lightning arrestor system results in loss of CR-3 startup transformer and LOOP	Diesel generator A starts and provides power to 4160-V bus A loads	Diesel generator B fails to start due to maladjusted timing relay	Power to 4160-V bus B provided through fossil unit startup transformer	Potential Severe Core Damage
---	---	--	---	--	------------------------------

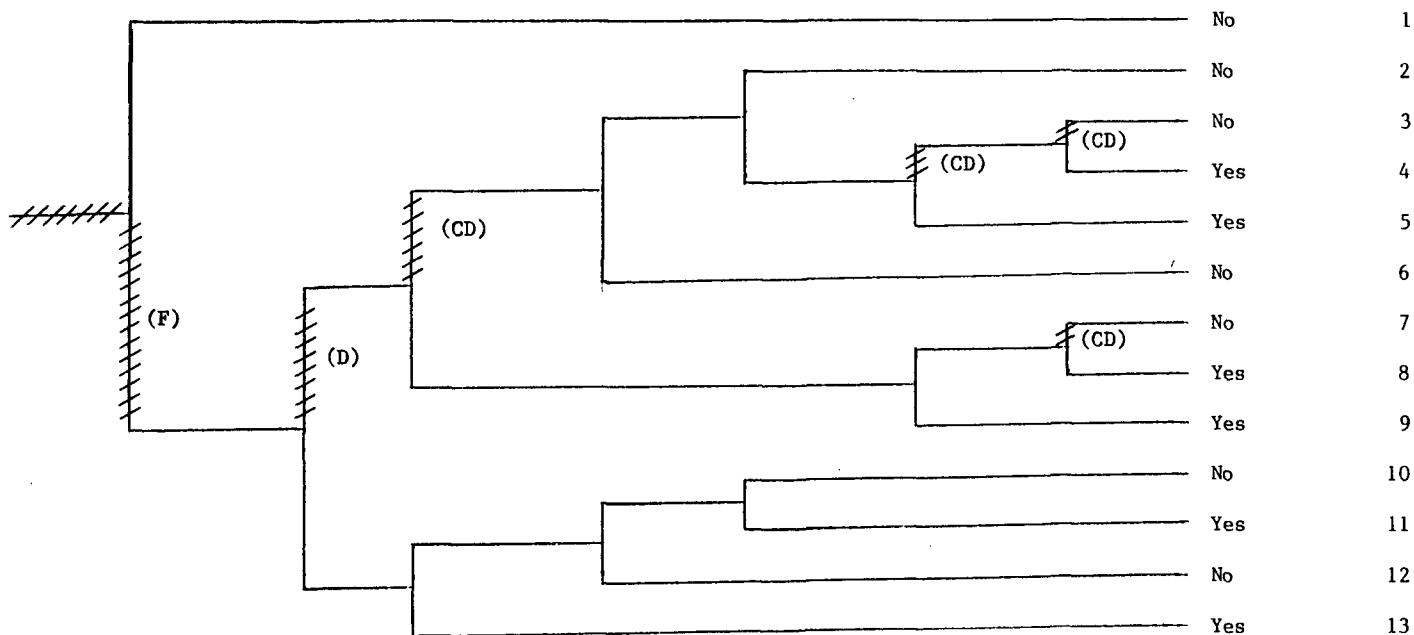
NSIC 167624 - Sequence of Interest for Loss of Offsite Power and Diesel Generator Failure to Start at Crystal River 3

Loss of Offsite Power	Turbine Generator Runs Back and Assumes House Loads	Emergency Power	Auxiliary Feedwater and Secondary Heat Removal	PORV Demanded	PORV or PORV Isolation Valve Closure	High Pressure Injection	Long Term Core Cooling	Potential Severe Core Damage	Sequence No.
-----------------------	---	-----------------	--	---------------	--------------------------------------	-------------------------	------------------------	------------------------------	--------------
