FUEL & PLANT MATERIALS TECHNOLOGY
FINAL REPORT

LABORATORY EXAMINATION OF RECIRCULATION LINE
DECONTAMINATION FLANGE FROM
MONTICELLO NUCLEAR POWER STATION
(WORK PERFORMED FOR NORTHERN STATES POWER)

January 15, 1988

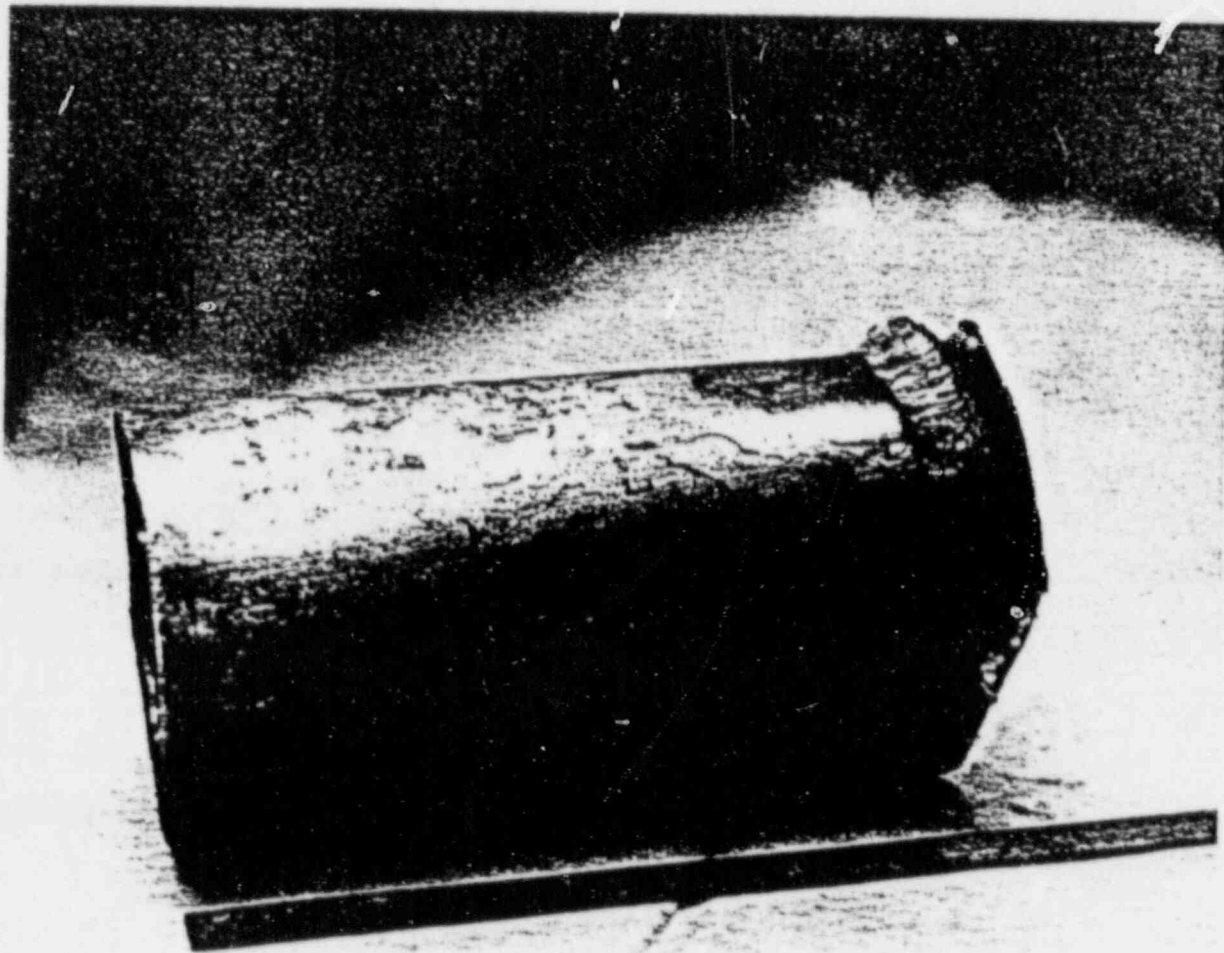
The specimen received consisted of the socket weld and the top four inches of pipe. Figures 1 and 2 are photographs of the as received specimen. A crack about 1 inch on the OD and 5/8 inch on the ID was visible with the unaided eye. Some staining/streaking was visible on the OD of the pipe and weld

Figure 1. Side view of as received specimen showing visible crack at fusion line on OD surface and Serial Number 469167.

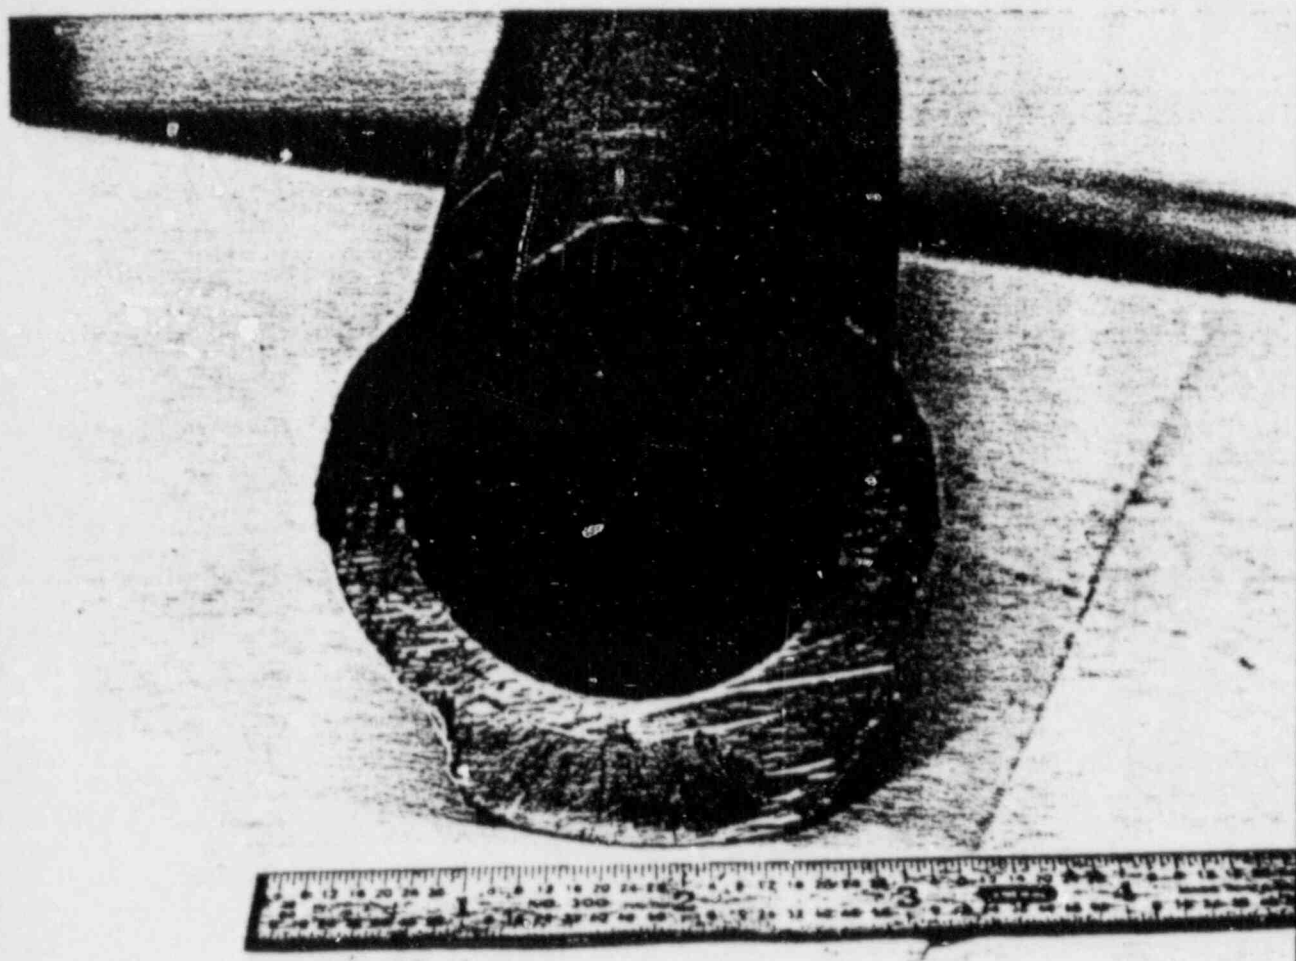
Figure 2. End view of as received specimen.

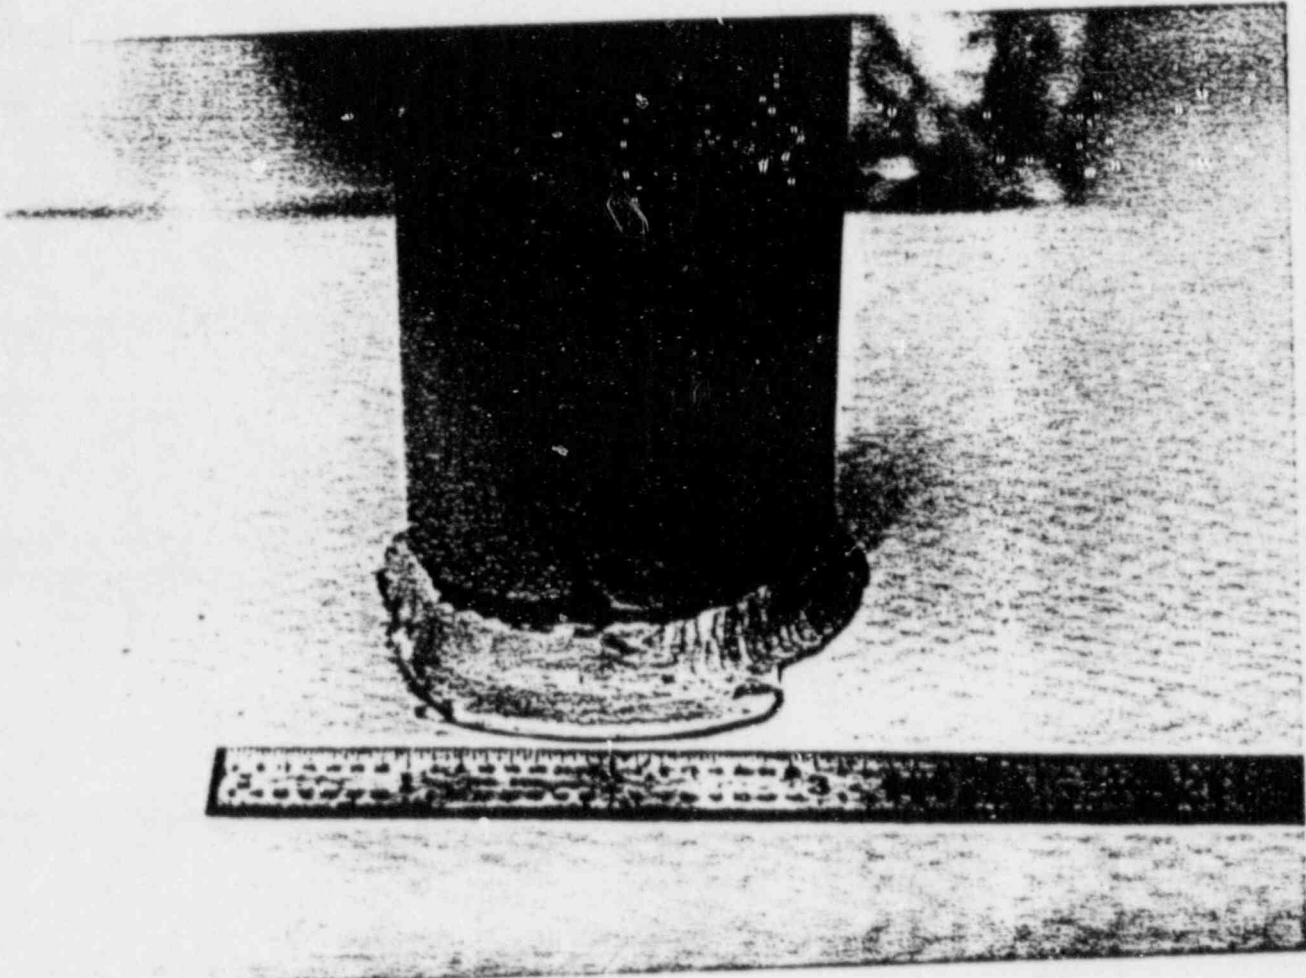
probably due to corrosion during the leak. A slight oxidation stain was also visible along the crack on the ID surface. Liquid penetrant examination of the OD and ID was performed as shown in Figures 3 and 4. The OD indication was about 2-1/4 inches long and followed the weld fusion line. The ID indication was about 3/4 inch long. The longer indication visible in Figure 4 is due to the gap between the pipe and socket fitting beyond the weld. After visual and liquid penetrant examination, the specimen was sectioned transversely about 1/2 inch from the fusion line and then axially to remove specimens for optical metallography and Scanning Electron Microscopy. Figure 6 is a close-up photograph of the SEM specimen showing a dark brown oxidation layer on the fracture surface close to the OD and becoming lighter in color towards the ID.

Figure 3. Penetrant test indication at fusion line on OD surface.

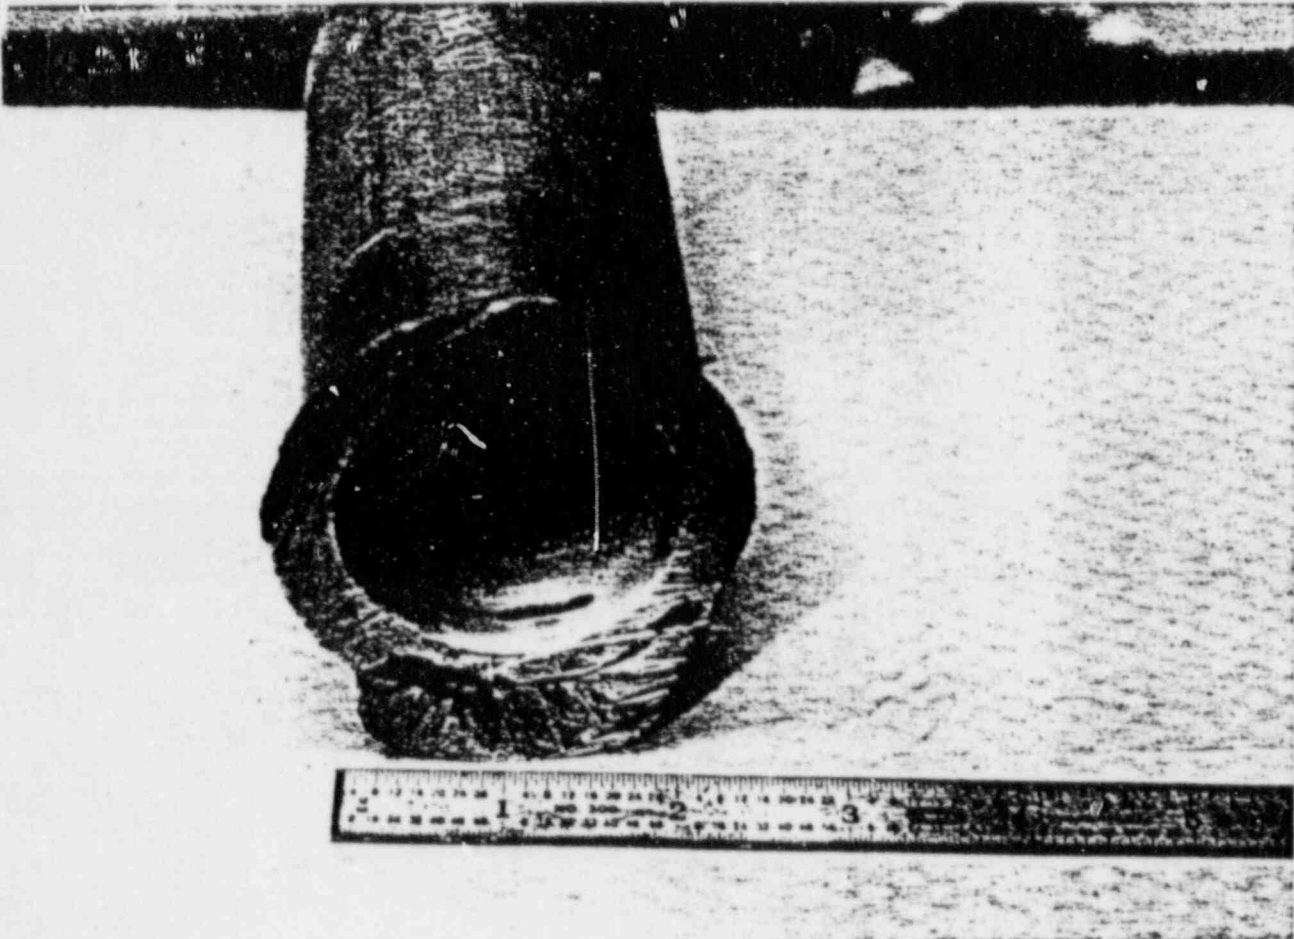
Figure 4. Liquid penetrant indication at ID surface. The longer indication is due to the gap between the pipe and the socket beyond the weld and is not connected to the crack.

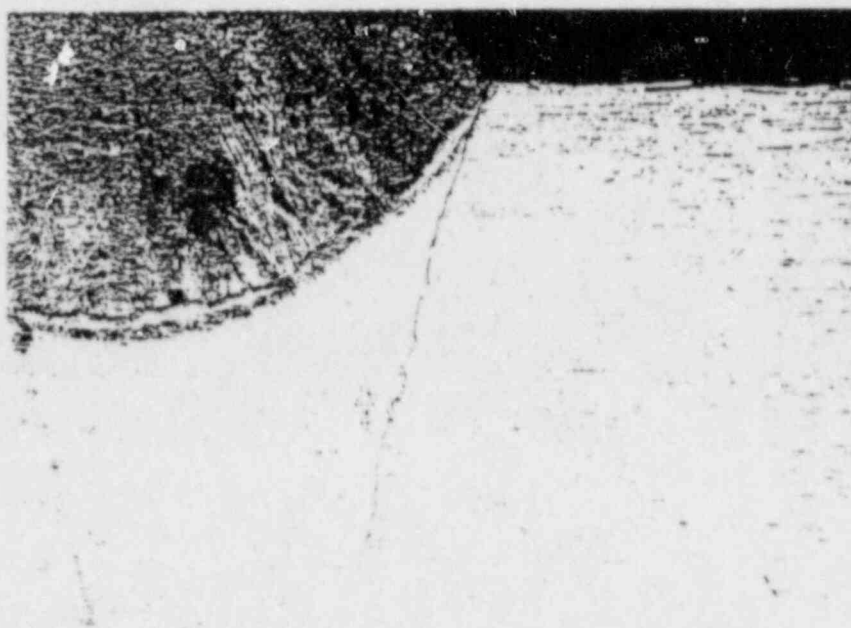
Figure 7. Specimen #1, near OD limit of crack.

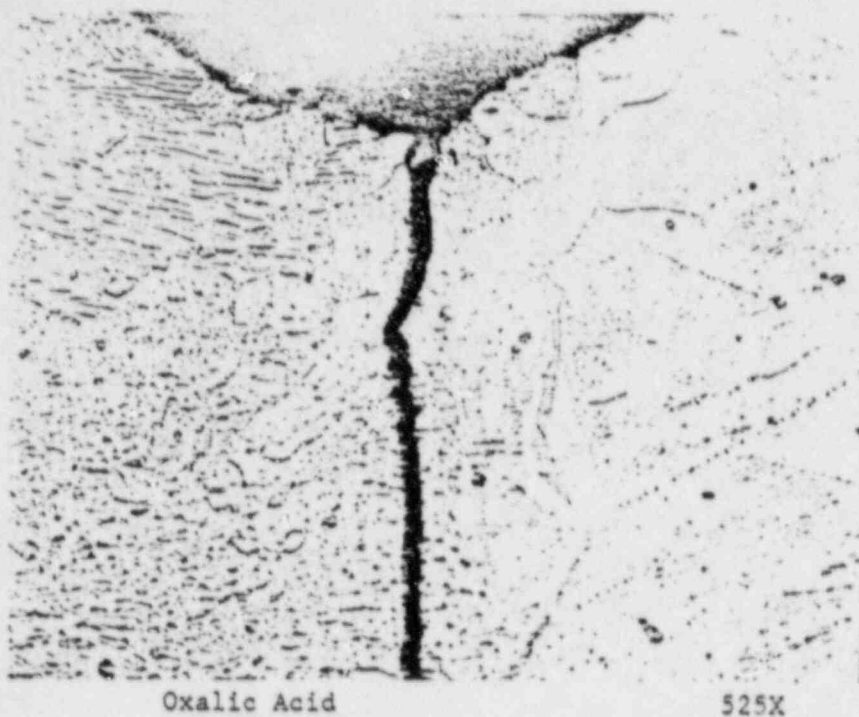
Figure 8. Specimen #1, fusion line region of crack.

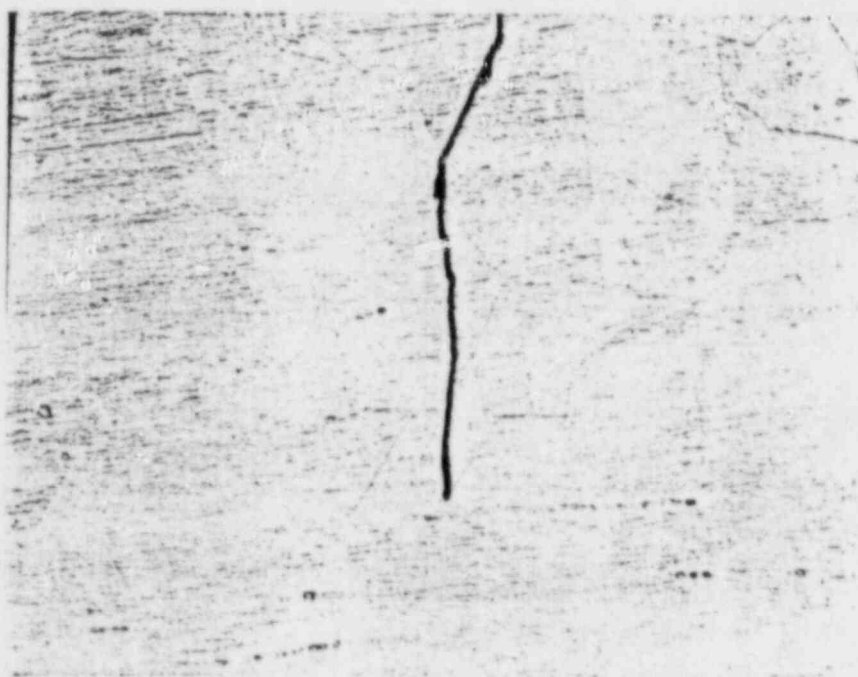
Figure 9. Crack tip, specimen #1.

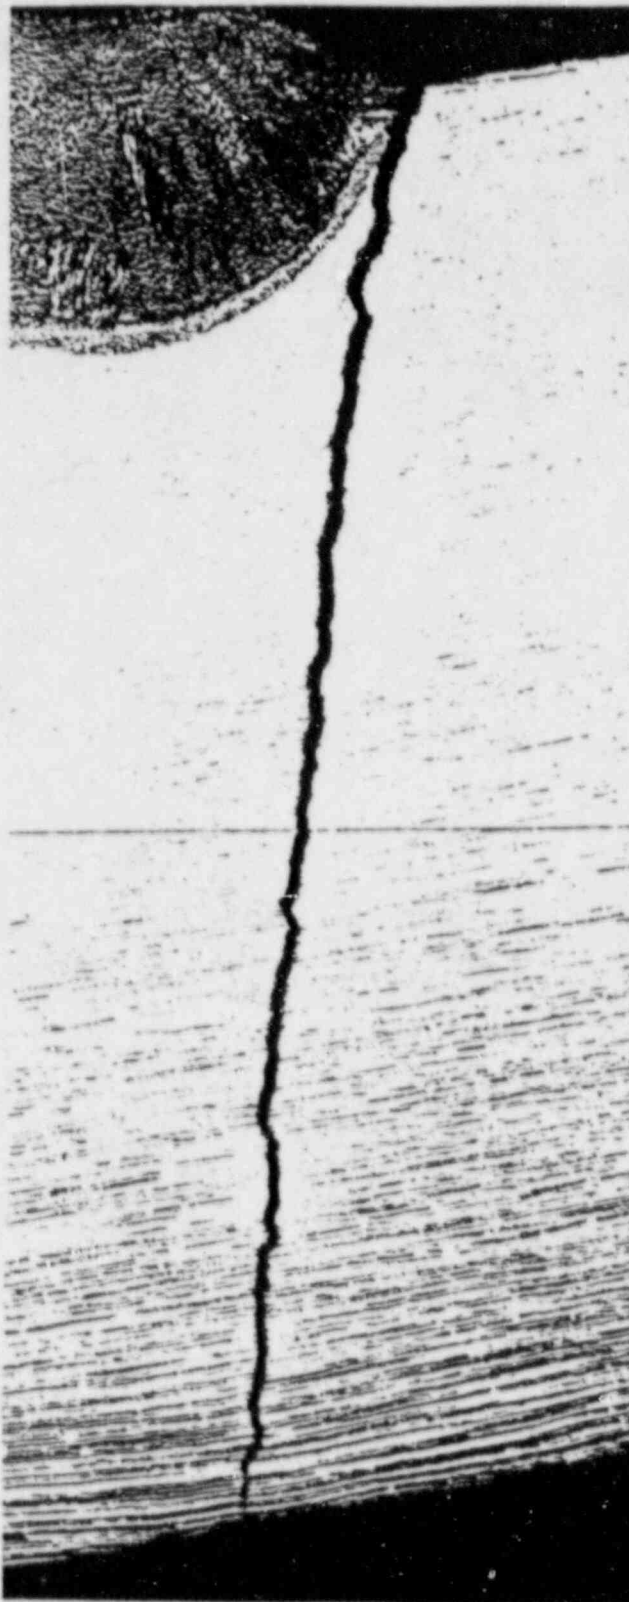
Figure 10. Specimen #2, center of through wall portion of crack.

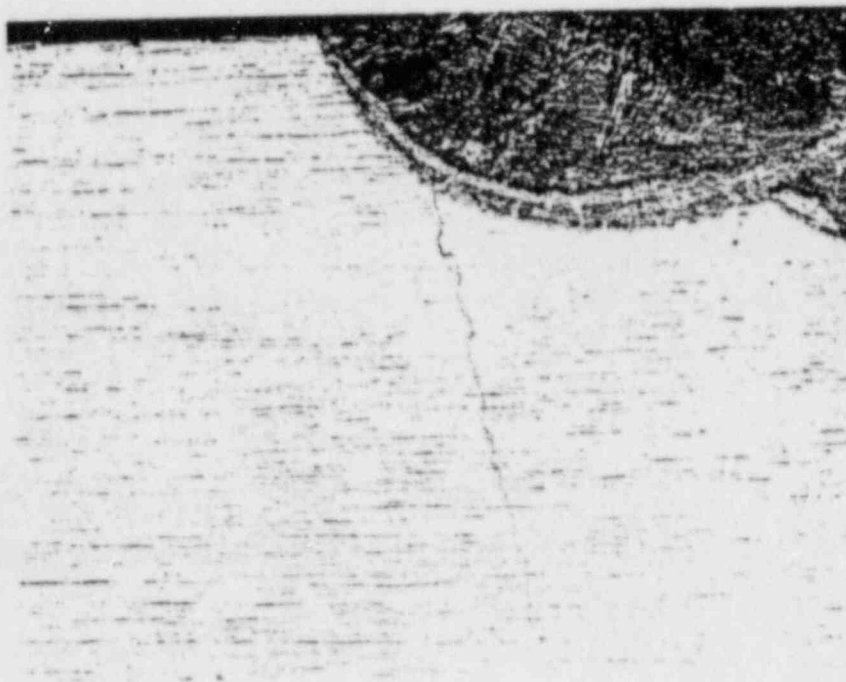
Figure 11. Specimen #3, near OD limit of crack.

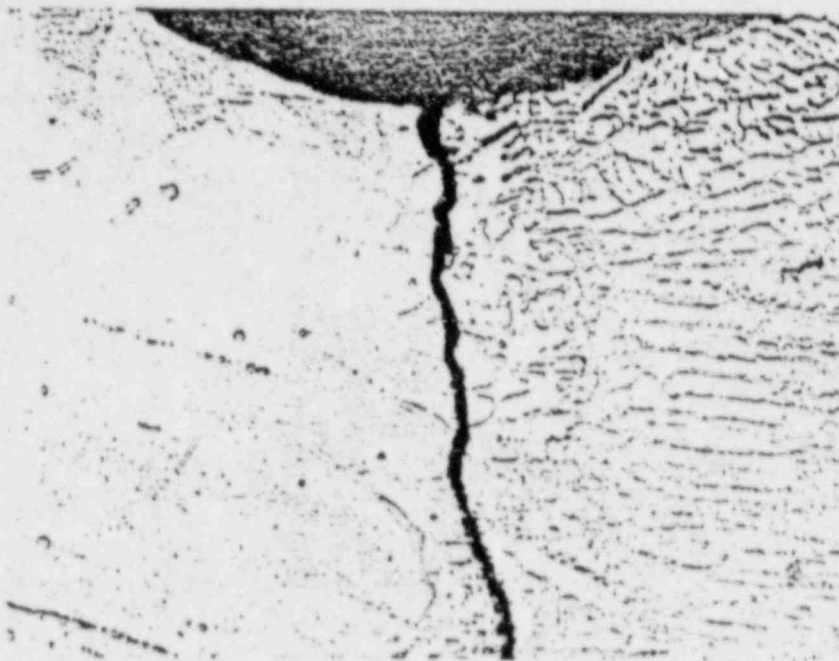
Figure 12. Specimen #3 fusion line region of crack.

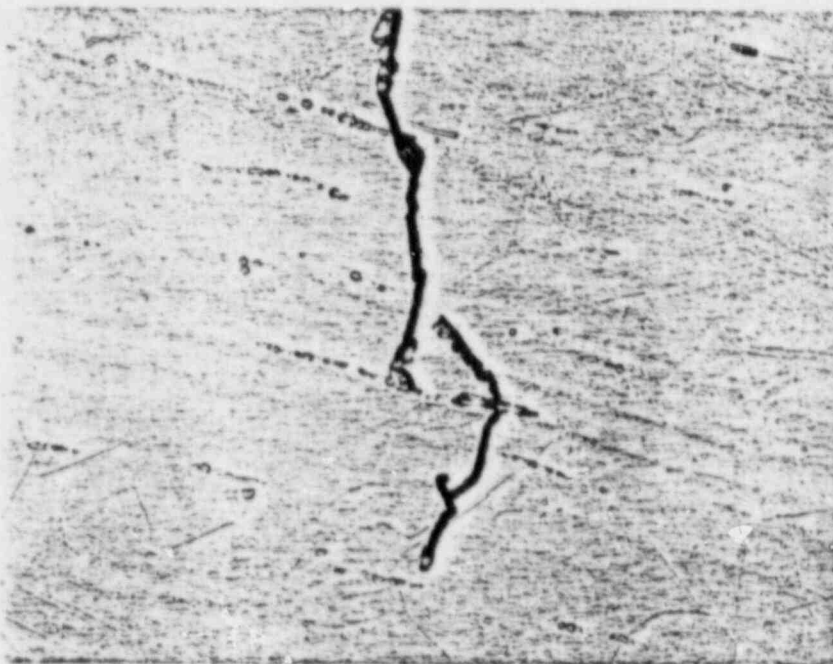
Figure 13. Crack tip, specimen #3.

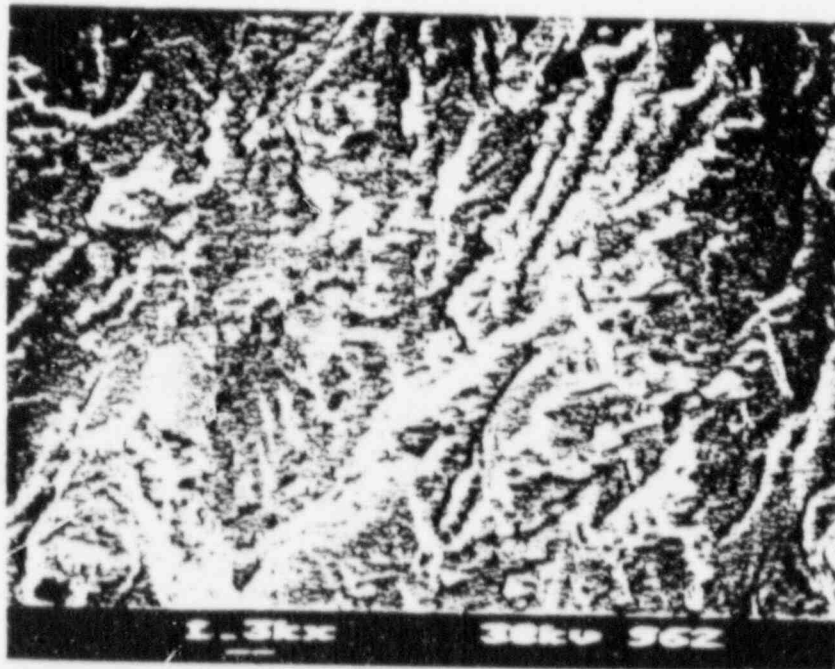
SEM evaluations of the fracture surface (Figures 14 and 15) provide additional evidence of the transgranular cracking mechanism. The above findings lead to the conclusion that the observed cracking was the result of high cycle fatigue. Crack initiation occurred at the weld fusion line which acted as a stress riser at the pipe OD.

Figure 14. SEM fractograph near OD and crack center.

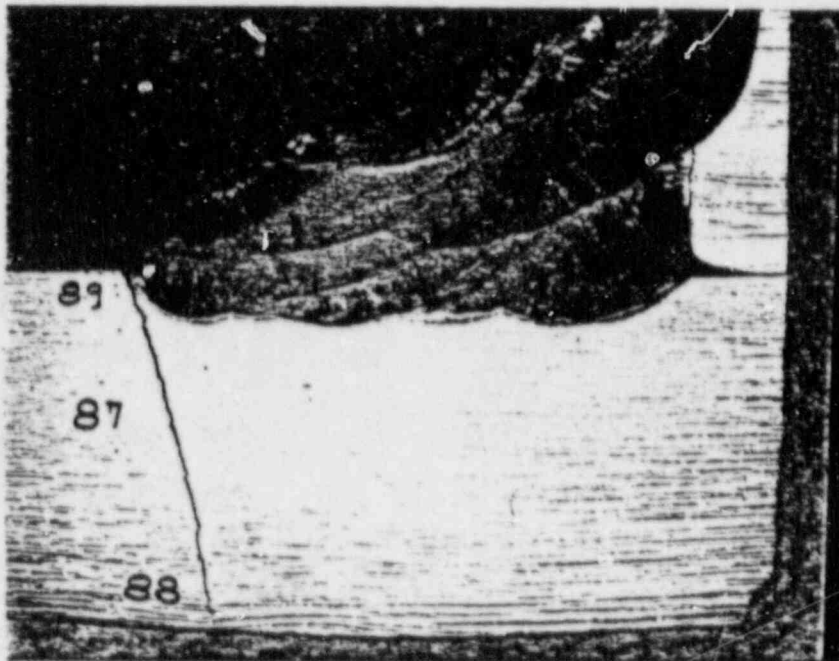
Hardness measurements using a 200 gram load were conducted on specimen #2 near the through wall portion of the crack. The results shown in Figure 16 indicate that the base material meets current requirements for annealed Type 316L pipe (Rockwell B-92). The hardness measurements ranged from Rockwell B-87 to -89.

Figure 16. Hardness measurement location and results
200 gram load, specimen #2. Rockwell B
equivalent.
