I.V. Systems Division

PDR 3019882  
-21175-01  
(2-96-016)  
CC: EICS

Subject: Reply to Your Letter dated December 4 1996

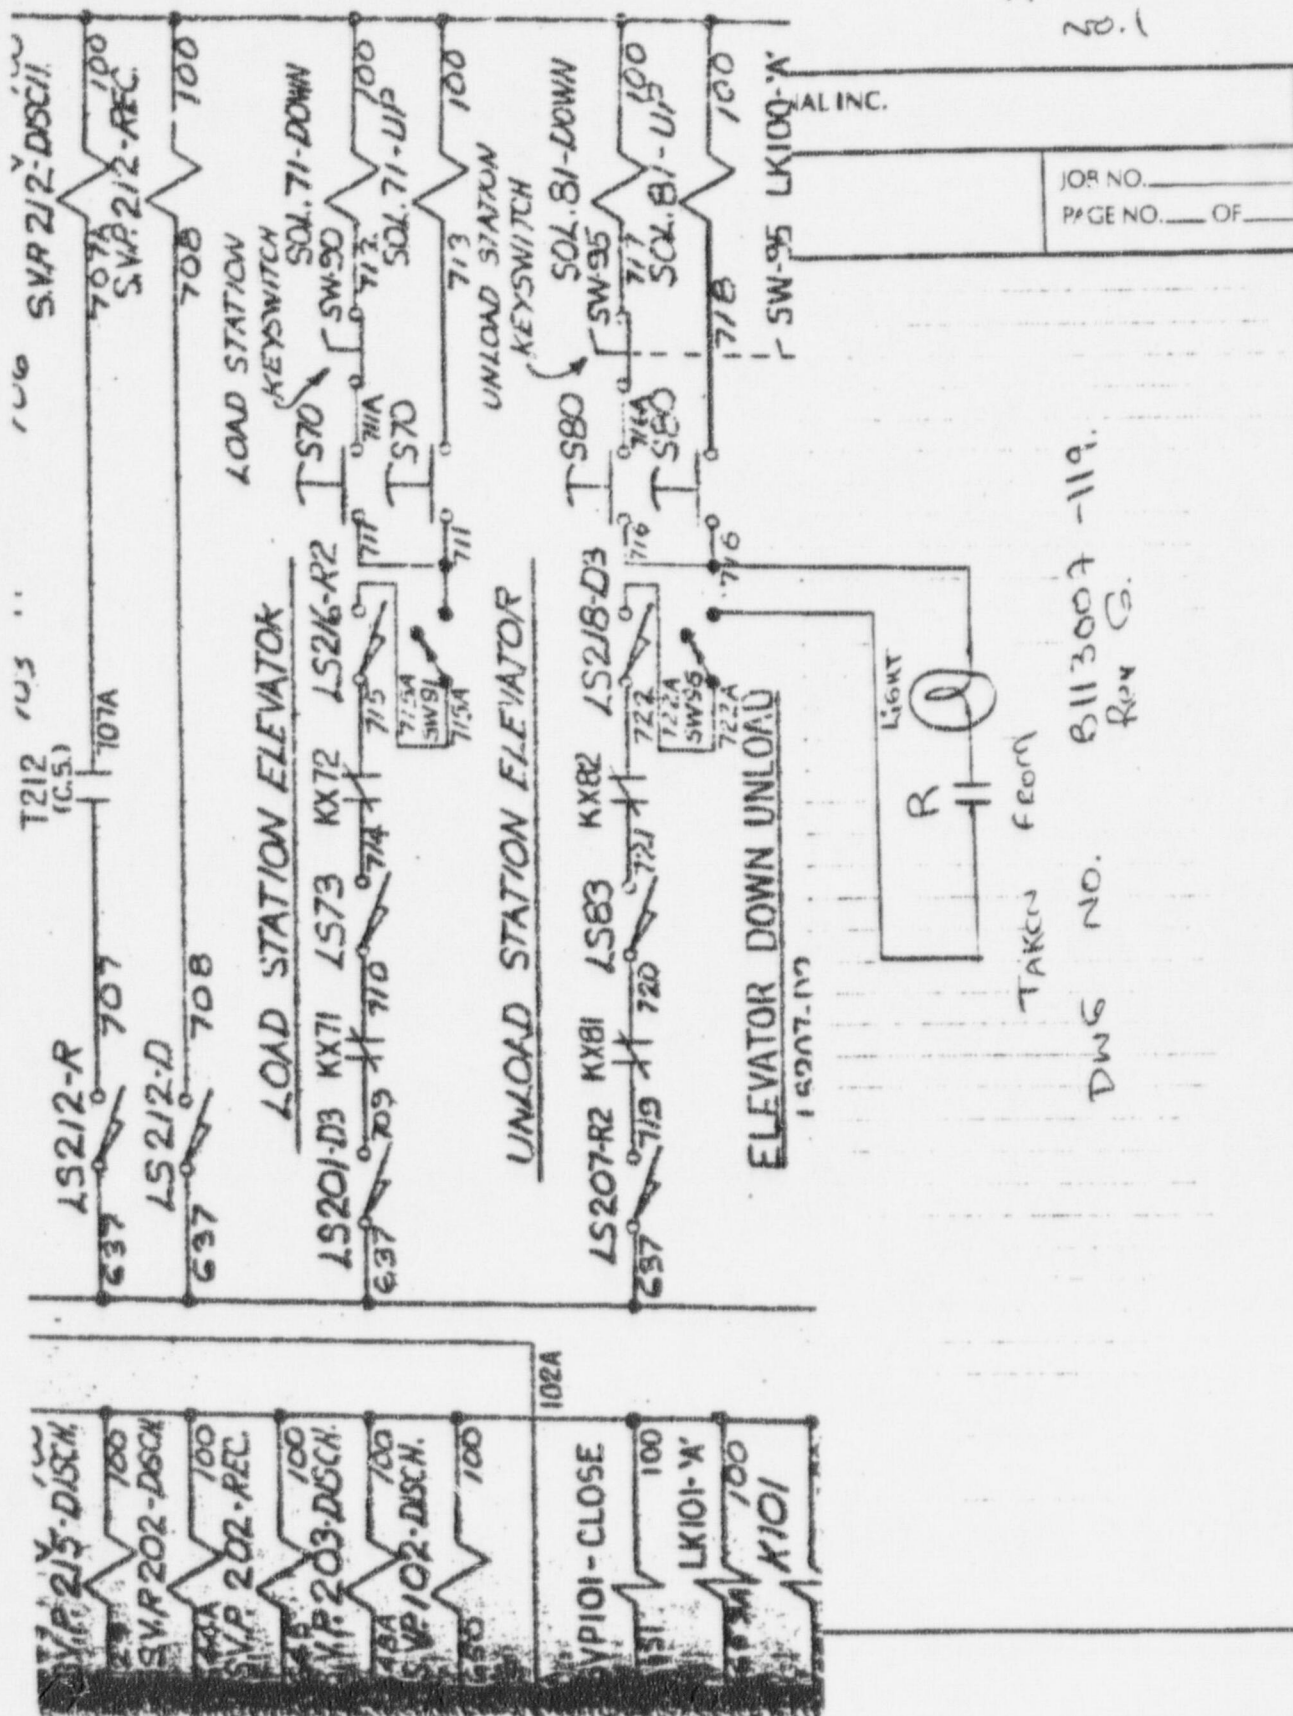
ATTACHMENT  
NO.1

The first change, photo switch on the elevators, is unclear in what part of the circuit this applies. I have revised a copy of the section of the schematic that it appears to apply to, please see first attachment. If this is the case, and I have interpreted your sketch correctly, then it would appear that the solenoids for the elevators would rely on having a light bulb in place to operate. While this is not a safety concern it would be a reliability problem, for example the elevator would not work when the light bulb burnt out. You may choose to use a different set of contacts of relay R to illuminate the light, see second attachment.

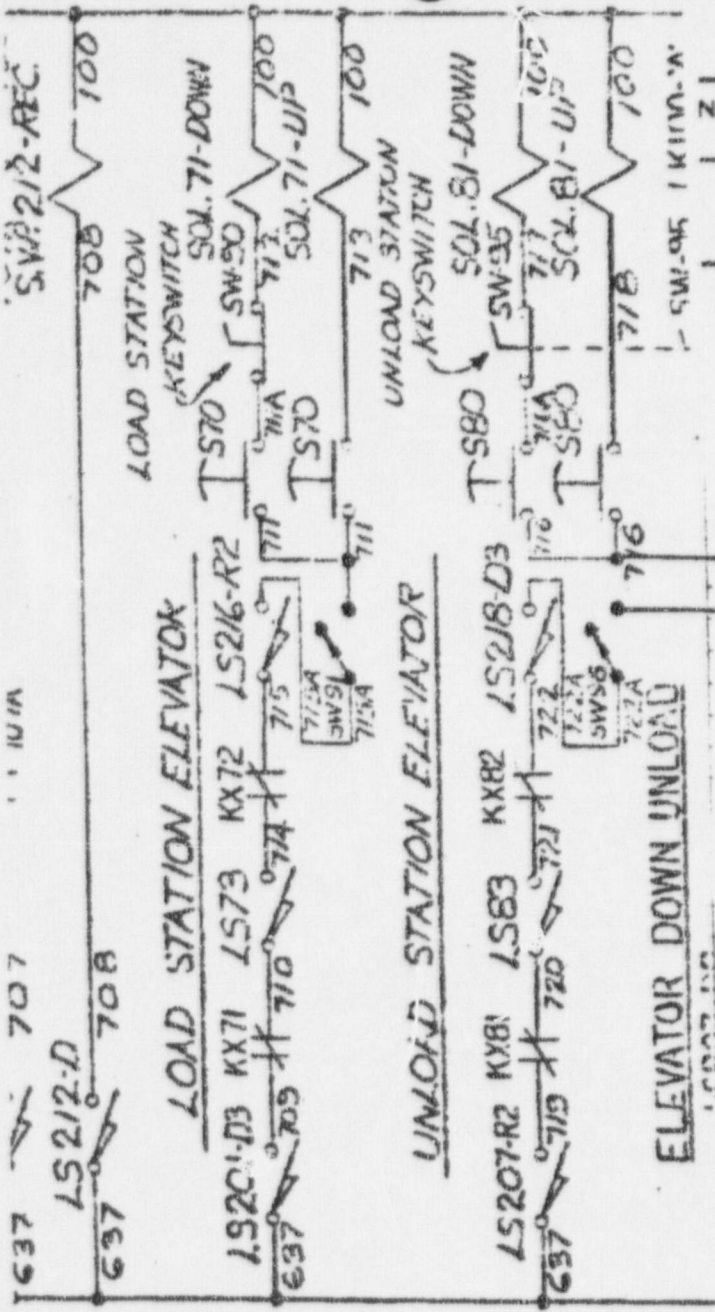
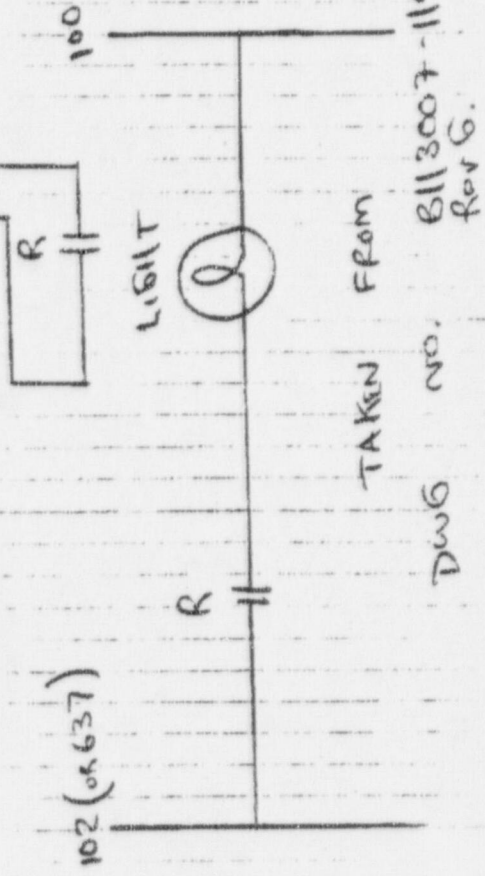
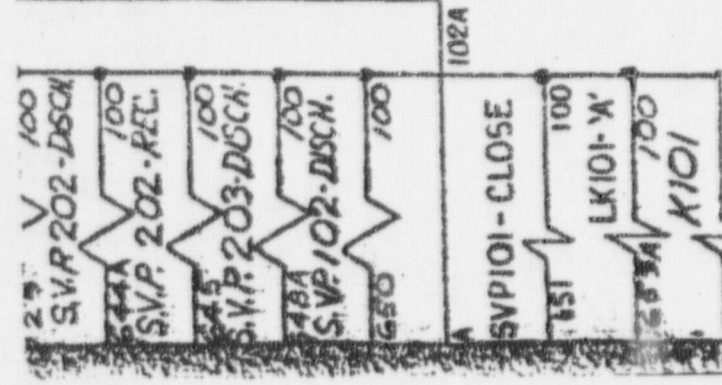
ATTACHMENT  
NO. 2

TAKEN FROM  
DWG NO. B113007-119  
REV 6.
