LICENSEE EVENT REPORT (LER)

FACILITY NAME (1) Pilgrim Nuclear Power Station										DOCKET NUMBER (2) 0 5 0 0 0 2 9 3				PAGE (3) 1 OF 4									
TITLE (4) Failure of Fire Damper to Close Due to Orientation of Clover Hooks																							
EVENT DATE (5)			LER NUMBER (6)				REPORT DATE (7)			OTHER FACILITIES INVOLVED (8)													
MONTH	DAY	YEAR	YEAR	SEQUENTIAL NUMBER	REVISION NUMBER	MONTH	DAY	YEAR	FACILITY NAMES				DOCKET NUMBER(S)										
									N/A				0 5 0 0 0										
1	2	1	7	8	7	8	7	0	2	0	0	0	1	1	4	8	8	N/A				0 5 0 0 0	
OPERATING MODE (9)		THIS REPORT IS SUBMITTED PURSUANT TO THE REQUIREMENTS OF 10 CFR §. (Check one or more of the following) (11)																					
N		20.402(b)				20.405(c)				50.73(a)(2)(iv)				73.71(b)									
POWER LEVEL (10)		0 0 0				20.405(a)(1)(i)				50.36(c)(1)				50.73(a)(2)(v)				73.71(c)

The attached Licensee Event Report (LER) 87-020-00 "Failure of Fire Damper to Close Due to Orientation of Clover Hooks" is submitted in accordance with 10CFR Part 50.73.

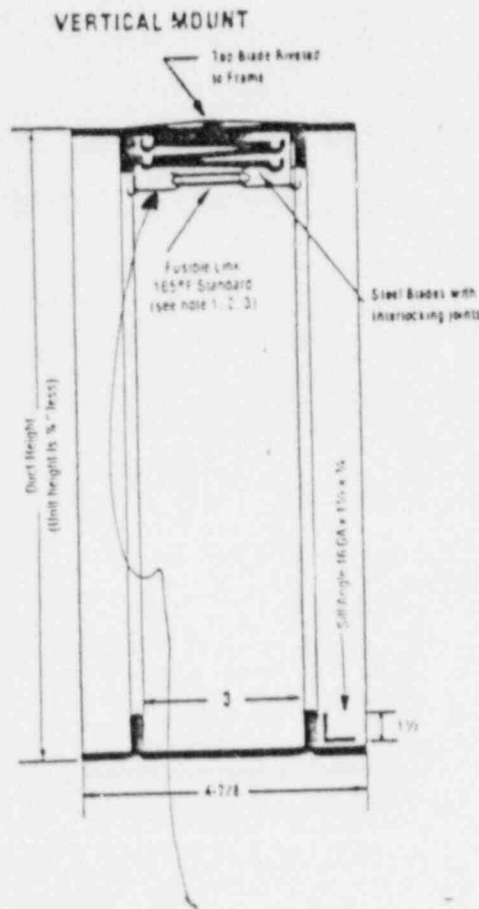
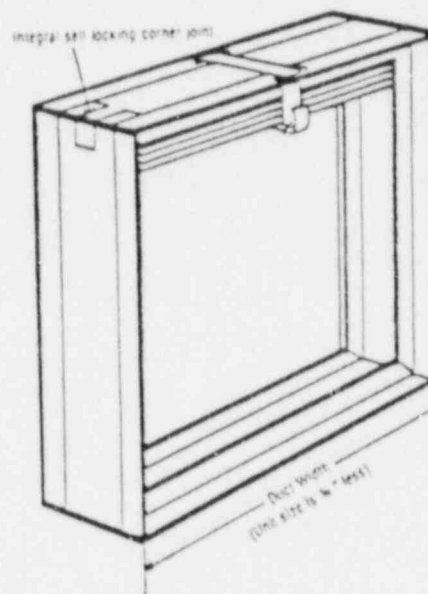
Fire Damper CPR-2 did not close due to the clover hook catching on the edge of the damper blade preventing it from closing.

Fire Damper CPR-2 did not close following actuation due to the orientation of the clover hook, i.e., open side of hook facing damper. When the damper began to close, the clover hook caught on the damper blade preventing full closure. Installation instructions for the dampers did not specify orientation for the clover hooks. The vendor (Air Balance Inc.) data shows the open side of the clover hook facing the damper blade. Page 4 of 4 depicts a typical damper with the clover hooks oriented facing the damper blade.

orientation of
the clover hook (i.e., open side of hook facing damper)

Field Revision Notice (FRN) 86-31-129, to PDC 86-31, was issued to require the physical orientation of the clover hooks to face outward (away) from the damper. This action will preclude recurrence of this event.
