Subject: University of Virginia Reactor Facility
Docket No. 50-62 and License No. R-66
Follow-up Report on Neutron Radiography Facility
Improvements Made following July 2, 1987 Incident

UPDATE ON UVA NEUTRON RADIOGRAPHY FACILITY

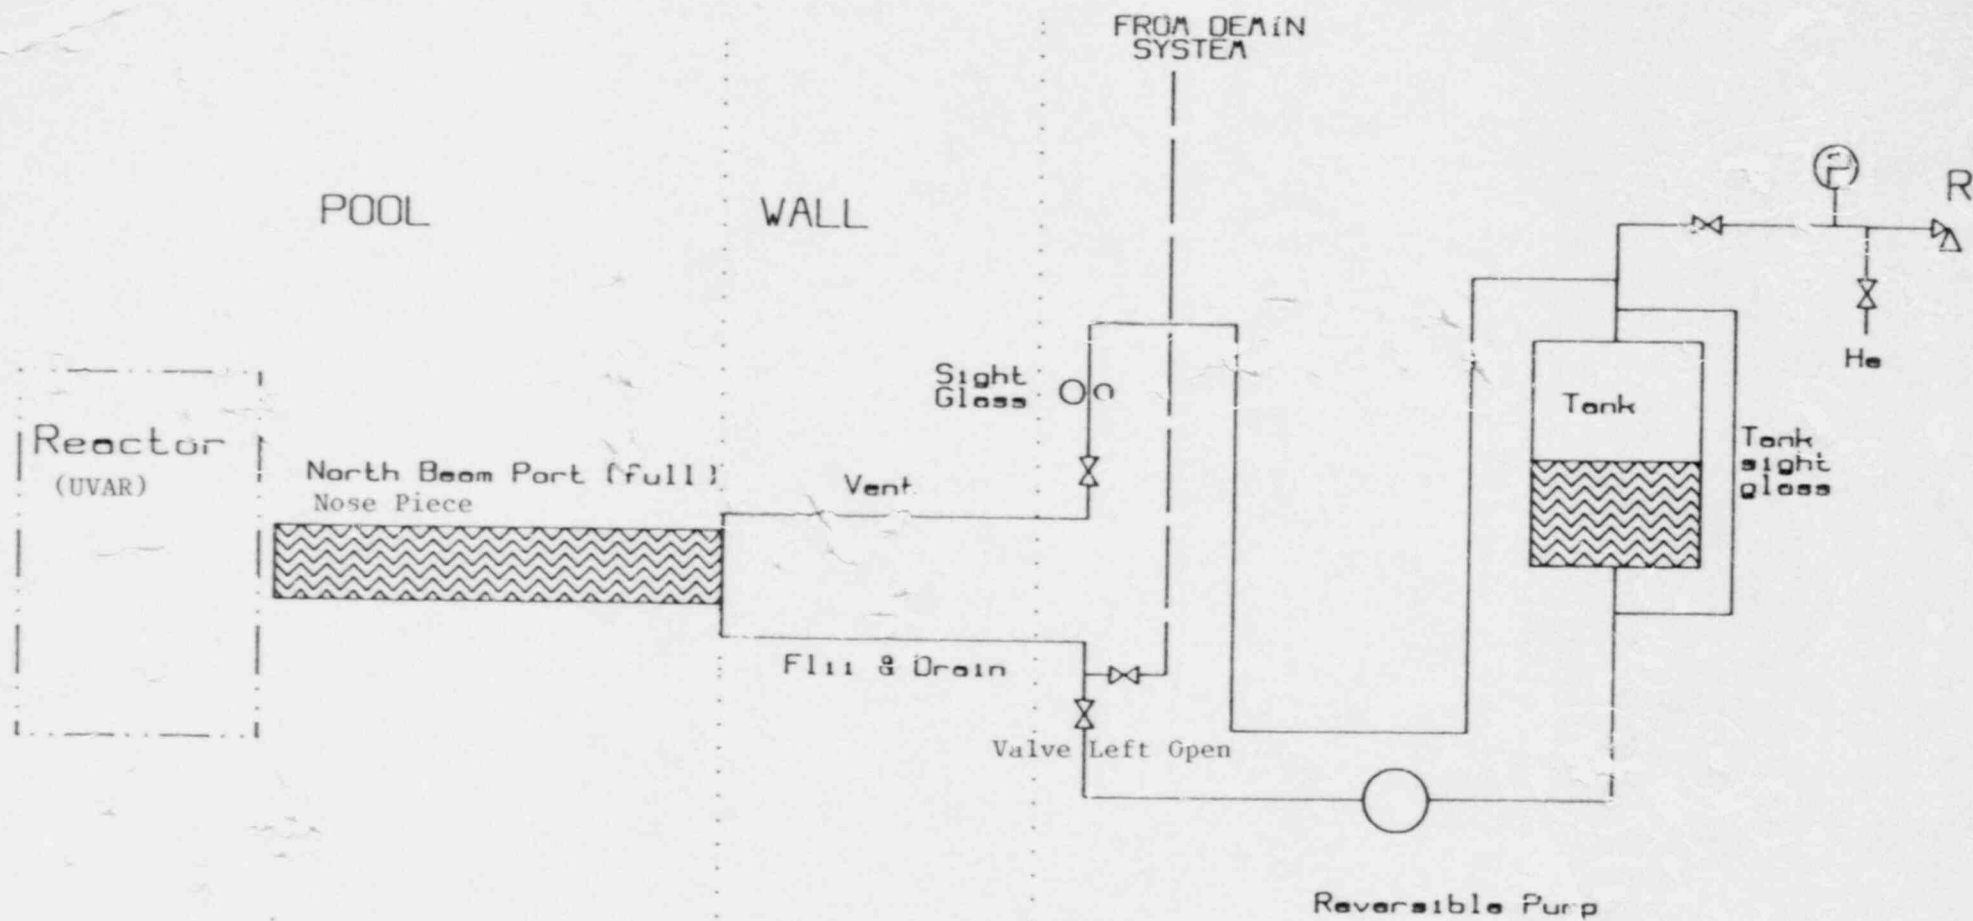
NEUTRON RADIOGRAPHY WATER SHIELD FILL/DRAIN SYSTEM

Information about the set-up of NR facility and the north beam tube nosepiece's fill/drain system were furnished to the NRC inspectors at the time of the July and August 1987 NRC inspections. A diagram of the drain/fill system as it was in November of 1987 is attached to this report, but reference may have to be made to prior reports, for a background to the July 2 event. In brief, draining of water from the north beamport's nosepiece is by way of the lower aluminum exit line which is connected to a clear rubber hose extending to the water and helium cover gas reservoir tank. This flexible hose passes through the drain/fill pump, which operates on the basis of a rolling mechanism. Depending on the position of the rollers, a drain path can exist when a perfect seal at the point at which the rollers pinch the flexible hose is not made. However, given that the reservoir is located at a level higher than that of the beamtube, it had previously been thought that a drain not involving the pump would in all cases be from the reservoir to the beamtube nosepiece, i.e. a "fail-safe" situation.

After careful consideration and planning, a valve located at the beamport nosepiece's lower exit line was closed. This permitted the observation of the drainage rate. In this new configuration, water could be displaced from the nosepiece to the reservoir only through the beamport's upper exit line. The attached schematic indicates that a second transparent TYGON hose links the beamport nosepiece's upper line with the reservoir tank. The amount of water displaced from the nosepiece was then measurable from the movement of the gas/liquid interface within the TYGON hose, until the moment when the interface reached the reservoir tank. The closing of the valve on the lower line clearly had no safety significance, for any expansion caused by gas in the beamtube nosepiece could be relieved to the reservoir tank.

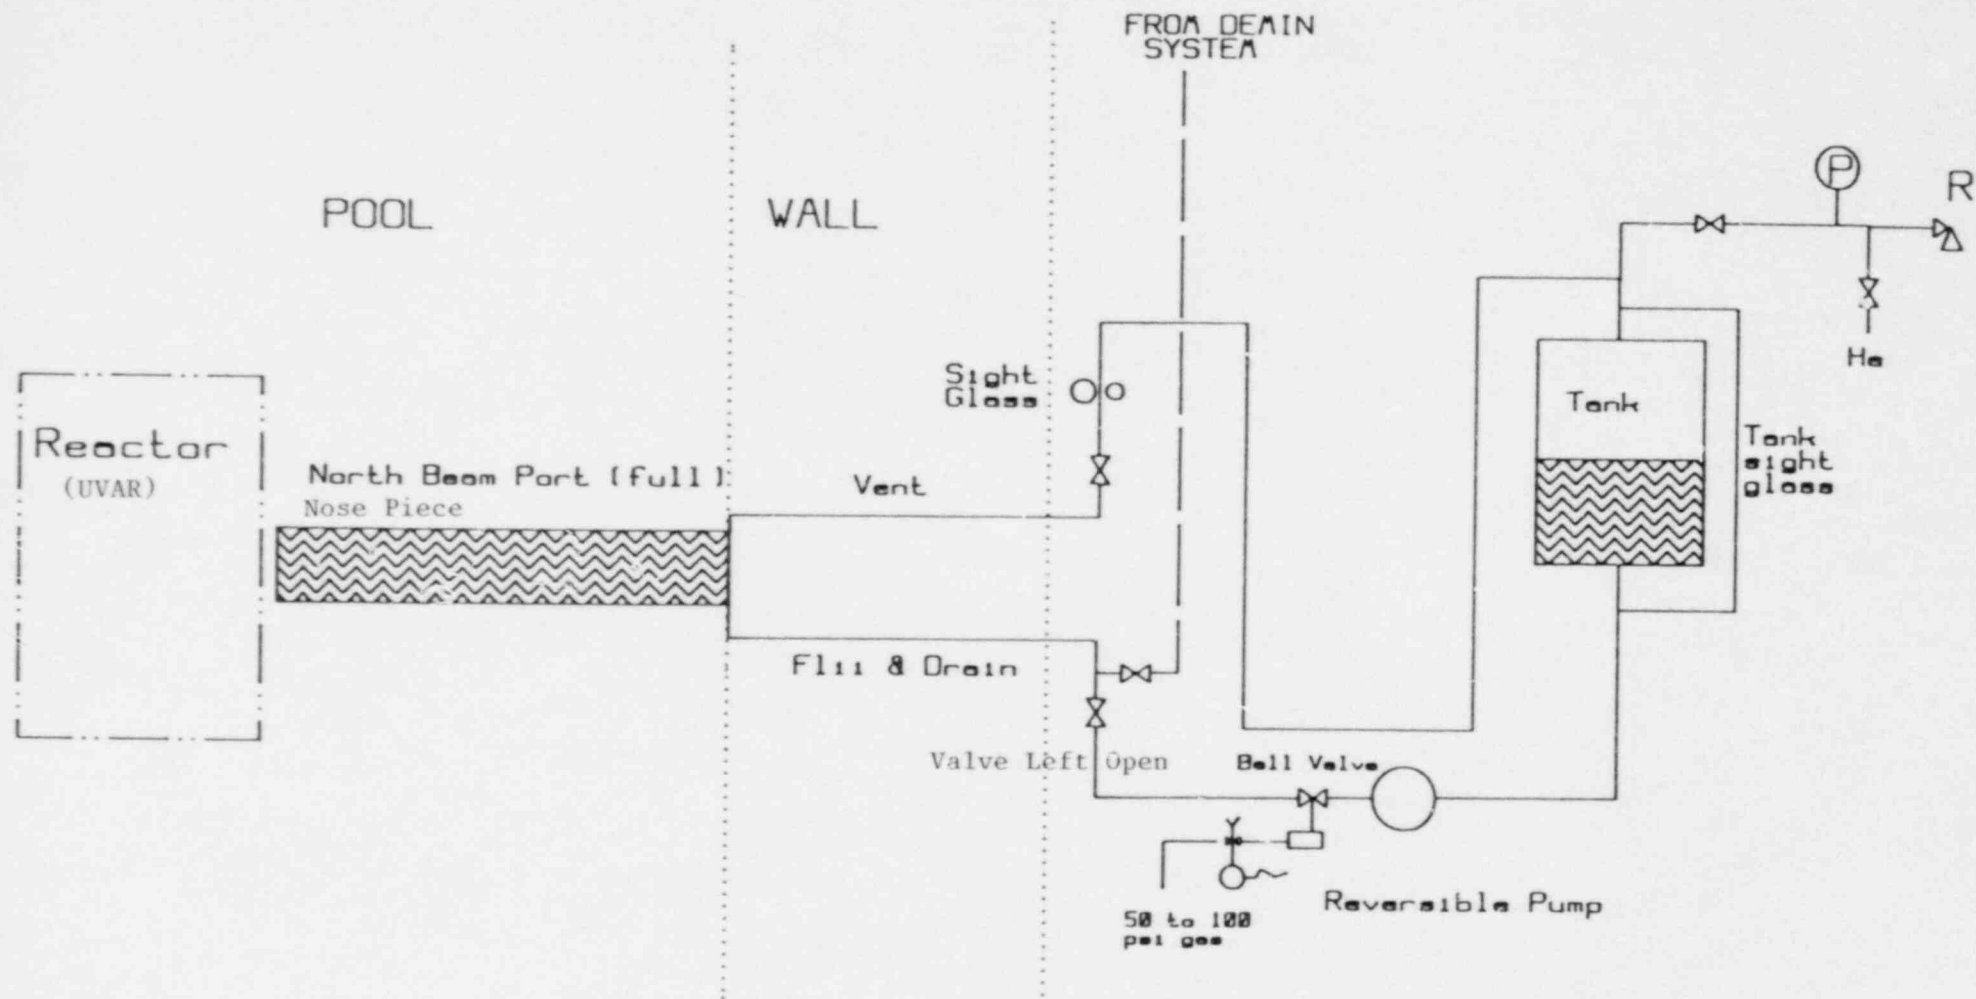
NEUTRON RADIOGRAPHY WATER SHIELD FILL/DRAIN SYSTEM

Update to show addition
of automatic BALL VALVE
2/23/88 BH

An additional device was installed to further preclude unintentional drains. Since the drain/fill pump would permit leakage from the nosepiece to the reservoir by way of the lower line, whenever a tight seal was not made by the pump's rollers on the flexible rubber hose, approval was obtained for the installation in this line of a pneumatically operated ball valve. This valve is normally closed, and opens only when the pump is energized. With the additional safety features in place, the Reactor Director returned the neutron radiography facility to routine use.
