Contract Program or Project Title: Cable Tray Fire Tests

Subject of This Document: Full Scale Fire Test No. 1

Type of Document: Quick-Look Report

Date of Document: October 6, 1978

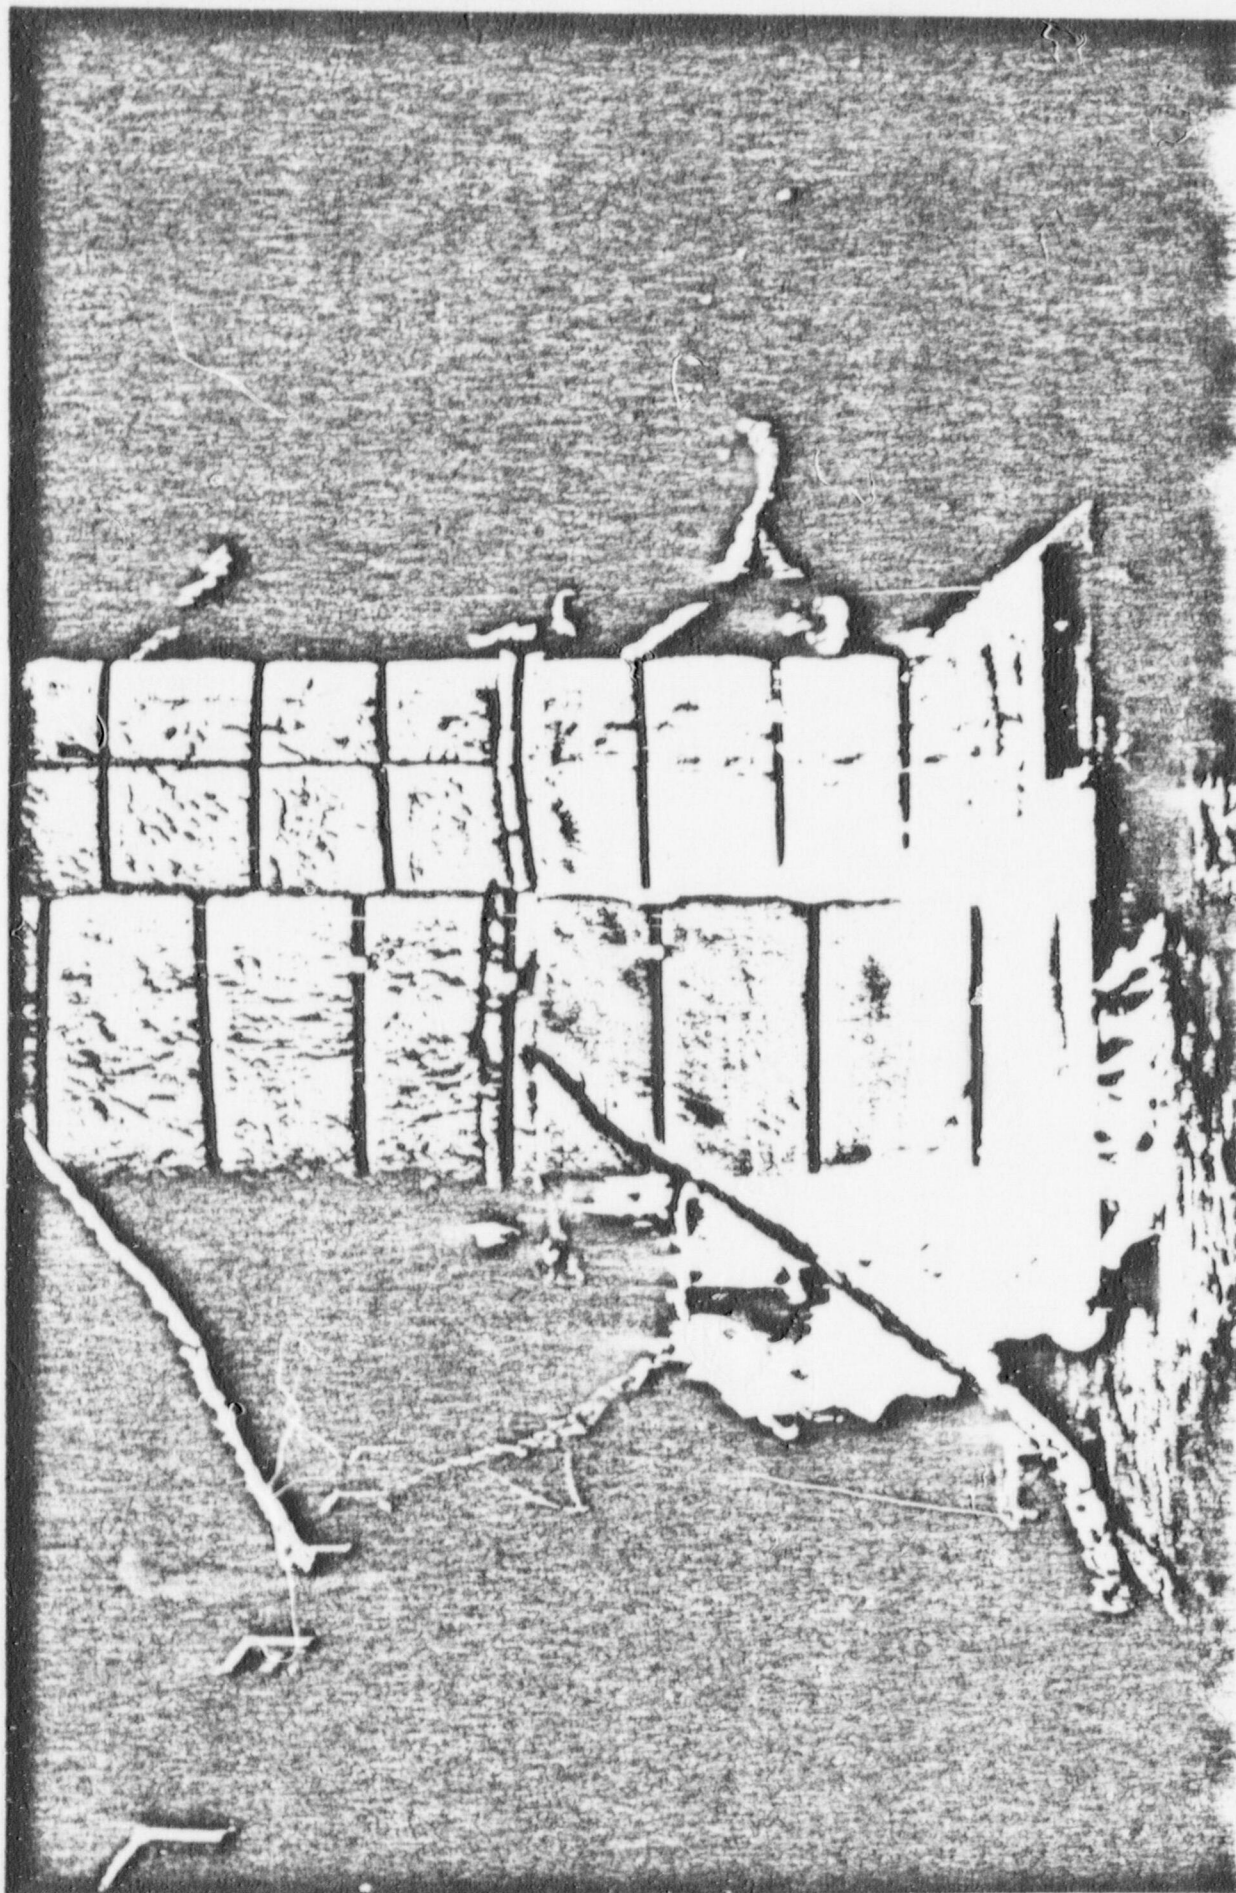
FIGURE 6 - TEST ASSEMBLY AT TEN SECONDS

<u>Time (Min:Sec)</u>	<u>Description</u>
0:10	Flaming appeared uniform over the entire pan area with a maximum flame height of 4 ft. Appearance of test assembly is shown in Figure 6.

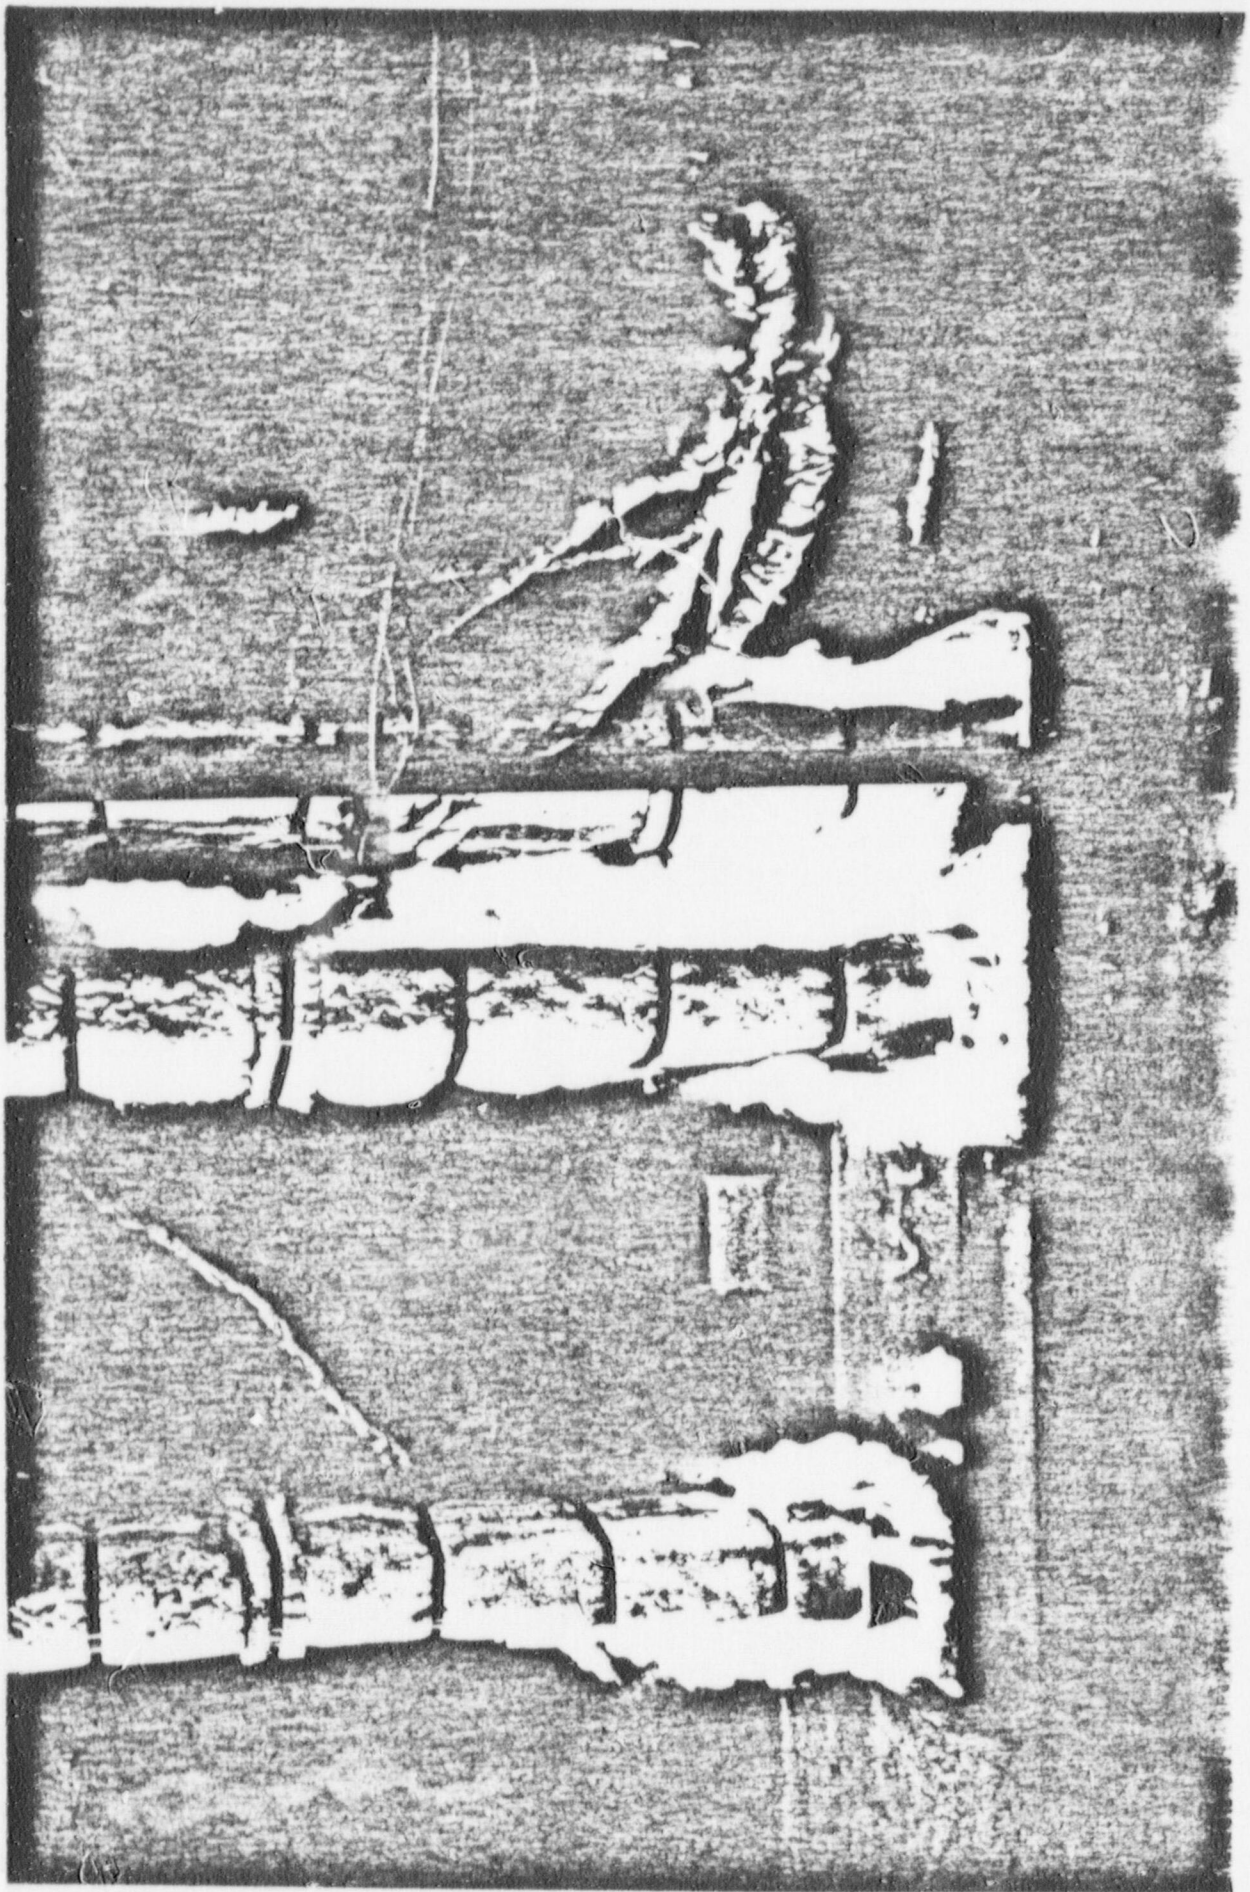
FIGURE 7- TEST ASSEMBLY AT NINETY SECONDS

1:30	All flames now issued from the base of mineral wool on each cable tray. (It appeared the heptane had been soaked up by the wool, and was burning slowly in wick fashion.) Maximum flame height was approximately 3 ft except between trays 1 and 3. Maximum flame height between these two trays was 6 ft. Appearance of test assembly is shown in Figure 7.

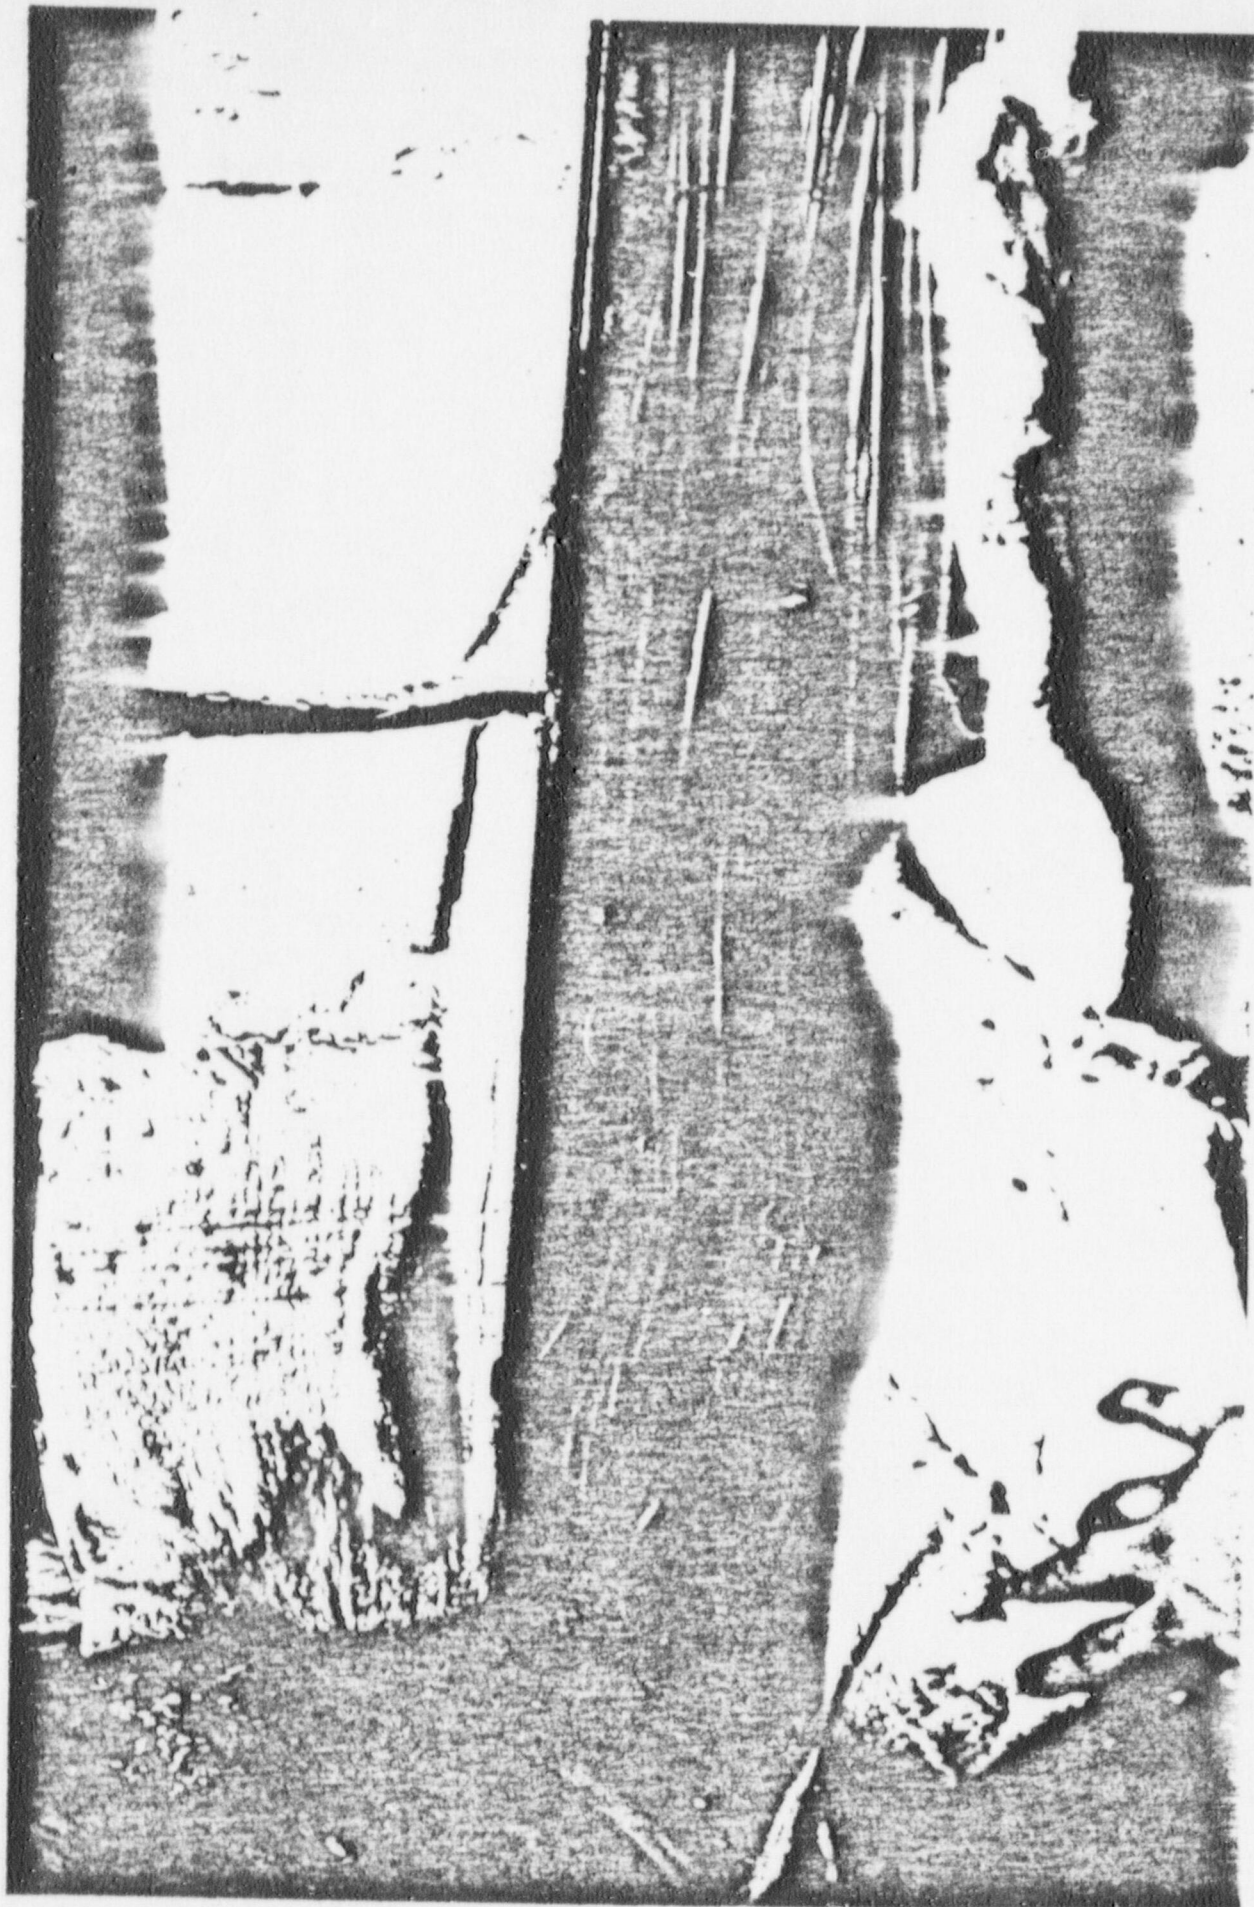
FIGURE 11 - TRAY 3 AFTER TEST

1. Post Test Visual Observation - The mineral wool was blackened about the base of each tray and extended upward approximately 1 ft on trays 1, 2, and 4. On tray 3, the blackened area extended to approximately 4 ft above the floor. The interior surface of the wool appeared unchanged, except for small areas of light brown near the base in trays 1, 2, 3, and 4 as shown in Figure 11.

In all cable trays except tray 5, thermal damage of cables was observed near the base. A summary of damage is shown in Table 12. Cable damage in tray 3 is shown in Figures 11 and 12. Cable damage in tray 2 is shown in Figure 13.

<u>Tray No.</u>	<u>Description</u>
1	Cable material at bottom of bundle loop melted and charred.
2	Cable material of all cables in contact with bottom tray rung melted.
3	Cable material at bottom of bundle loop and along tray side channels melted and charred. Greatest amount of cable damage occurred in tray 3.
4	Cable material at bottom of bundle loop melted and charred.
5	No cable damage observed.
