IOWA STATE
UNIVERSITY

Docket: 50-116

Subject: Malfunction of the UTR-10 Shim-safety Rod

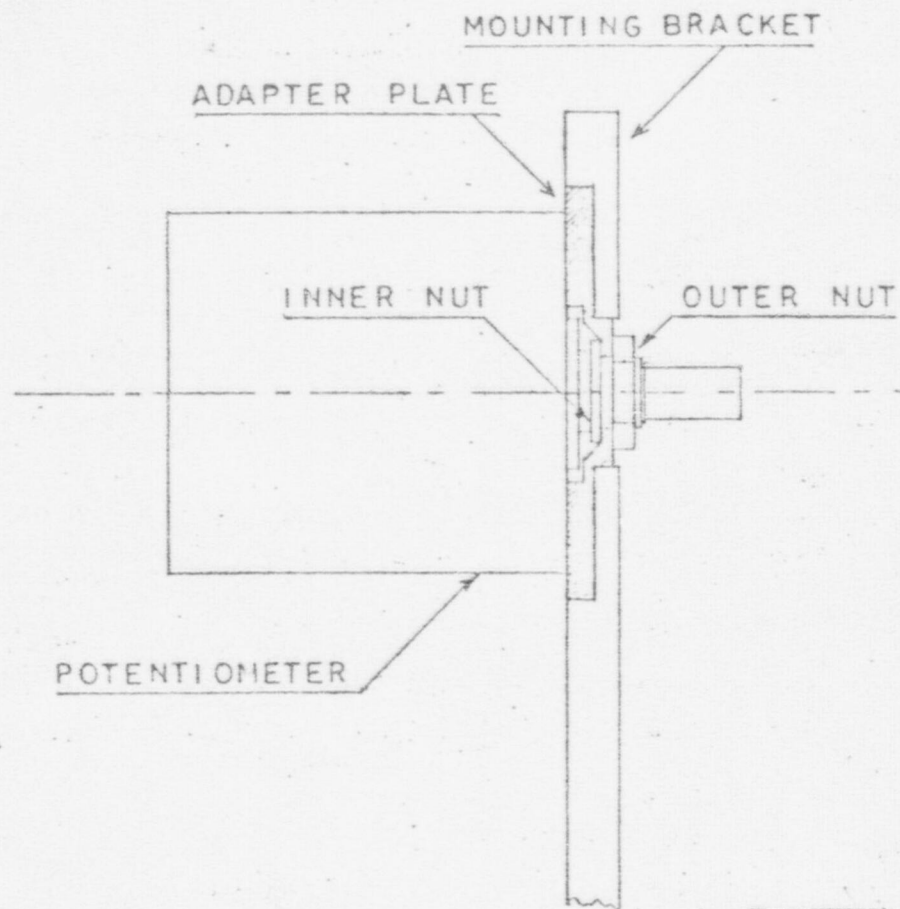
FIGURE 1a

Inspection of the rod drive unit showed that the position potentiometer mounting nut was loose allowing the potentiometer gear to mismatch with the rod drive gear. The mismatch prevented normal spring-force insertion.

BEFORE

Two modifications were initiated. The potentiometer mounting hardware was changed to permit use of a lock washer. See Figures 1a and 1b. A fiducial mark was added to the nut and mounting bracket

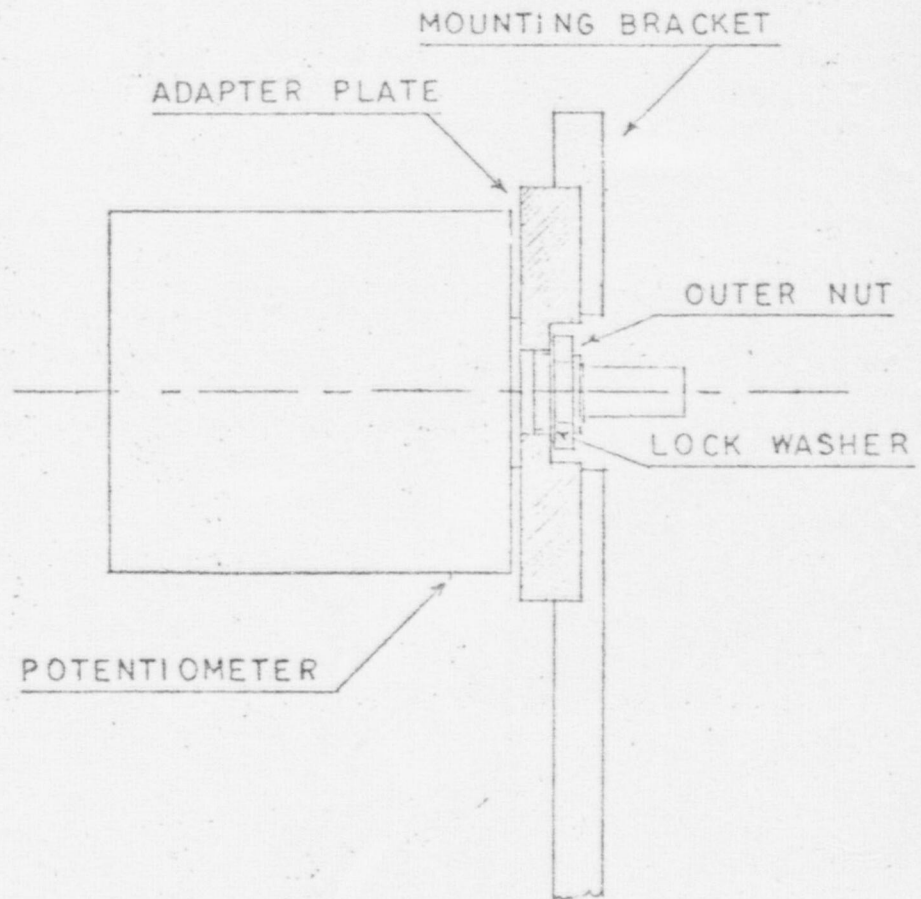
FIGURE 1b

AFTER

to indicate during visual inspection if nut rotation has occurred. Second, the inspection interval has been reduced to six months.
