Subject: Reportable Occurrence 50-29/77-30/01T
Errors in Accident Analysis

(LER 77-30/1T)
LICENSEE EVENT REPORT

SUMMARY OF MEETING HELD ON JUNE 17, 1977, FOR BRIEFING ON MATTERS RELATING TO ECCS PERFORMANCE EVALUATION FOR YANKEE-ROWE

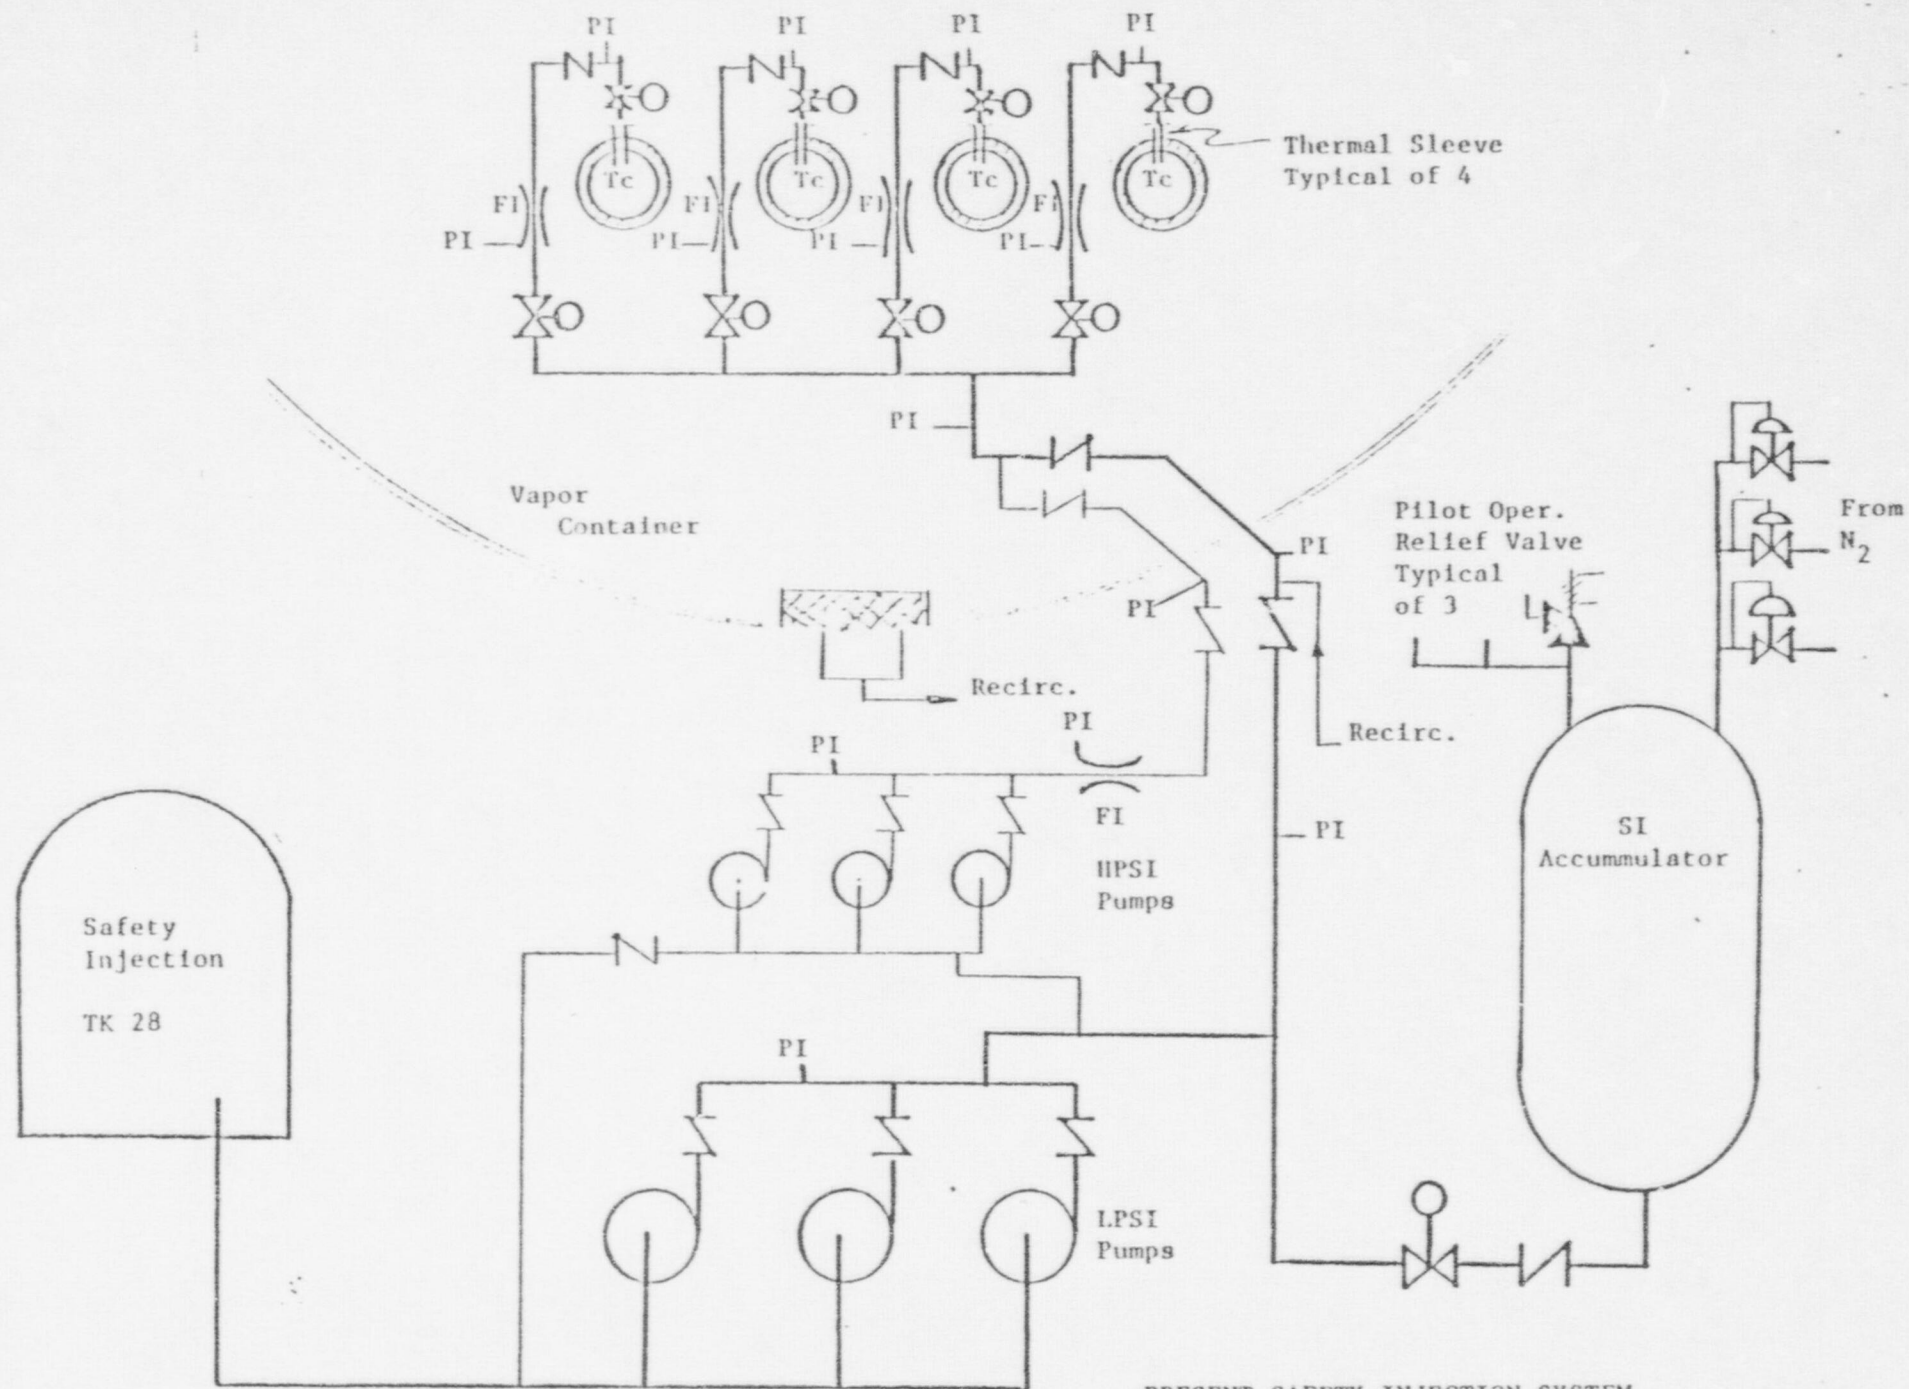
PRESENT SAFETY INJECTION SYSTEM

THE ECCS SYSTEM IN ITS PRESENT CONFIGURATION WAS ORIGINALLY DESIGNED TO PROVIDE THE CAPABILITY TO ISOLATE FLOW TO AN INDIVIDUAL RC LOOP. THIS WAS REQUIRED ONLY IN THE CASE OF A RUPTURE OF THE SI BRANCH LINE DOWNSTREAM OF THE CHECK VALVE.

THE CORE XII ECCS ANALYSIS DID NOT ASSUME ISOLATION OF FLOW TO THE BREAK. BASED ON THE ASSUMPTION THAT ISOLATION WAS NOT ESSENTIAL, YANKEE PROPOSED TO PROTECT AGAINST OPERATOR ERROR AND SPURIOUS FAILURE BY REMOVING POWER FROM THE BRANCH LINE MOTOR OPERATED VALVES.

YANKEE PROPOSES TO RESTORE POWER TO CS-MOV-536, 537, 538, 539 AND SI-MOV-22, 23, 24, 25 WHICH WILL PROVIDE REDUNDANT CAPABILITY TO ISOLATE THE BROKEN BRANCH LINE, FROM THE CONTROL ROOM. RESTORATION OF POWER WILL PROVIDE PROTECTION AGAINST

1. RELOCATE THE DOWNSTREAM VALVES OUTSIDE THE LOOP, I.E. REMOTE FROM LOCA IMPACT, OR
2. INSTALL NEW REPLACEMENT VALVES OUTSIDE THE LOOP.

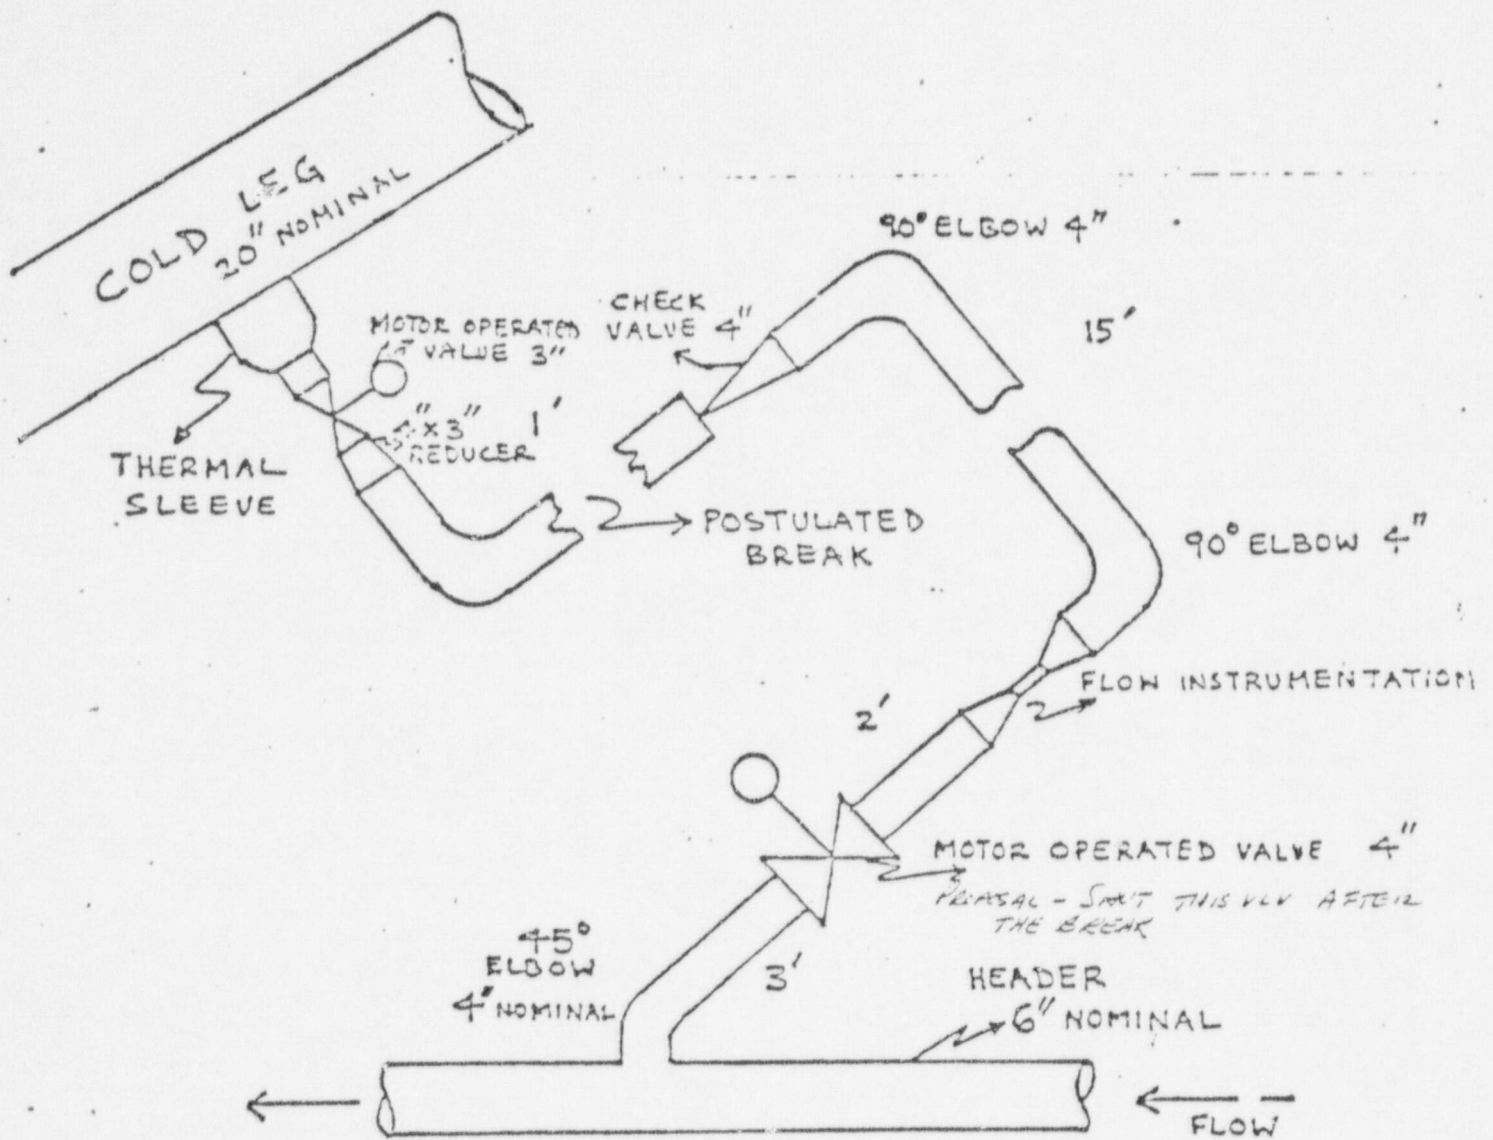
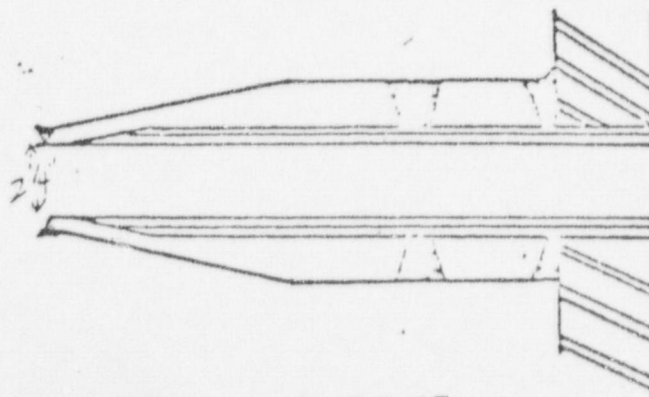
ECCS INJECTION LOOP GEOMETRY

YAEC has previously determined in its ECCS performance analysis for Core XII that a break in a safety injection line at the location of the 2 1/4 inch I.D. thermal sleeve would be the most limiting small break (resulting in highest clad temperature for the spectrum of small breaks). During the Core XIII ECC performance analysis efforts YAEC discovered that if a break were assumed in the short 4 inch pipe section downstream of the 4 inch check valve in the safety injection line, this would result in a higher peak clad temperature than for the break location at the thermal sleeve. While the RCS blowdown characteristics would remain the same (blowdown would still be through the flow resistance of the thermal sleeve), the spill of accumulator and pumped injection water to the containment floor (previously assumed through the 2 1/4 inch thermal sleeve) would be significantly greater because of the lower flow resistance at the location of the 4 inch break.

- To provide the increased permanent flow resistances in each safety injection line by replacement of the 4 inch check valves with a 2 1/2 inch check valve or by other appropriate means as determined to be suitable and practical. Provide descriptions and bases for the modifications.
