NORTH ANNA 2 STEAM GENERATOR
TUBE FATIGUE EVALUATION AND
REMEDIAL ACTIONS REPORT

MARCH 16, 1988

PREPARED BY:
WESTINGHOUSE ELECTRIC CORPORATION
SERVICE TECHNOLOGY DIVISION
P. O. BOX 3377
PITTSBURGH, PA. 15230

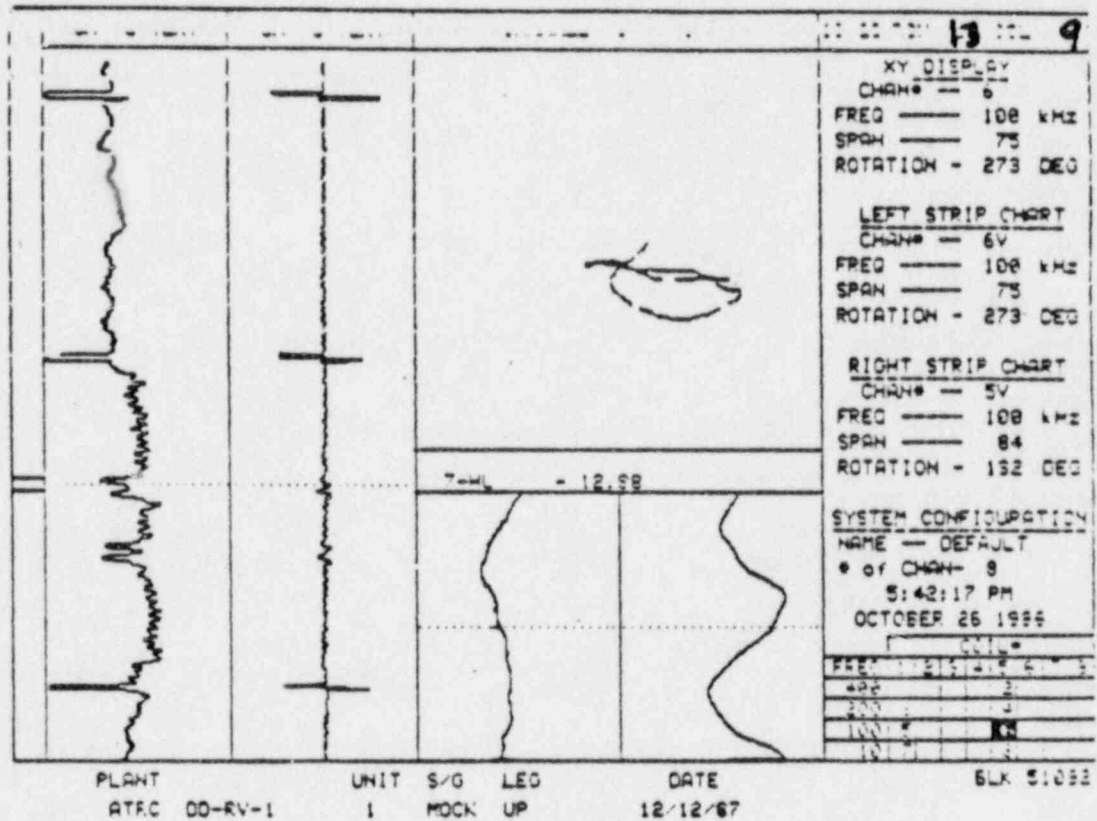
FIGURE 3-1 Typical Eddy Current Signal for AVBs

Since tube supports limit tube vibration potential, an evaluation of the presence or absence of AVB support was needed for each North Anna #2 tube. The minimum depth of AVB insertion in the Series 51 steam generator is to tube Row 11, and in most cases, the actual depth of insertion went to Row 10, 9, 8, and sometimes Row 7. Direct visual or fiberoptic observation of AVB positions would have been difficult and potentially unreliable, therefore, eddy current test information was used to evaluate presence of AVBs. A typical ECT data trace indicating the intersection of an AVB with the tube is shown in Figure 3-1.

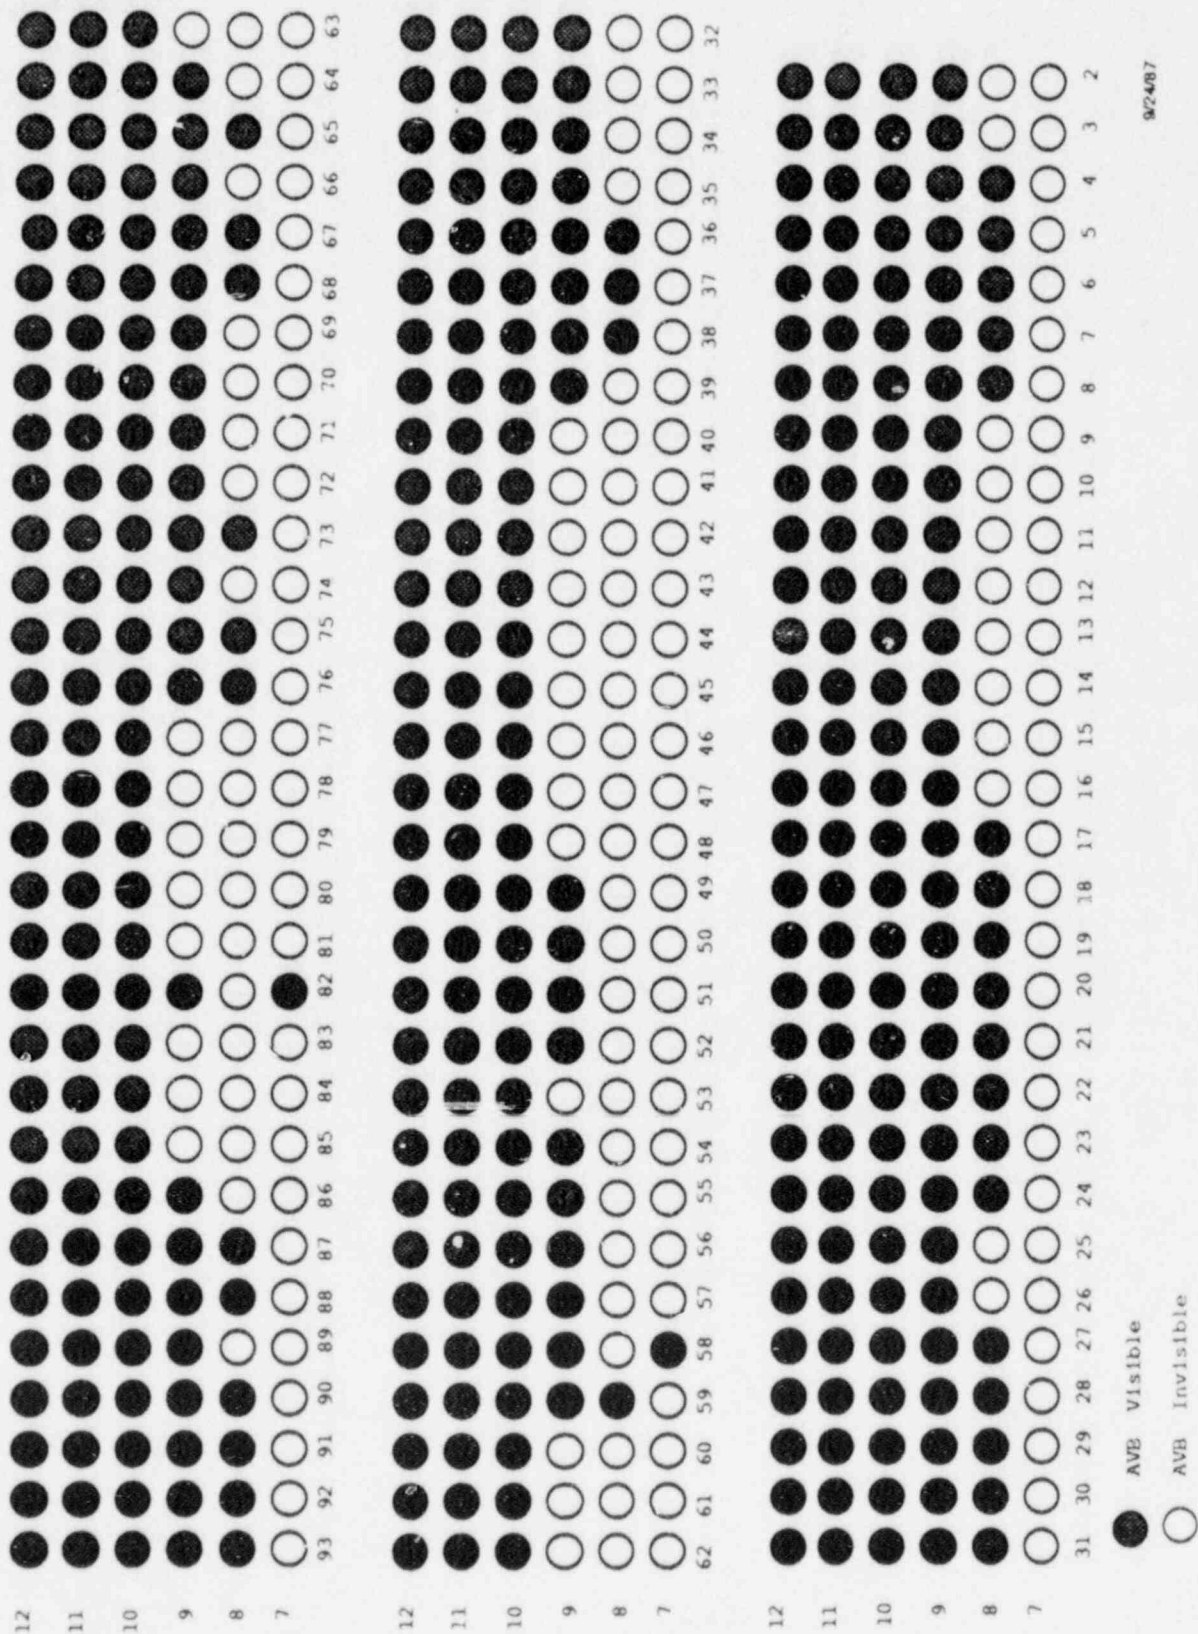
FIGURE 3-2
North Anna #2: S/G -A
AVB Visibility

no AVB eddy current signals were apparent. Initial ECT evaluations of North Anna #2 AVB positions were limited to interpreting whether or not an AVB was "visible" or "invisible". Rows 8 through 12 were examined and "visible" and "invisible" interpretations were made for all tubes. Some anomalies appeared where it is likely that the signals were masked by copper deposits. Figures 3-2 through 3-4 show the "visible" - "invisible" map (without AVBs) in this preliminary stage of data interpretation.

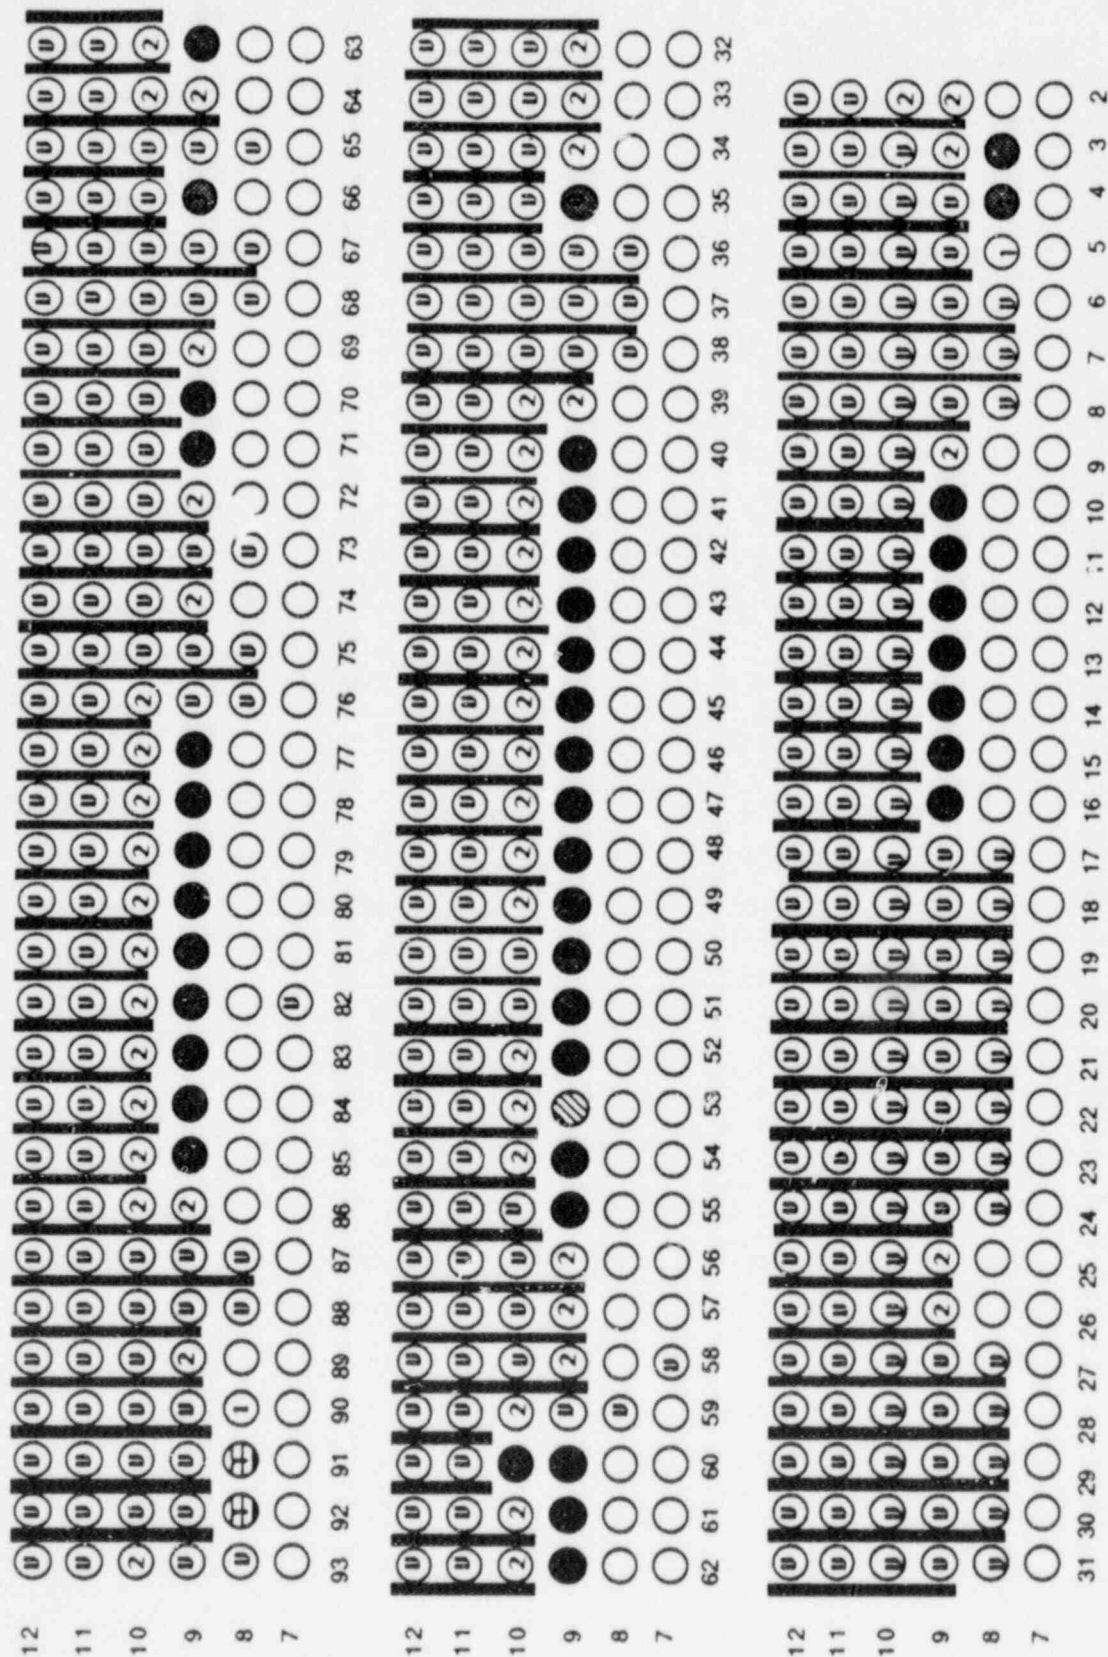
**North Anna #2 (VGB): S/G - A
AVB Insertion and Plugging**

Figures 3-5 through 3-7 show AVB insertion maps developed according to the above guidelines of the AVB "visible" analysis, "0, 1, or 2 AVB Present" analysis, as well as top tube support plate denting results of preventively plugged tubes.

These criteria are essentially identical with the North Anna #1 tube plugging criteria, except that the acceptability of single-sided support was extended from Row 9 to include all rows in the Unit #2 evaluation. The above criteria led to preventive plugging of all tubes without at least single-sided AVB support in Rows 9 or larger, and Columns 3, 4, 91, and 92 in Row 8. The tubes selected for preventive plugging are also shown in Figures 3-5 through 3-7.

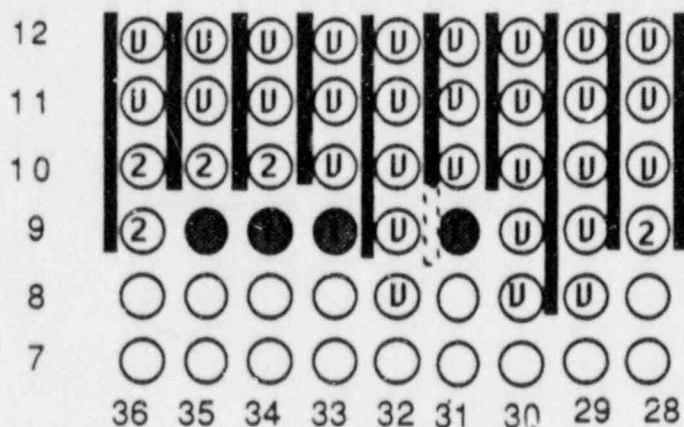
North Anna #2 (VGB): S/G -B
Isolated View of R9C32

An example the second condition be seen in SG-B, Column 32 (See Figure 5-1). R8C32 and R9C32 are reported as "visible". By the second guideline, R9C32 is assumed to be supported, and is shown with single-sided AVB support. Although support is reasonably assumed for R9C32, both adjacent tubes, R9C31 and R9C33 were plugged, since it could not be determined on which side support was provided to R9C32.

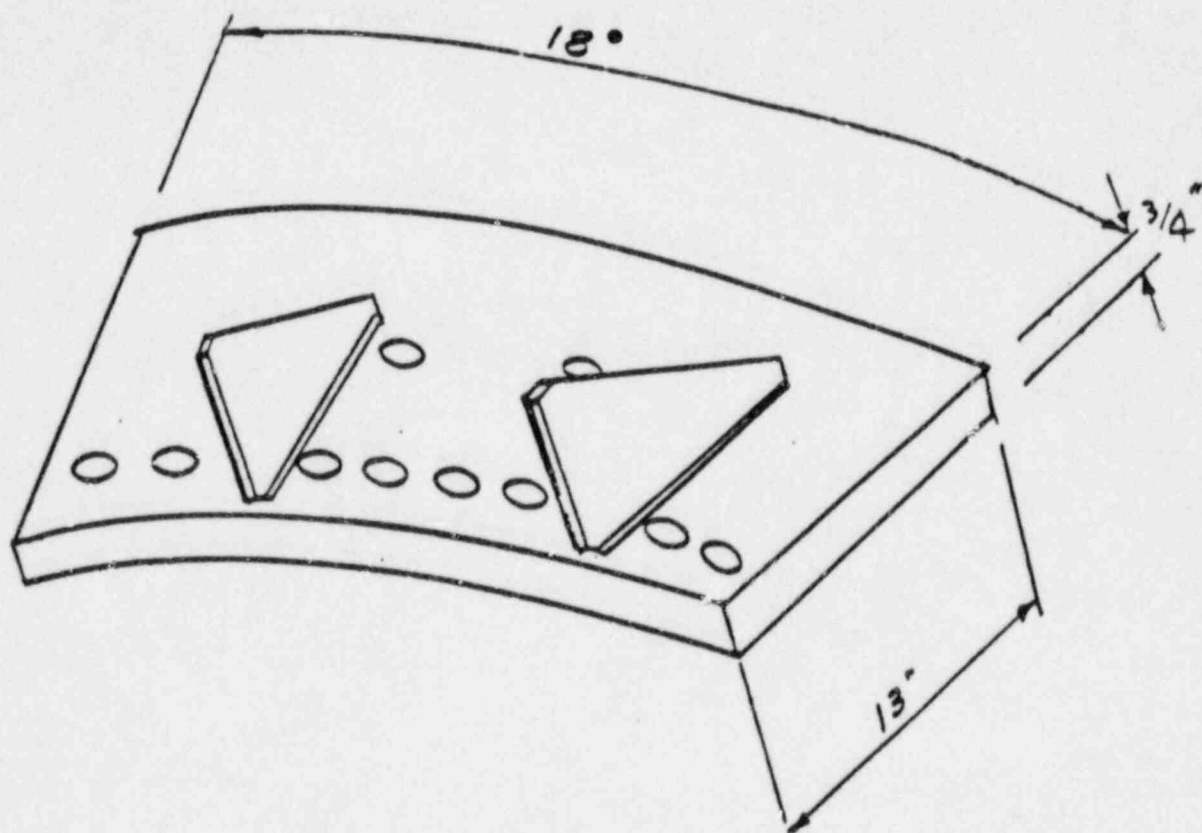
FIGURE 6-1 Typical Downcomer Flow Resistance Plate

The mechanical, structural, and thermal-hydraulic implications of the Downcomer Flow Resistance Plate modification (DFRP) are identical to those of Unit #1 (See Reference 1). Figure 6-1 shows a typical DFRP.
