PDR-016
RESPONSE TO FREEDOM OF
INFORMATION ACT (FOIA) REQUEST

SUBJECT: NOTICE OF VIOLATION (NRC INSPECTION REPORT 50-445/87-27;
50-446/87-20)

AFW FAN MOTORS AGENDA

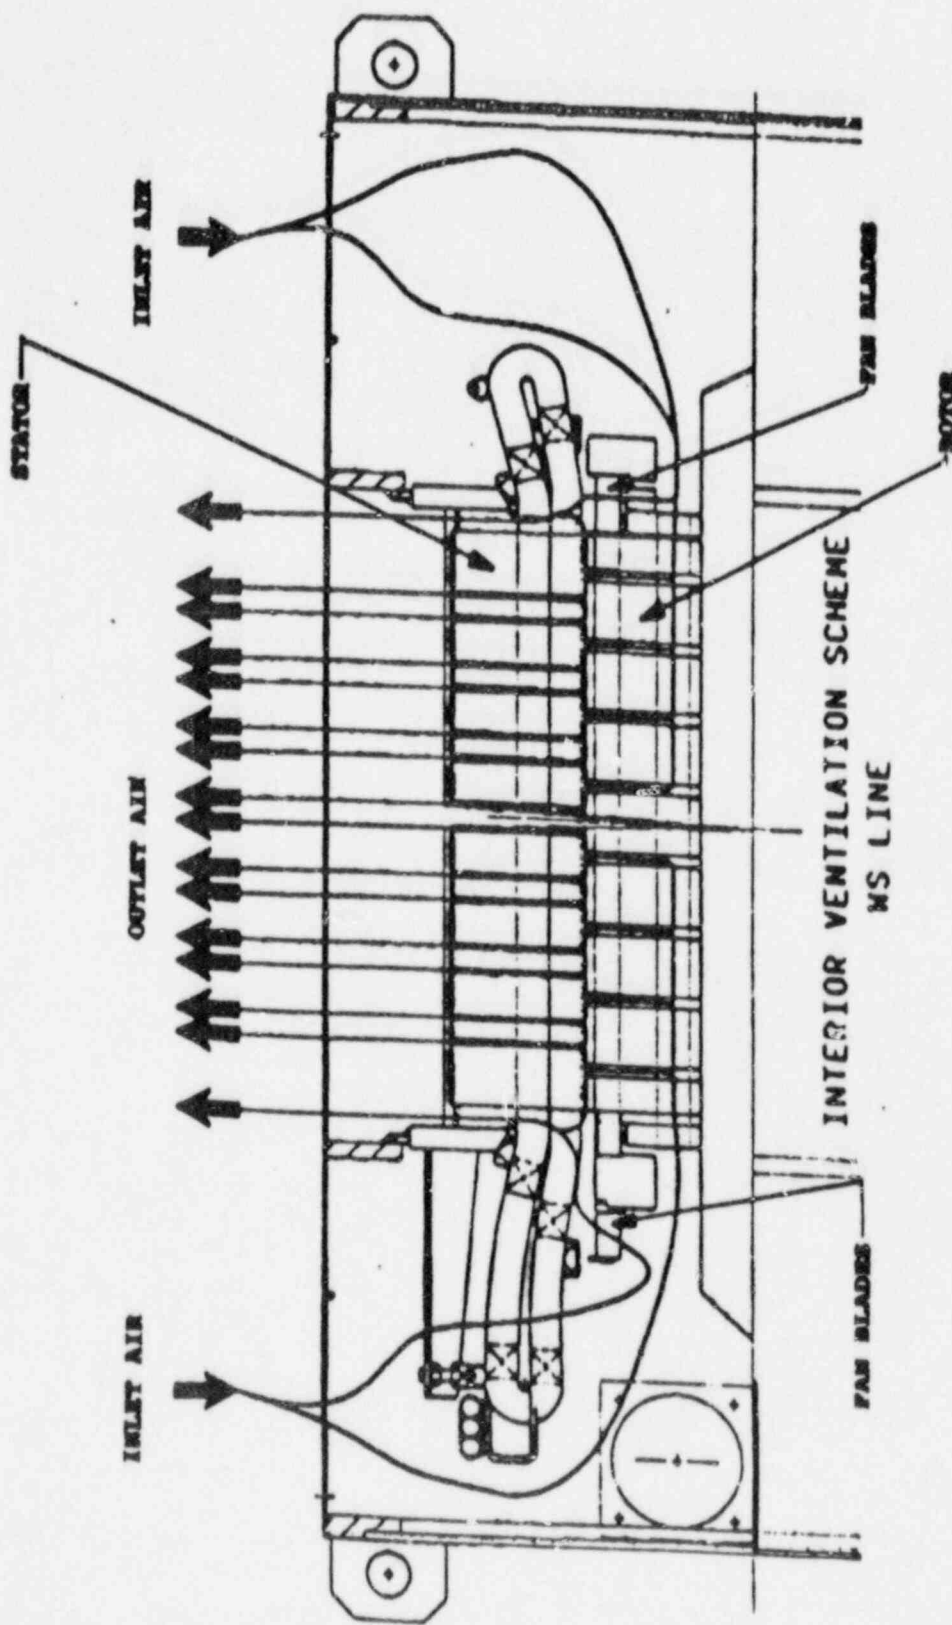
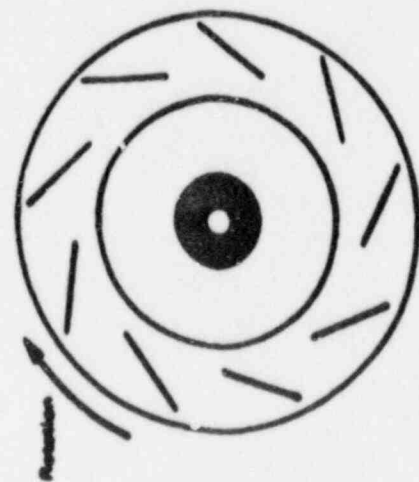
BACKWARD INCLINED (forward curved) FAN
 INTENDED BY WESTINGHOUSE
