SUBJECT: REVIEW OF PRELIMINARY ACCIDENT SEQUENCE PRECURSOR ANALYSIS OF  
OPERATIONAL EVENT AT ARKANSAS NUCLEAR ONE, UNIT 1

**LER No. 313/96-005**

Event Description: Reactor Trip and Subsequent Steam Generator Dryout

Plant: Arkansas Nuclear One, Unit 1

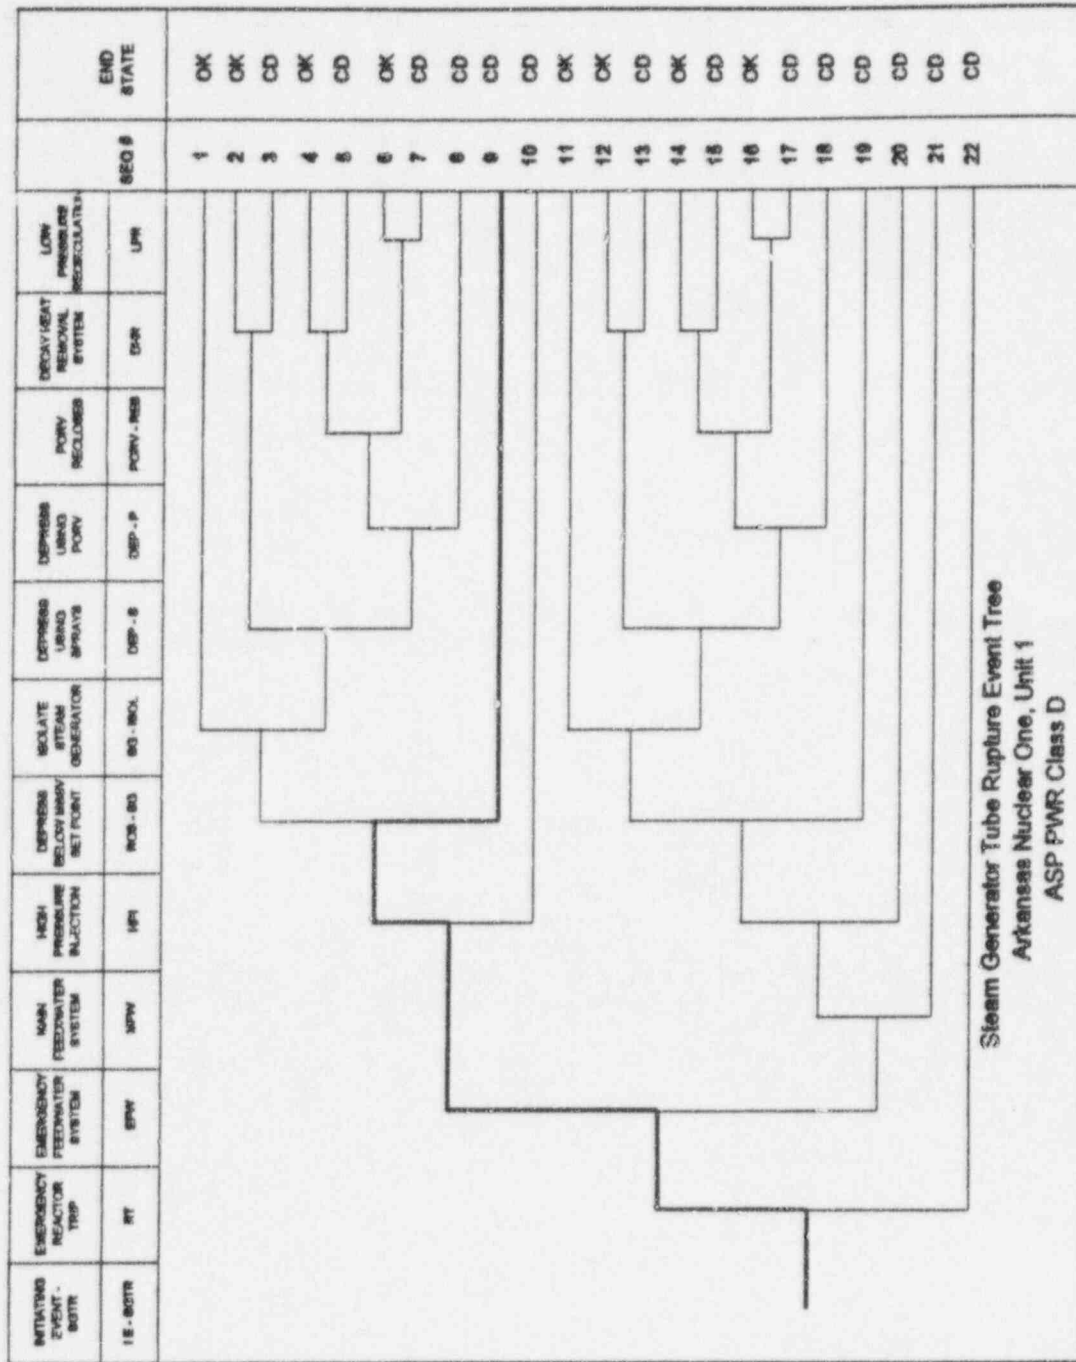
Fig. 1 Dominant core damage sequence for LER 313/96-005.

The dominant core damage sequence, highlighted as sequence number 9 on Figure 1, contributes approximately 89% to the estimated CCDP for SGTR. The dominant sequence involves

- SGTR initiating event occurs,
- the reactor is successfully tripped,
- EFW is successful,
- HPI is successful,
- the operators fail to depressurize the RCS below the MSSV setpoint<sup>d</sup>,
