## LICENSEE EVENT REPORT (LER)

FACILITY NAME (1) Joseph M. Farley - Unit 1										DOCKET NUMBER (2) 0 5 0 0 0 3 4 8				PAGE (3) 1 OF 0 9	
TITLE (4) Potential Inoperability Of The A Train Charging Pump Due To Gas Accumulation															
EVENT DATE (5)			LEN NUMBER (6)				REPORT DATE (7)			OTHER FACILITIES INVOLVED (8)					
MONTH	DAY	YEAR	YEAR	SEQUENTIAL NUMBER	REVISION NUMBER	MONTH	DAY	YEAR	FACILITY NAMES			DOCKET NUMBER(S)			
0 3	0 1	8 8	8 8	0 0 6	0 0	0 3	3 1	8 8	J. M. Farley - Unit 2			0 5 0 0 0 3 6 4			
OPERATING MODE (9) 1			THIS REPORT IS SUBMITTED PURSUANT TO THE REQUIREMENTS OF 10 CFR 5. (Check one or more of the following) (11)												
POWER LEVEL (10) 1 0 0			20.402(b)		20.405(c)		50.73(a)(2)(iv)		73.71(b)

Joseph M. Farley Nuclear Plant .. Unit 1  
Licensee Event Report No. LER 88-006-00

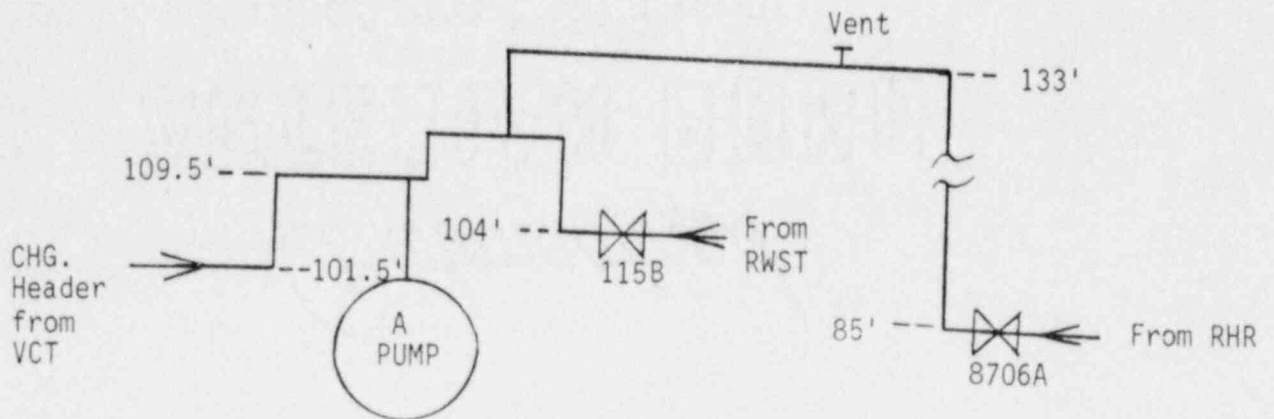
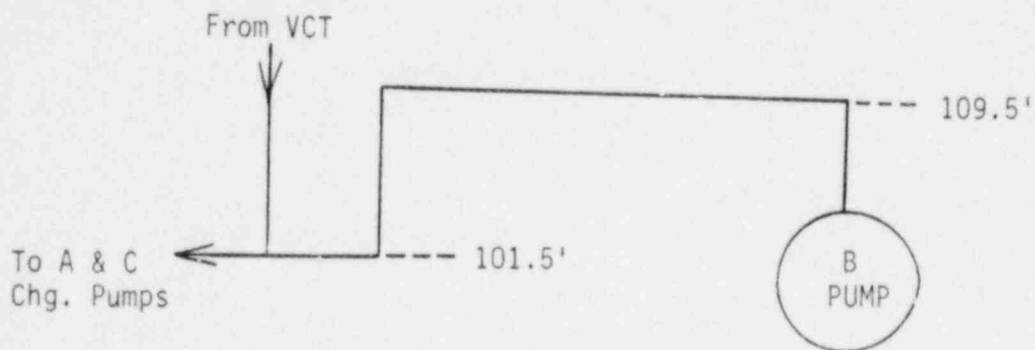
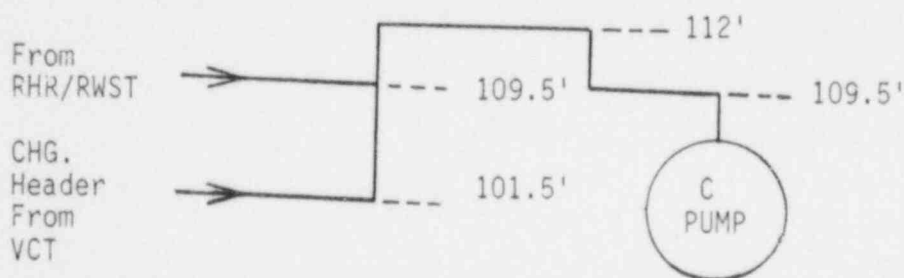
This event was caused by the piping configuration in that the layout of the A train supply line from RHR piping allowed hydrogen to accumulate. Normal suction for the charging pumps is from the VCT. The VCT contains an overpressure of hydrogen in equilibrium with the liquid. In general, the suction piping layout for each Unit 1 and 2 charging pump resembles an inverted loop (See Attachment). There is the potential for gas coming out of solution and migrating to these inverted loops.

For the Unit 1 A charging pump suction piping, the top of the inverted loop is at 109.5 ft. elevation. The RHR to charging pump suction header is connected to the top of the inverted loop and rises to elevation 133 ft. The vent used to vent the gas is located at this elevation. The Unit 2 A pump suction piping is similar to Unit 1 except the top of the loop is located at 114 ft. elevation. The high point and location of the vent in the RHR to charging pump suction header is at elevation 132.5 ft. Both of these geometries provide the conditions for trapping large amounts of hydrogen gas in the respective RHR to charging pump suction headers.

If hydrogen comes out of solution, it would accumulate in these A charging pump inverted loops. Review of the piping layouts identifies that the section of pipe containing the void is connected via a vertical pipe run to the charging pump suction piping at the top of the inverted loop. It is believed that hydrogen gas was evolving from the fluid and accumulating in the RHR to charging pump suction supply header, since this provided the high point in the system.

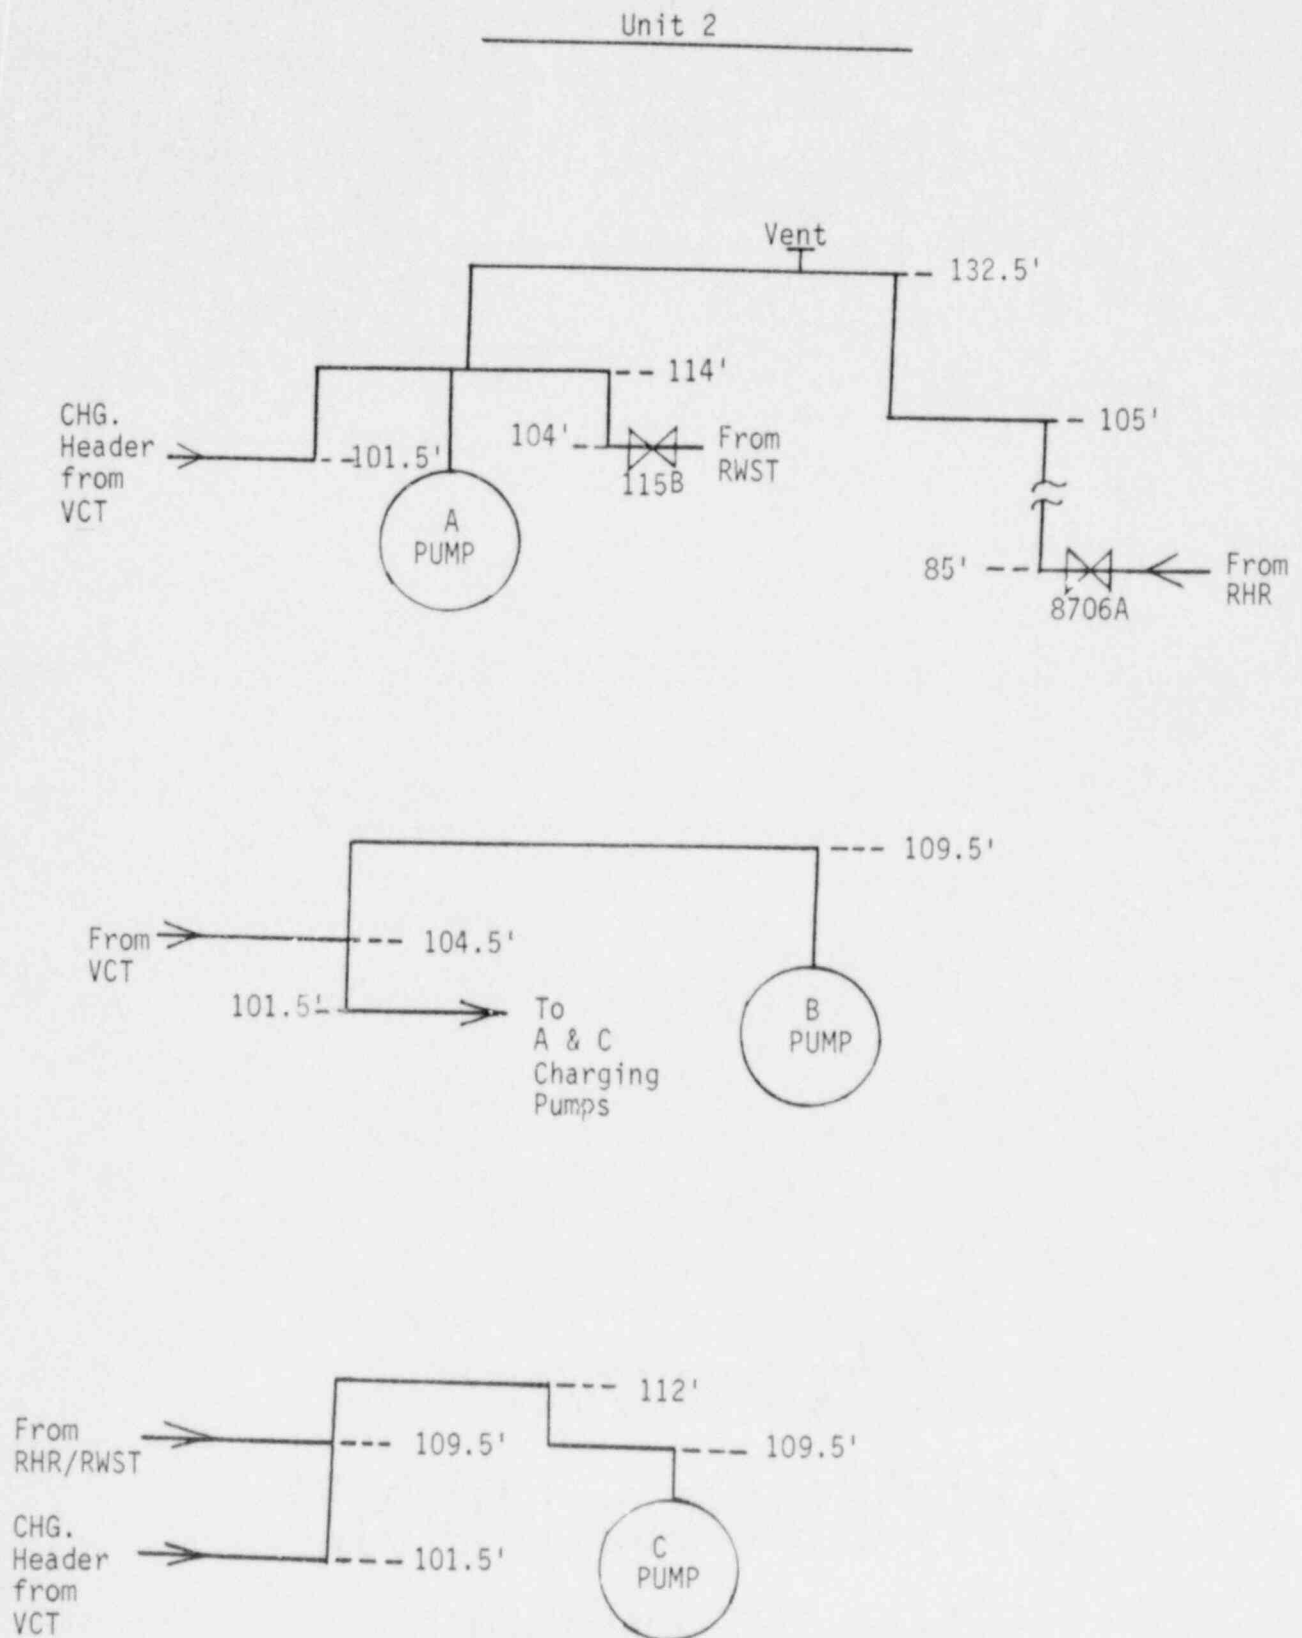
The B train (both Units 1 and 2) has a suction piping geometry which does not permit the voiding of large sections of piping, regardless of pump status. The geometry in these piping sections is such that any hydrogen evolving cannot be trapped and is therefore swept through the pump. This is due to the fact that there are no auxiliary lines (potential traps) connected to the suction piping at the top of the inverted loop. This is supported by the fact that the plant found no indication of hydrogen accumulation when venting the B train RHR to charging pump suction piping on both Units 1 and 2.
