Millstone Nuclear Power Station, Unit No. 1
Additional Information Concerning Generic Letter 87-05

Millstone Nuclear Power Station, Unit No. 1
Results of Sand Pocket Drain Line Inspection

Results of Drywell Inspection

ENGINEERING SUMMARY
DRYWELL LINER INSPECTION
ULTRASONIC LINER THICKNESS MEASUREMENTS

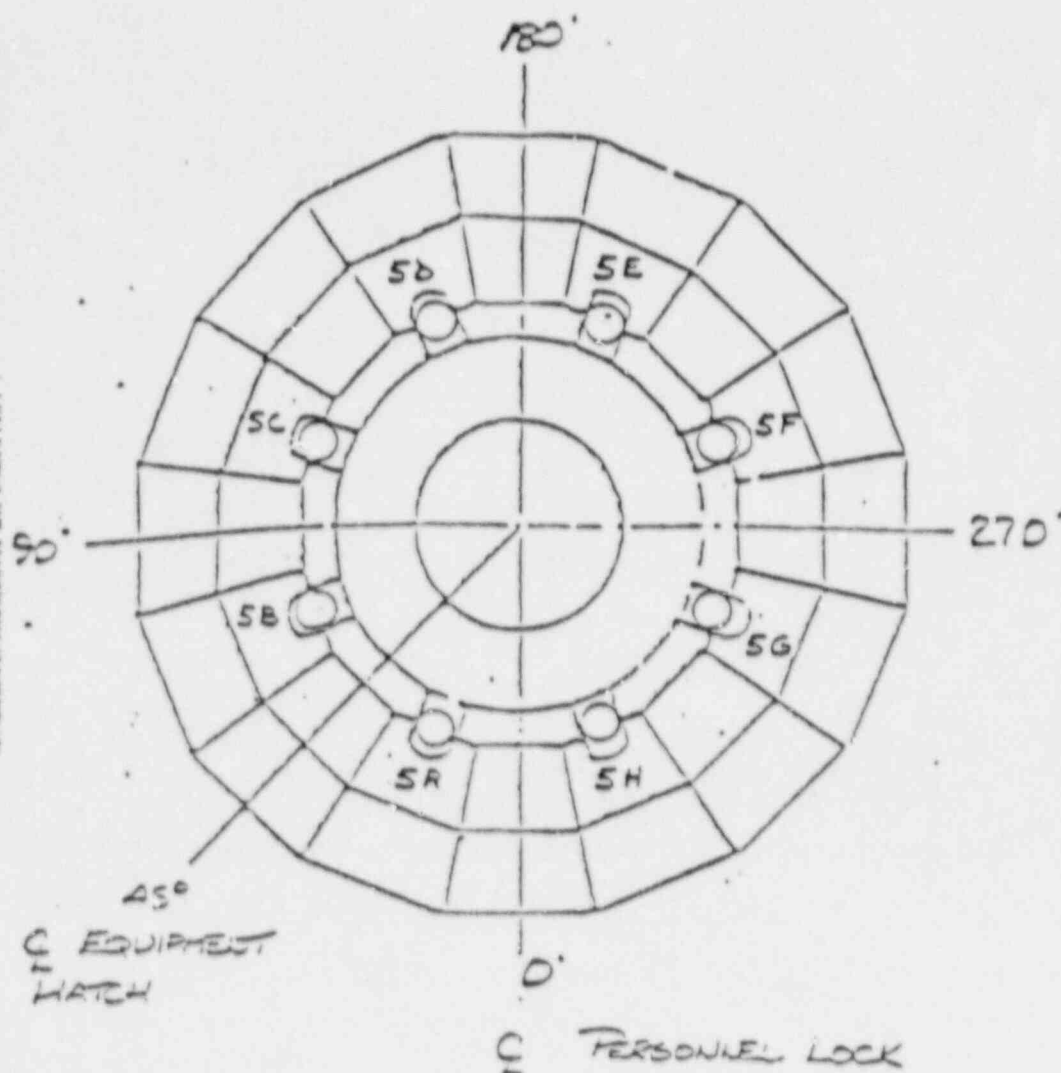
PLAN VIEW DRYWELL
N.T.S.
FIGURE 1

1. Fiberscopic inspections were performed on 5A, 5C, 5E, and 5G drain lines. These drain line locations are shown in Figure 1. Inspection results are as follows:
 - o Water pockets were present in all four drain lines.
 - o Drain lines in the concrete wall were not continuously sloped lines as shown in Figure 2. The lines appeared to be wavy throughout the thickness of the wall.
 - o Sand from the sand cushion was present in each of the drain lines.
 - o Water stains and sand were visible on the torus structure at the 11 o'clock position.

- o Drain lines in the concrete wall are not continuously sloped lines as shown in Figure 1 but have various peaks and valleys. It appears that the lines were not supported during the concrete pour of the wall and that they moved when the concrete was placed.

- o There is a wire cloth screen at the base of the metal trough which was not shown in Figure 1. The screen appears to be passing minor amounts of sand from the sand cushion. (See Table 1 for details of each screen.)

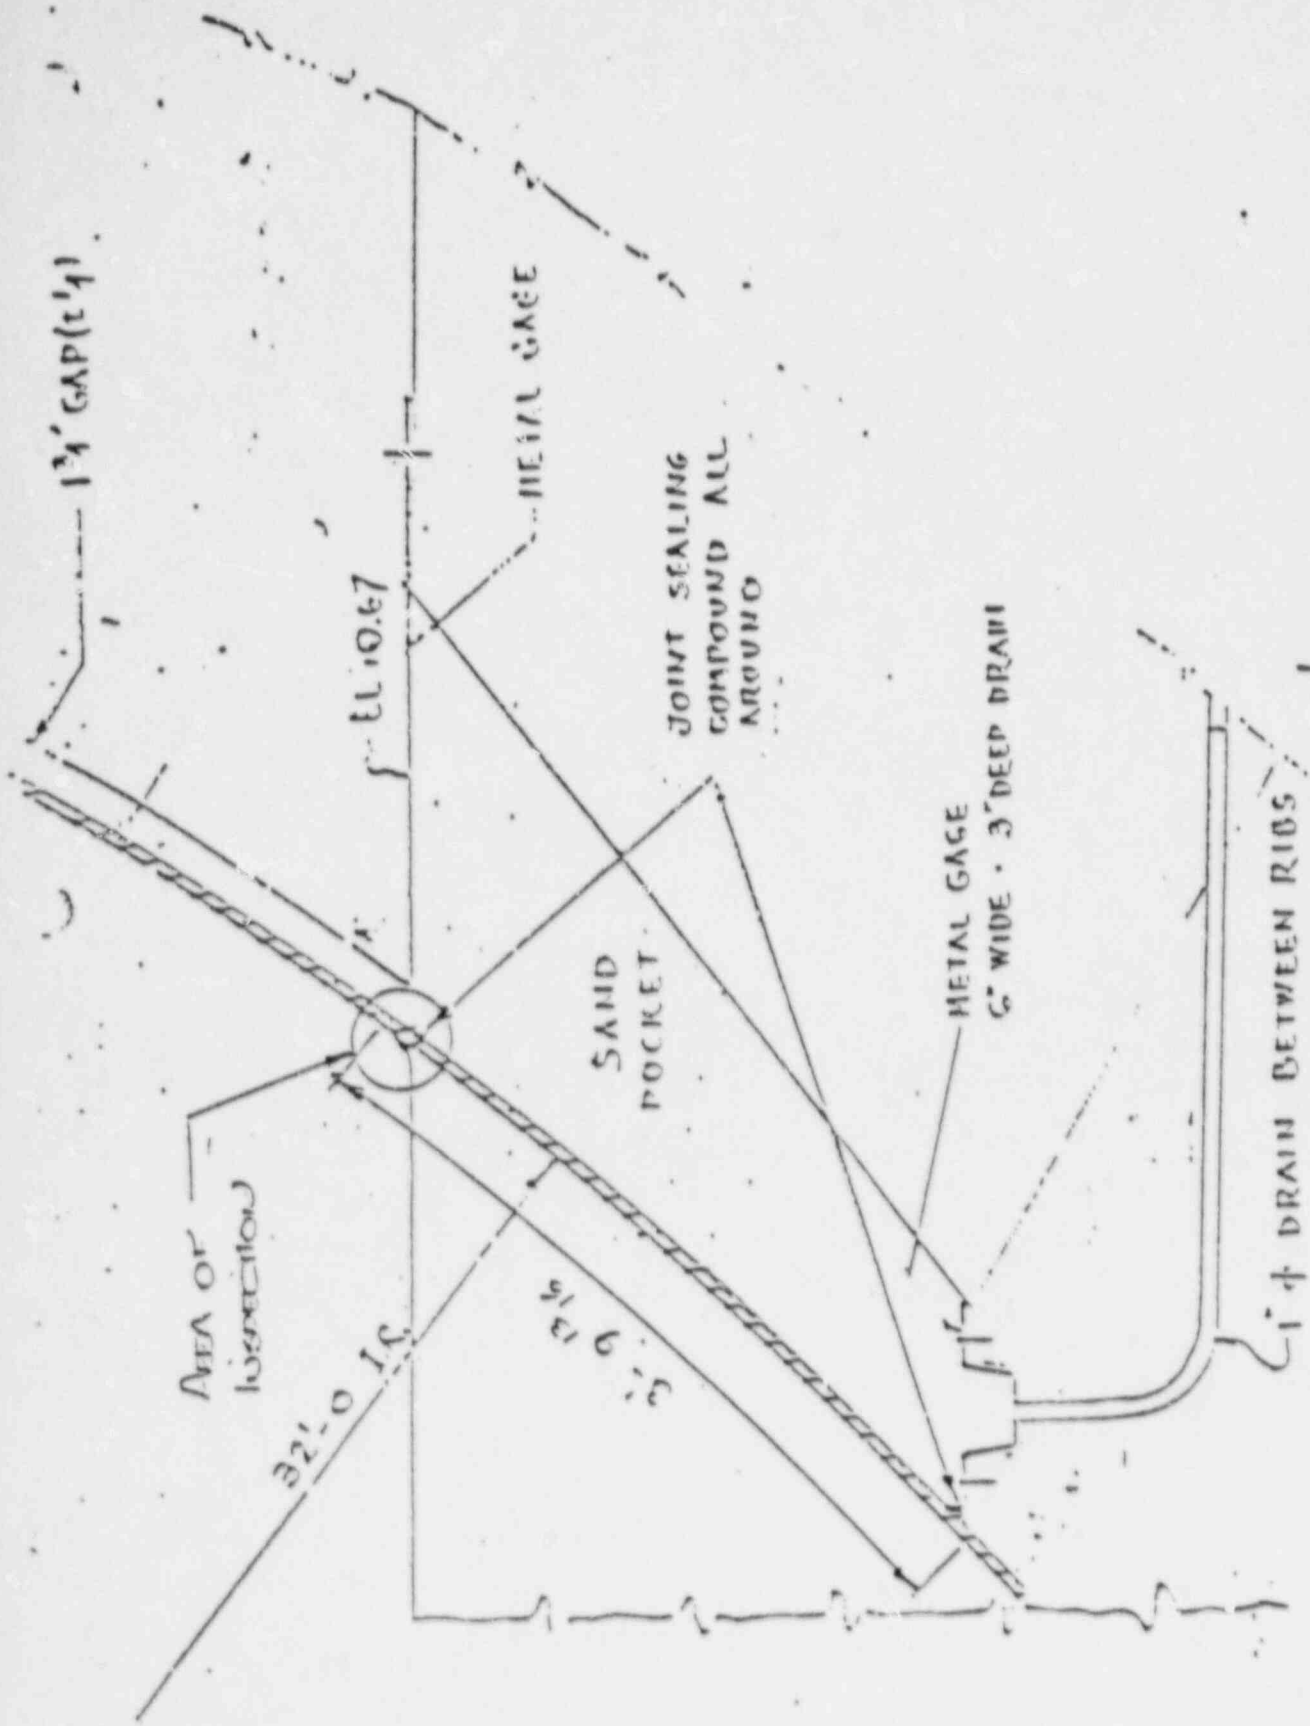
SAND POCKET DETAIL
FIGURE 2

The sand cushion drain line detail is shown in Figure 1. The detail presented shows a pre-formed metal trough 6 inches wide by 3 inches deep. A 1-inch diameter drain line is connected to the bottom of the metal trough. The drain line extends vertically downward, turns 90° to a horizontal position, and then slopes downward and extends through the concrete wall. This design permits any water to exit the drain line and into the torus room.

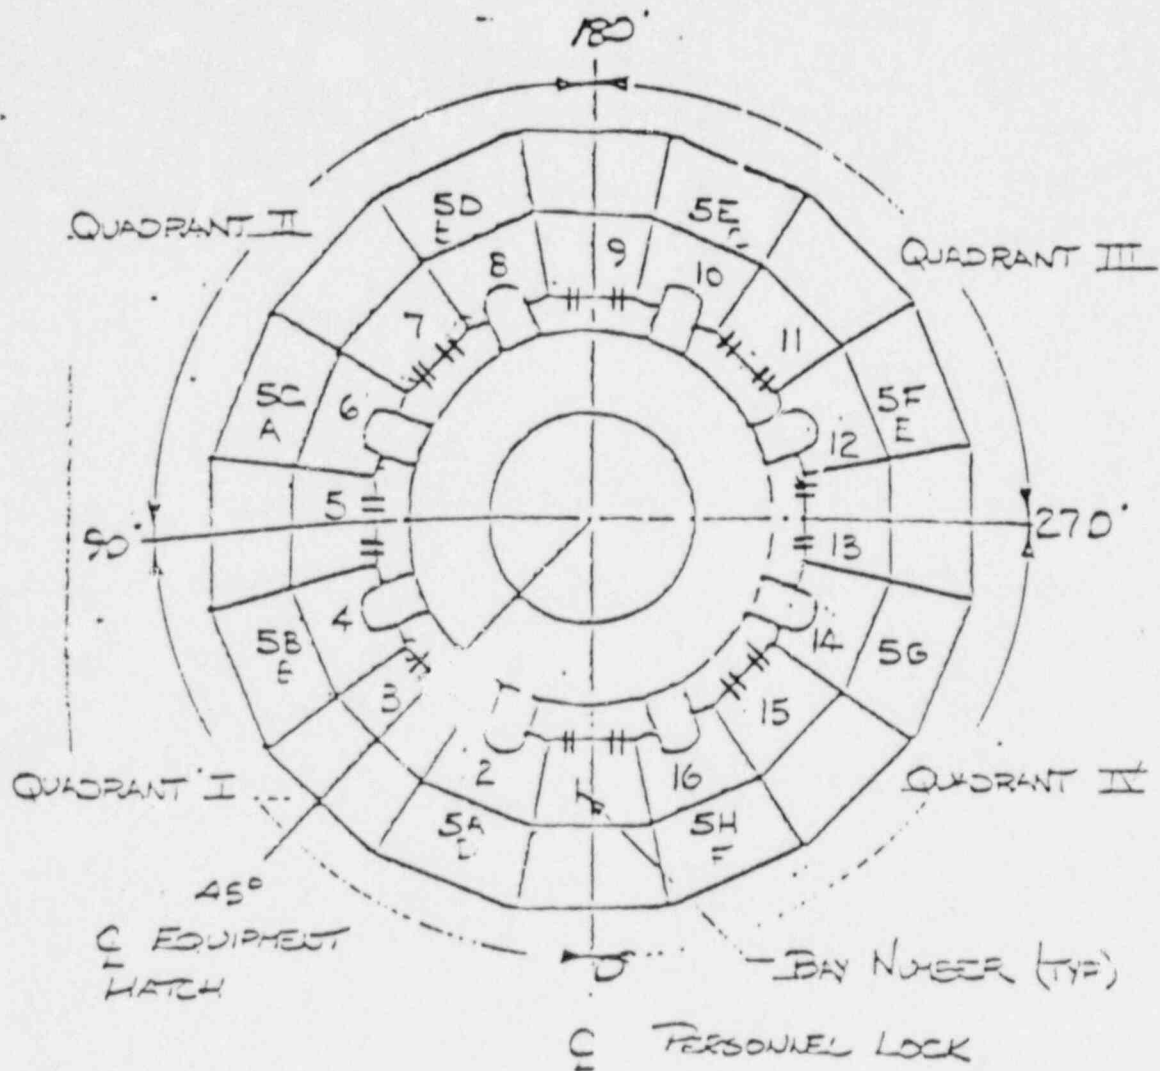
RAW VIEW DRYWELL
NITS.
FIGURE 1

The drywell liner shell thickness in the area of the sand cushion at elevation 0'-8" is 0.875 inches thick as shown on the original Chicago Bridge and Iron drawings. The shell is composed of many plate section welded together to form a spherical shell. See Figure 1 attached.

The drywell liner inspection ultrasonic thickness measurements are presented in Table 1. As can be seen from the table, 16 points were taken in each pocket. From these readings, the high and low readings were recorded and averaged to obtain the average shell thickness in the area of the concrete pocket. This average thickness is then compared to the center thickness of the 4" x 4" pocket and finally to the actual design plate thickness. The average plate thickness for all inspection pockets is 0.865 inches as compared to 0.875 inch design plate thickness.

Based on the recorded ultrasonic thickness measurements performed in the 16 inspection pockets, the measured shell liner thickness is within ASTM thickness tolerances and the shell liner shows no signs of plate degradation.
