Safety Evaluation Report

related to the restart of
Rancho Seco Nuclear Generating Station, Unit 1,
following the event of December 26, 1985

Docket No. 50-312

Sacramento Municipal Utility District

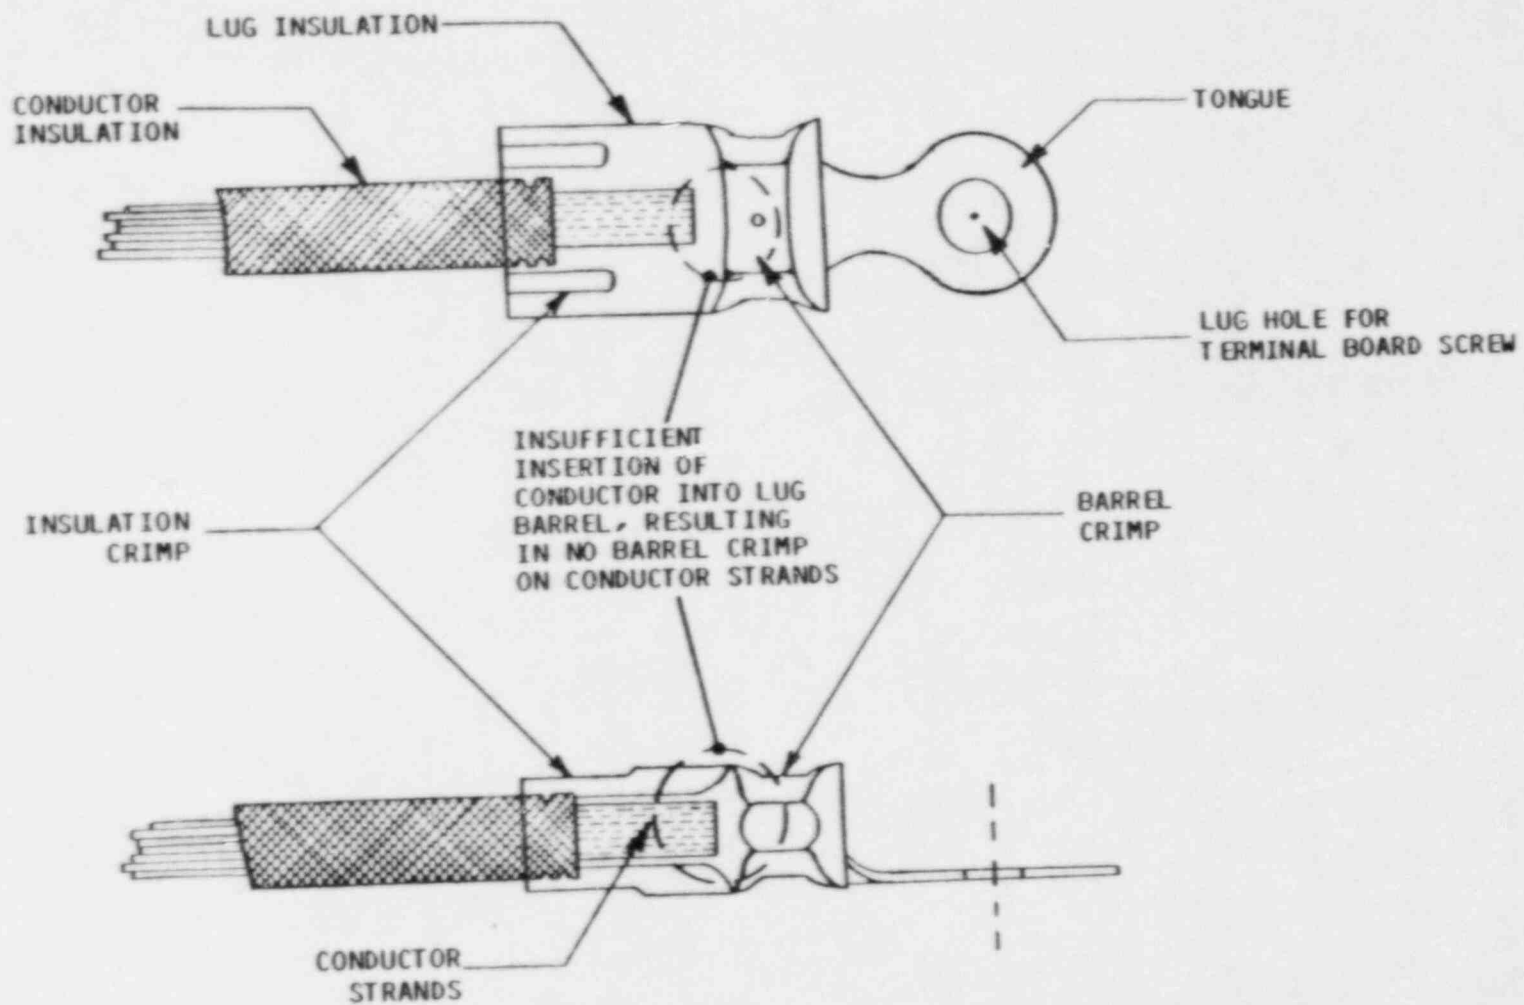
Figure 3.17 December 26, 1985 ICS compression lug termination failure

During in-plant investigations following the event, the licensee discovered an abnormal voltage drop measured between the positive 24-V dc bus and the input of the associated PSM sensing circuit. The voltage drop was found to be caused by a resistance created by a bad electrical connection in the distribution wiring between the +24-V dc bus and the PSM (the bad connection was external to the PSM module). This led the licensee to conclude that: "The root cause of the loss of ICS power was a manufacturing defect in the installation of wiring within the ICS cabinet," and "the direct cause was identified as the loss of ICS dc power caused by a manufacturing error on a lug improperly installed on a factory prepared wire."

The +24-V dc bus is located in ICS cabinet 3, and the PSM module is located in ICS cabinet 2. Power is routed to the PSM from the bus through ICS cabinet 1. The bad electrical connection identified as a contributing root cause for the December 26, 1985 event was located in ICS cabinet 1. The licensee's engineering report on action item 3A, "ICS Equipment Investigation," dated February 7, 1986, indicated that the bad electrical connection arose from a poor mechanical connection (i.e., crimp) of the ICS dc power distribution wire to its lug. When the wire was lifted, the lug actually fell off the end of the wire. The licensee stated that detailed examination of this connection failure revealed that the conductor had been insufficiently inserted into the lug barrel. This resulted in an inadequate barrel crimp on the conductor strands at the tongue end of the lug, creating a loose, high resistance connection (see Figure 3.17). Further investigation revealed that bad electrical connections also existed in ICS cabinets 3 and 5. The bad connections were due to either poor crimp connections or the use of improperly sized hardware to attach the lugs to the bus work (several screws holding lugs to bus bars were found to be loose).

The initial scope and content of the program consisted of visual inspections of compression lug terminations (both "internal" terminations installed by the vendor in the factory, and "external" terminations installed by the licensee between field wiring and the vendor-supplied cabinets/panels) within the five ICS cabinets and the seven NNI cabinets. The licensee inspected 2250 compression lug terminations within the ICS/NNI cabinets, and identified 2 failures (a failure is defined as a lug termination that becomes disconnected from its conductor during the inspection process) and 950 deviations. Examples of deviations are:

- conductors not visible at the tongue end of the lug barrel
- conductor extends too far beyond the tongue end of the lug barrel so that conductor strands are compressed under the terminal screw
- lug hole too large for terminal screw
- wrong size lug for conductor size
- improperly modified lug
- lugs installed face down (not inspectable)
- lugs bent more than 90 degrees
- lugs twisted or deformed
- more than two lugs on a single stud
- incorrect shield termination
- two lugs under one terminal screw not installed back to back

On the basis of these investigation results, the licensee developed and implemented an Electrical Termination Inspection and Upgrade Program designed to verify the adequacy of other terminations in cabinets supplied by the ICS vendor, Bailey Controls Corporation. The program included the following tasks:

The licensee has replaced the failed lugs, and either replaced or reworked all identified deviations so that these terminations satisfy the visual inspection criteria.

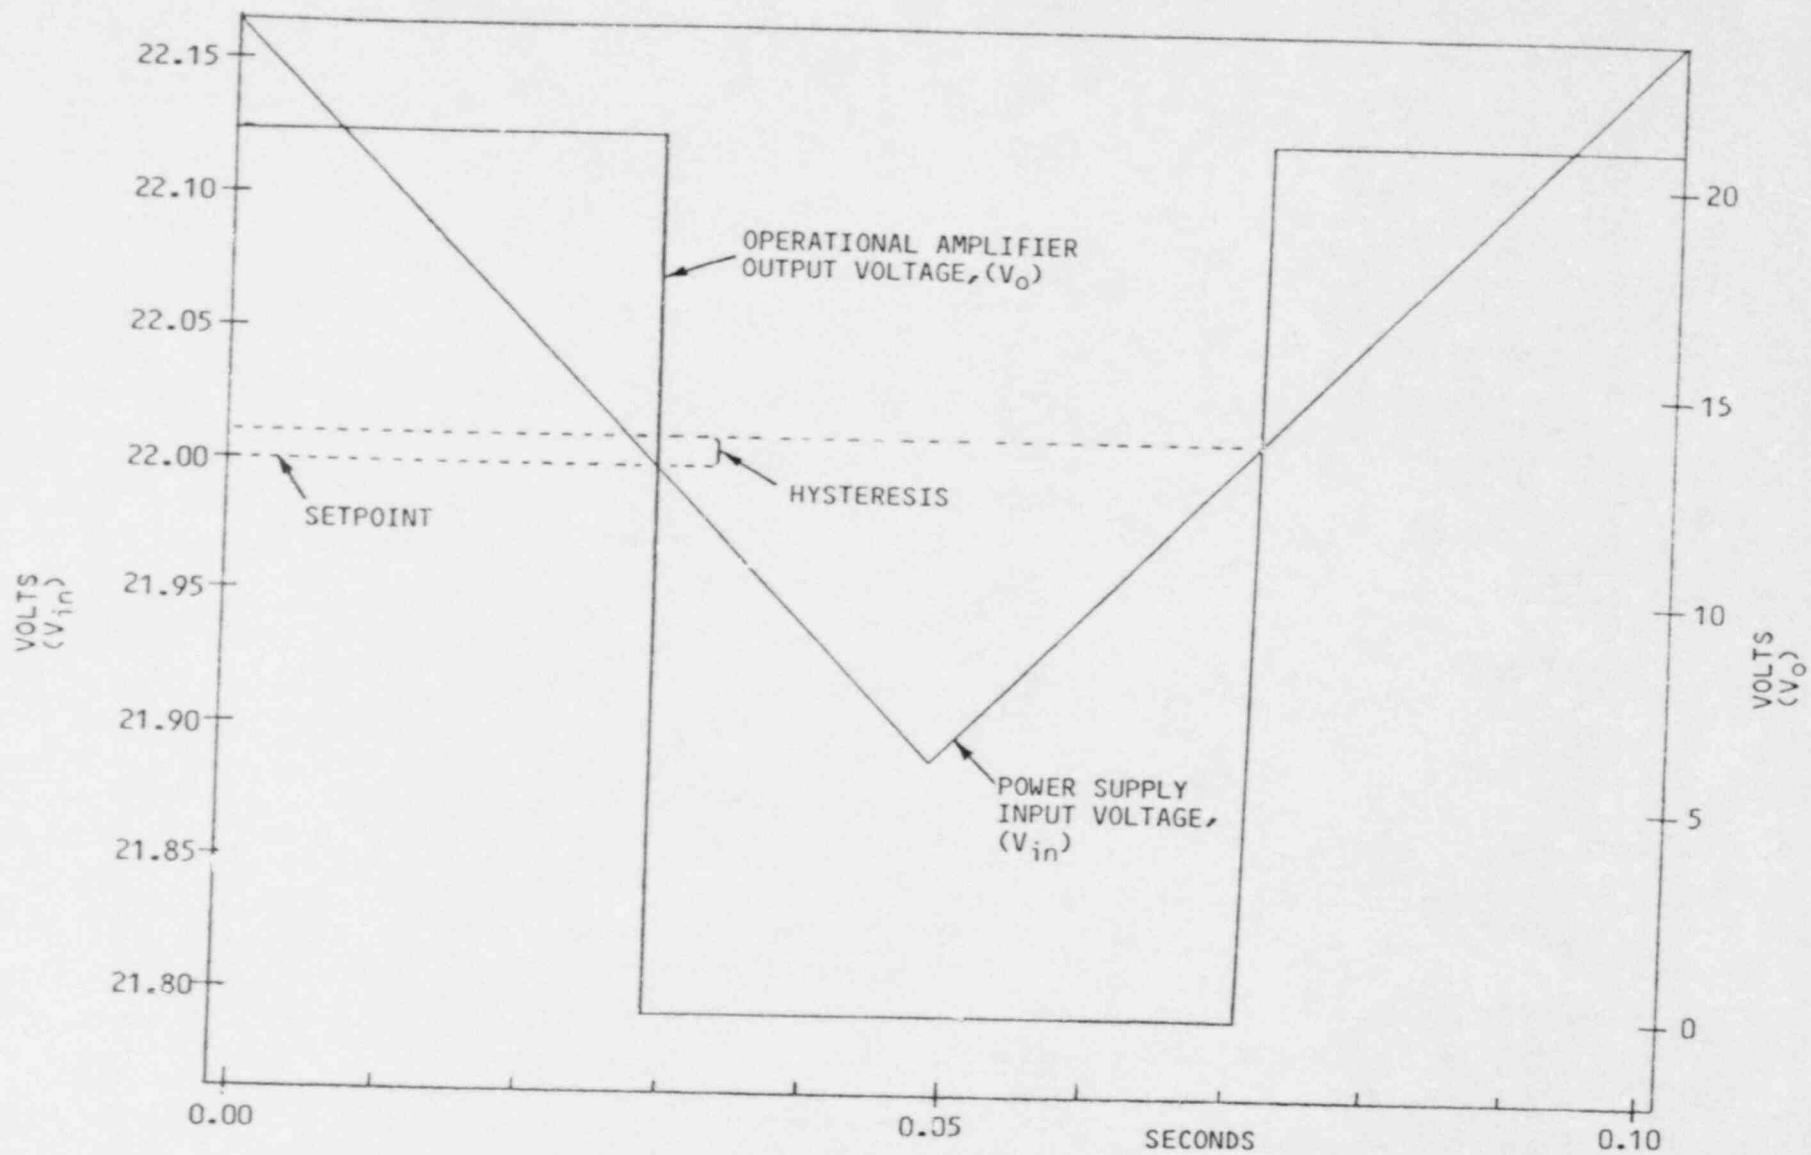
Figure 3.27 Power supply monitor, positive bus sensing circuit switching response with zero input resistance (ideal approximation)

The PSM positive bus monitoring undervoltage detection circuit was tested for sensitivity to input resistance by applying an input voltage to the PSM that was slowly ramped down through the trip setpoint, causing a trip to occur, and then ramped back up until reset occurred (i.e., the input voltage followed a triangular waveform). This test was repeated for 13 different values of series input resistance, ranging from 0 to 55 ohms. For each test, the input voltage (V_{in}), the operational amplifier output voltage (V_o), and the relay driver transistor collector voltage (V_c) were recorded using an oscilloscope (refer to Figure 3.26 for the monitored voltage points). The expected voltages for a 0-ohm input resistance and the voltages observed for a 1.7-ohm input resistance are shown in Figures 3.27 and 3.28, respectively.

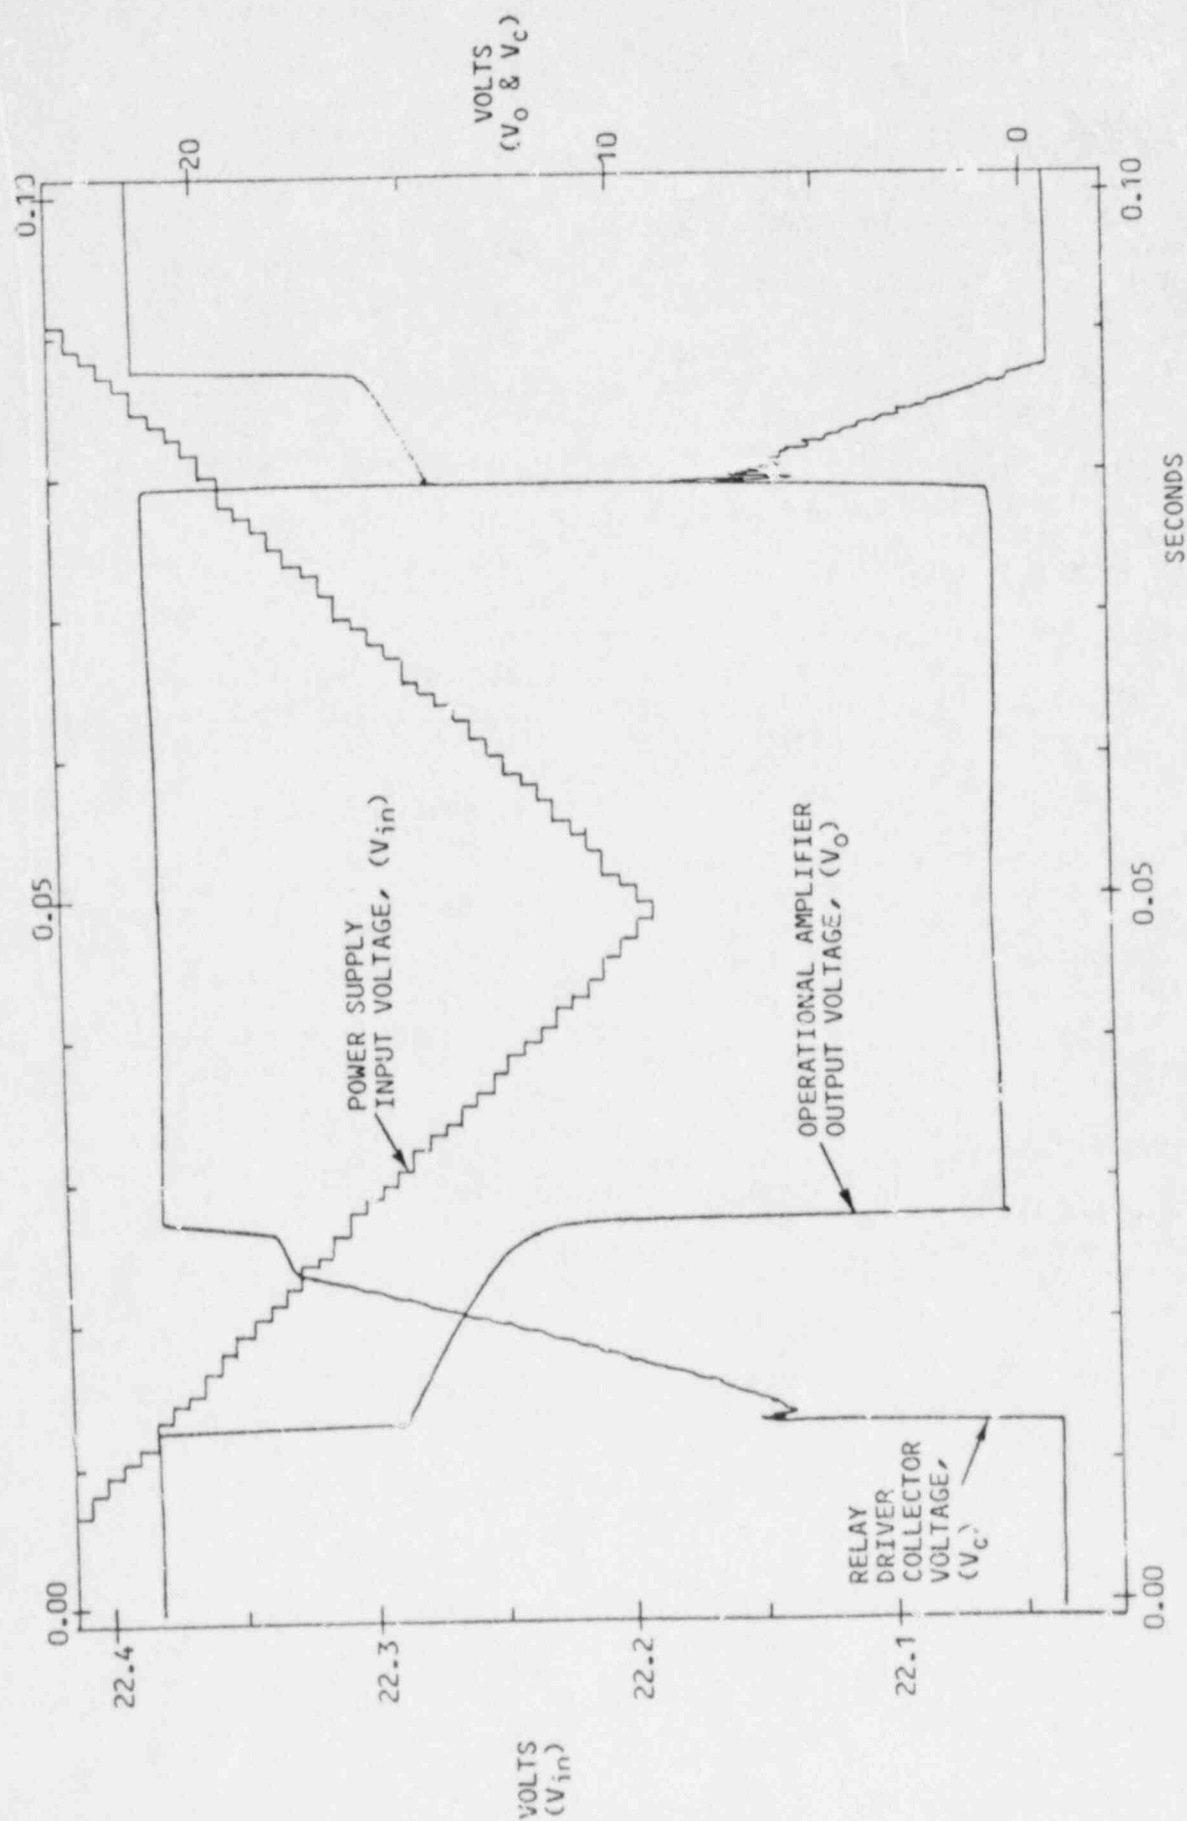
Figure 3.28 Power supply monitor, positive bus sensing circuit switching response with a 1.7-ohm input resistance

A series resistance at the input to the PSM would be expected to cause a voltage drop across the resistance, and hence a lower voltage being monitored/sensed by the undervoltage detection circuit than actually exists on the positive bus. Therefore, although bus voltage may be normal, the margin to the trip setpoint value decreases (in the direction toward PSM actuation), and the amount of the decrease would be expected to be essentially equal to the voltage drop (e.g., if the input resistance creates a voltage drop of 1 V so that the undervoltage detection circuit effectively believes that bus voltage is 23 V dc as opposed to an actual value of 24 V dc, then the margin to the

trip setpoint of 22.0 V dc would be reduced by approximately 1 V). However, since the operational amplifier comparator and output relay driver portions of the undervoltage detection circuit are also operating with a degraded voltage, the characteristics of the undervoltage detection circuit also change, causing it to behave in an abnormal manner. Instead of providing a sharp quick-action response upon the sensed input reaching the trip setpoint value (as shown in Figure 3.26), the circuit response becomes soft/slow and the trip setpoint value varies from its normal value as can be seen from Figure 3.28.
